ST JOHN'S CATHEDRAL

195 Church Street, Parramatta, NSW

Conservation Management Plan

**DRAFT #1
MAY 2018**

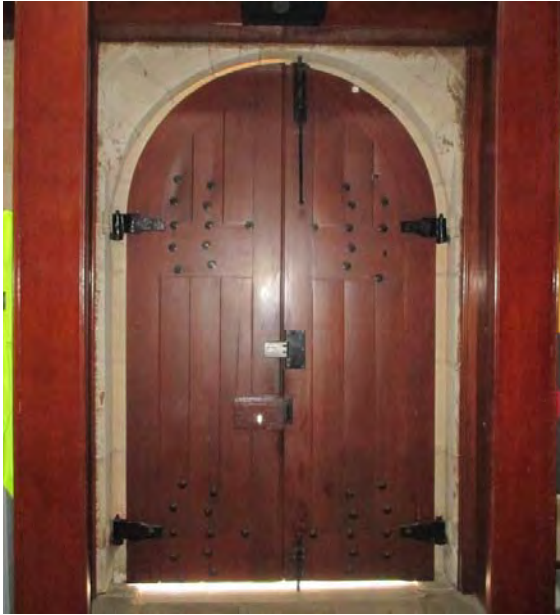
Figure 2.3.34: 1852-55 timber framed, ledged and braced door to the western elevation. This door has a stained finish internally.

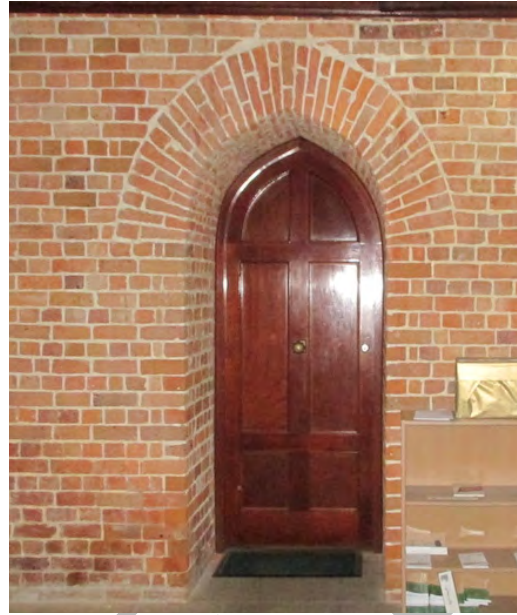
Figure 2.3.35: 1960's timber door to the North tower. Note unpainted sandstock brick.

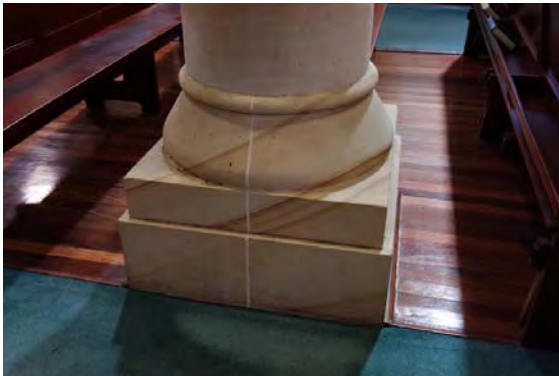
Figure 2.3.55: In 1967 a number of the stone bases were replaced as evidenced by the banded stone and the central joint.

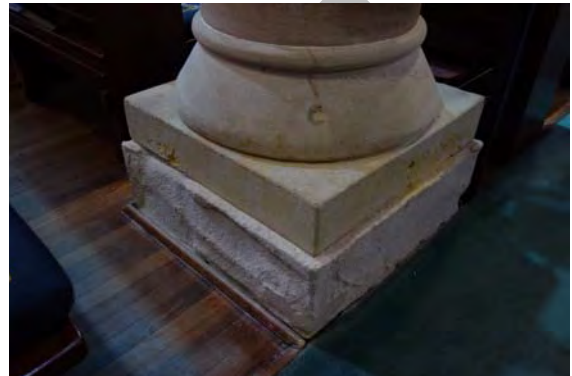
Figure 2.3.56: Erosion of the stone bases would appear to be ongoing.

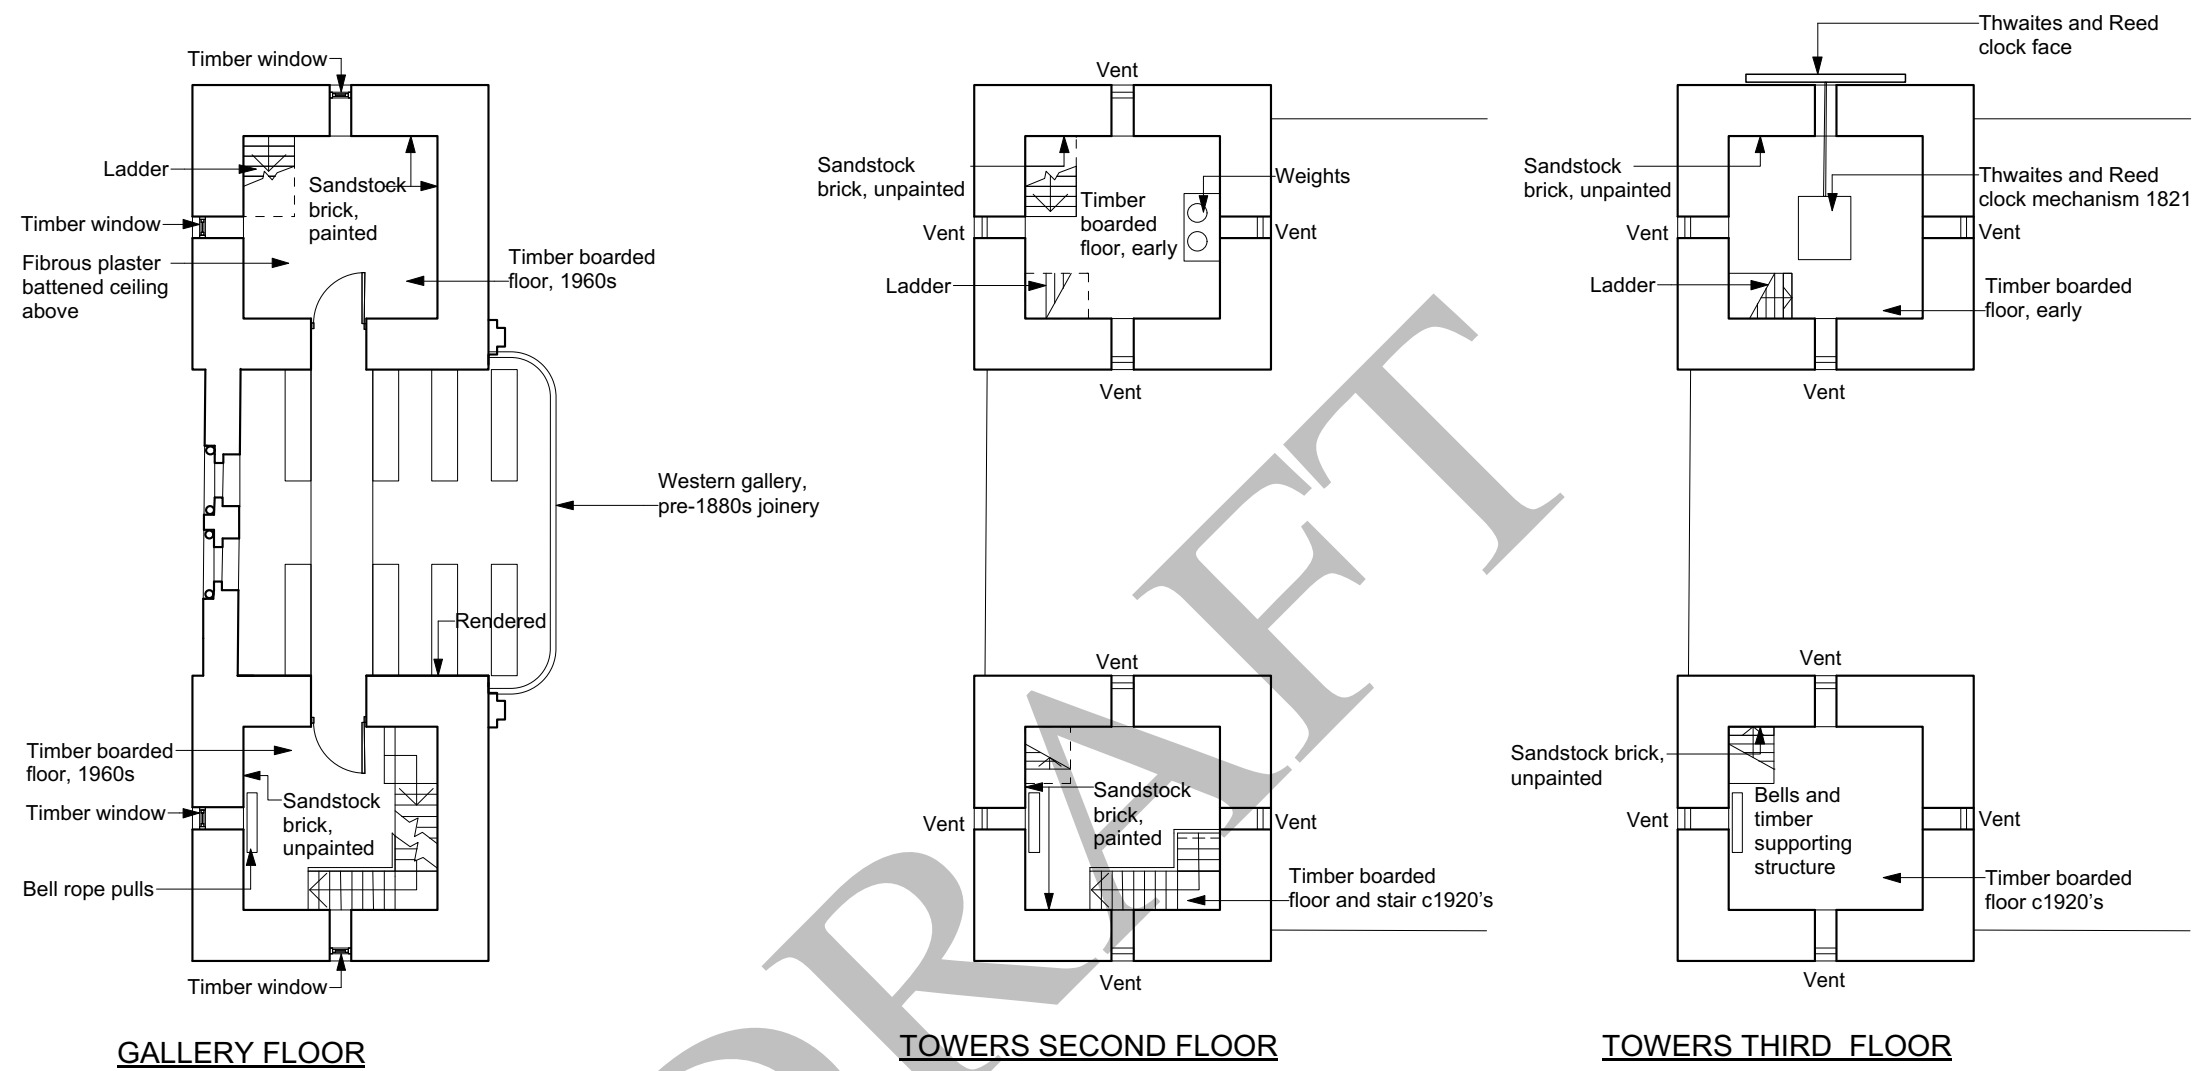
Figure 2.5.2: Fabric Survey – St John's Anglican Cathedral, Gallery, Levels 2 and 3 (Towers)

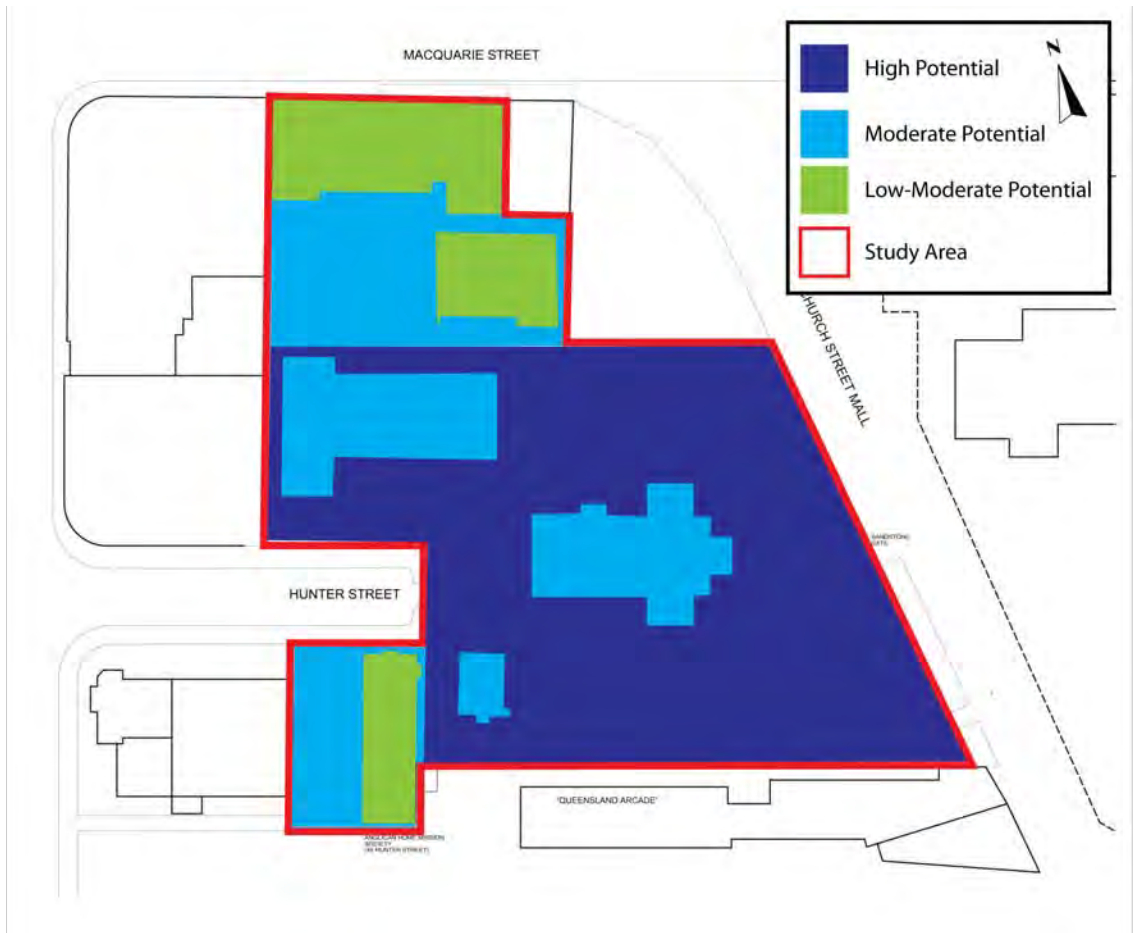
Figure 2.7.4: Historical Archaeological Potential and Historical Structures Overlay (Source: Curio Projects, 2017)

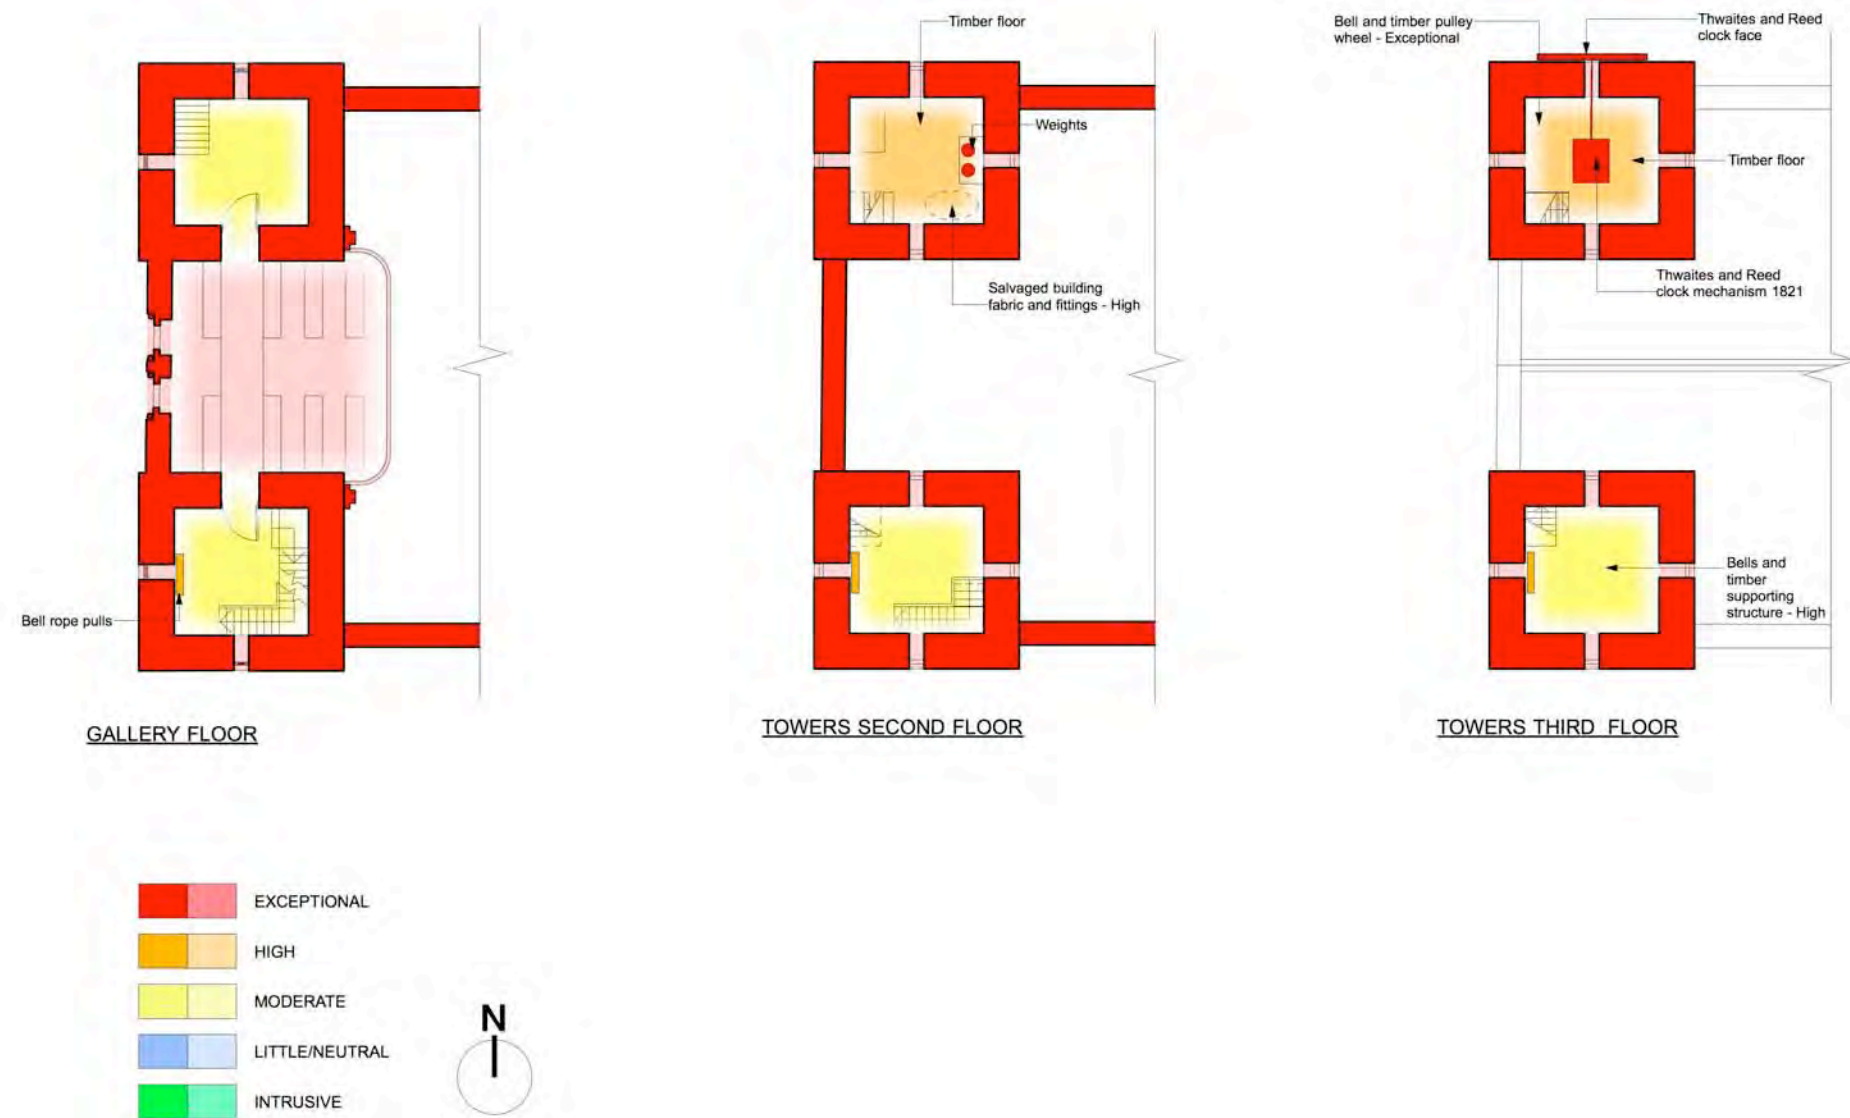
Figure 3.6: Significance Gradings: St John's Anglican Cathedral
