Civic Link Block 3- Aboriginal Cultural Heritage Due Diligence

1. INTRODUCTION

1.2. Project summary

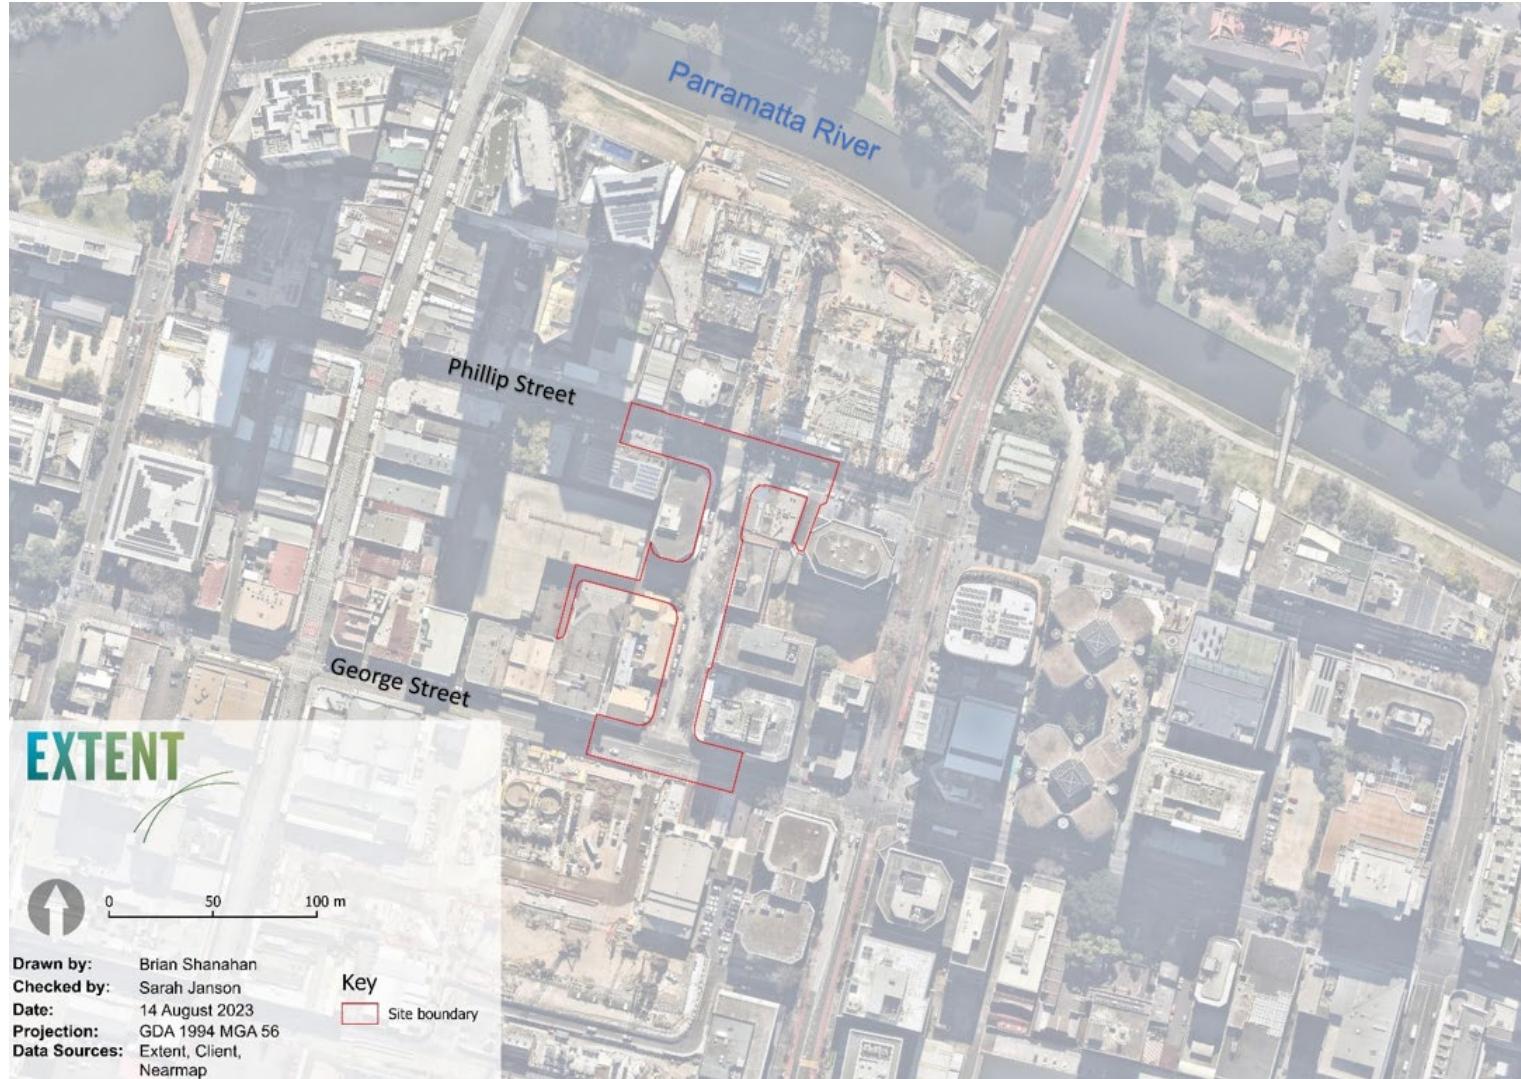
Figure 2. Extent of the proposed study area

The study area is shown in Figure 1 and Figure 2.

There is one registered Aboriginal site, AHIMS 45-6-3679, within the subject land (Figure 2), however this has been classified as 'not a site'. This means the site had been originally entered and accepted onto AHIMS as a valid site but after further investigations it was decided it is not an Aboriginal site. AHIMS 45-6-3679 was listed as three discrete locations along Phillip Street, which had minimal subsurface disturbances mapped and was therefore registered to enable testing to establish the level of disturbance (Figure 3). The site card notes that it was inferred that due to the absence of documented sources, it could not definitively be determined that Parramatta Sand Body deposits had not survived in these areas. The associated report and the information regarding the eventual non-site decision has been requested for further information but was unavailable at time of writing.

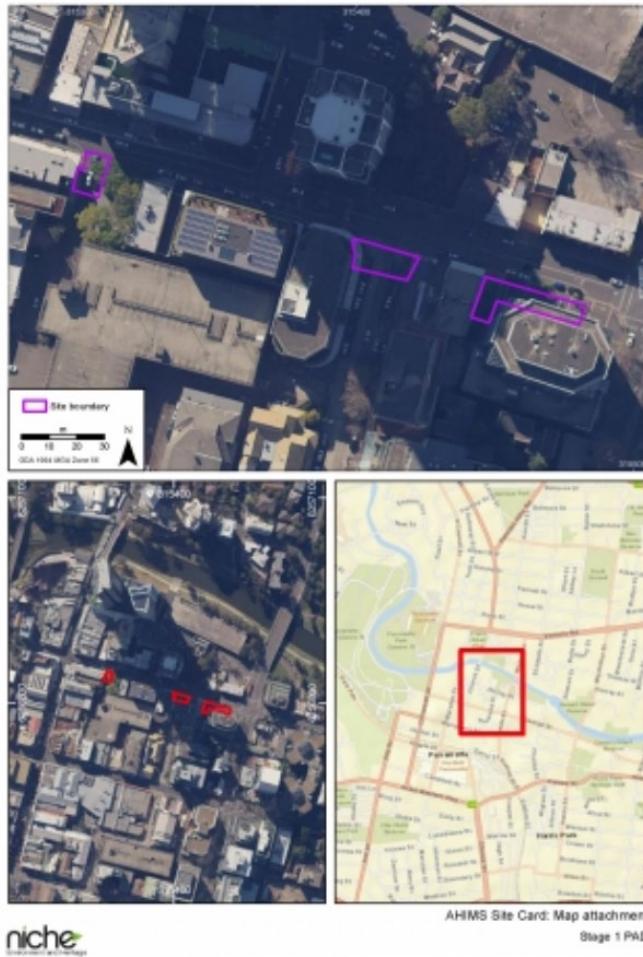
Figure 3. Extract from site card for AHIMS 45-6-3679 showing initial location and extent of Potential Archaeological Deposit.

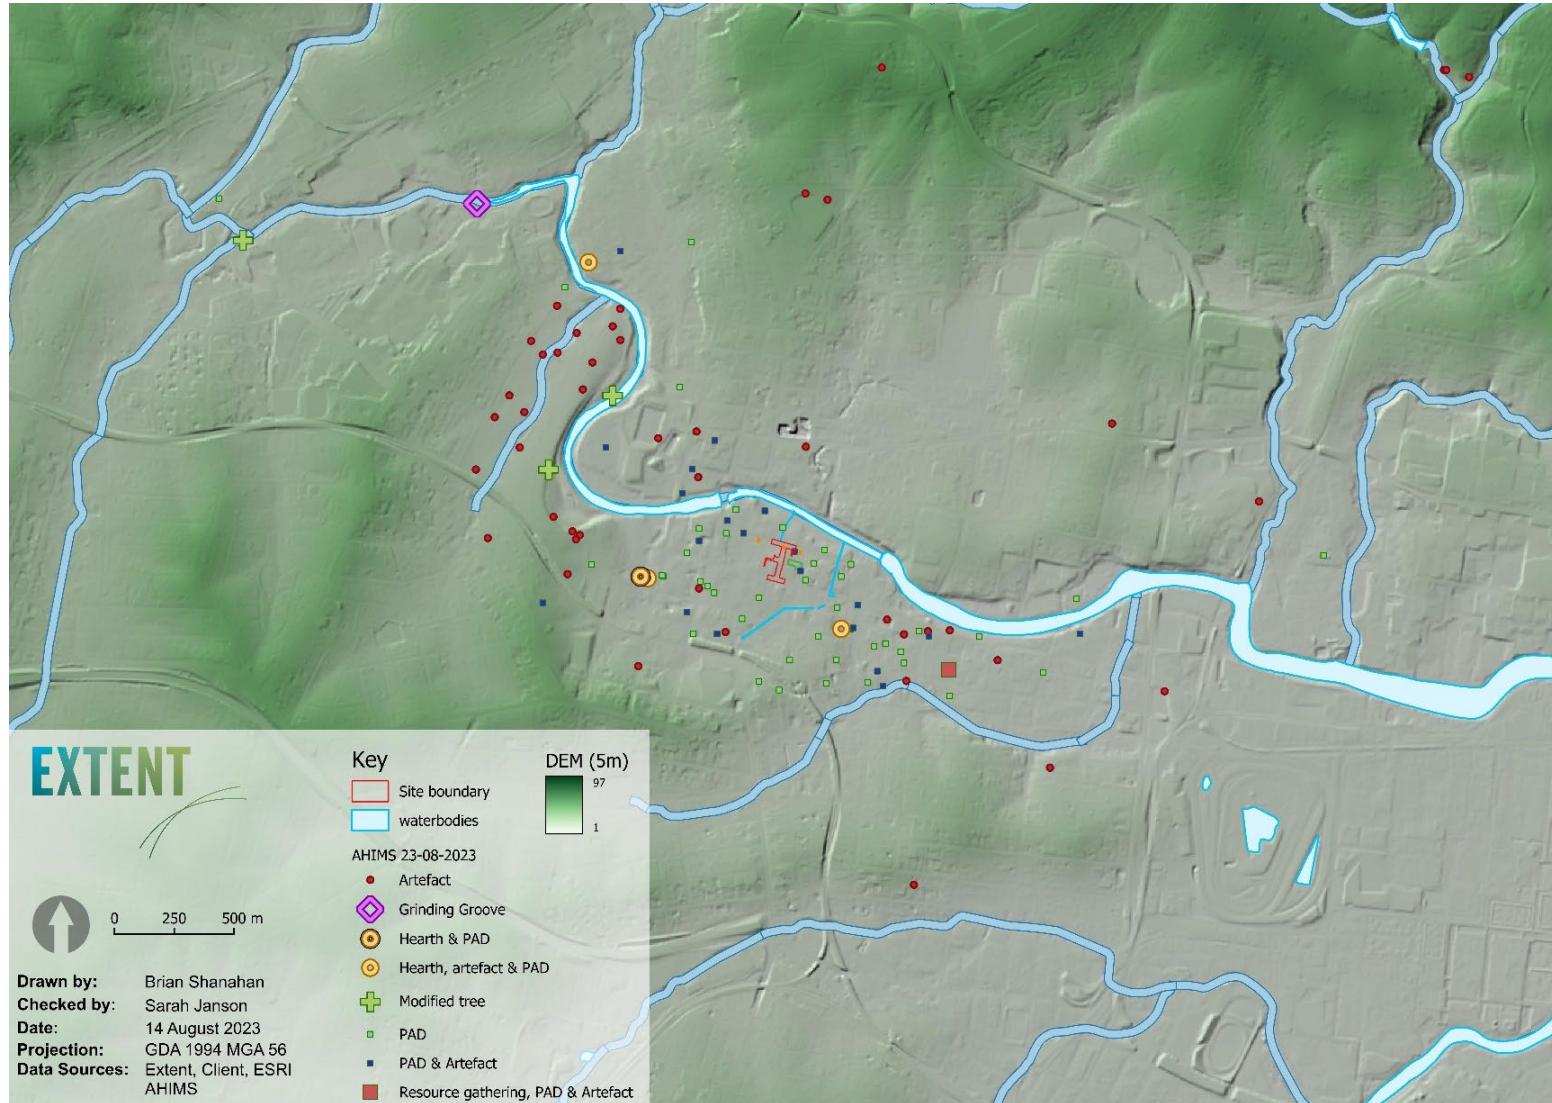
Figure 4. Overview of AHIMS Sites within and near the study area.

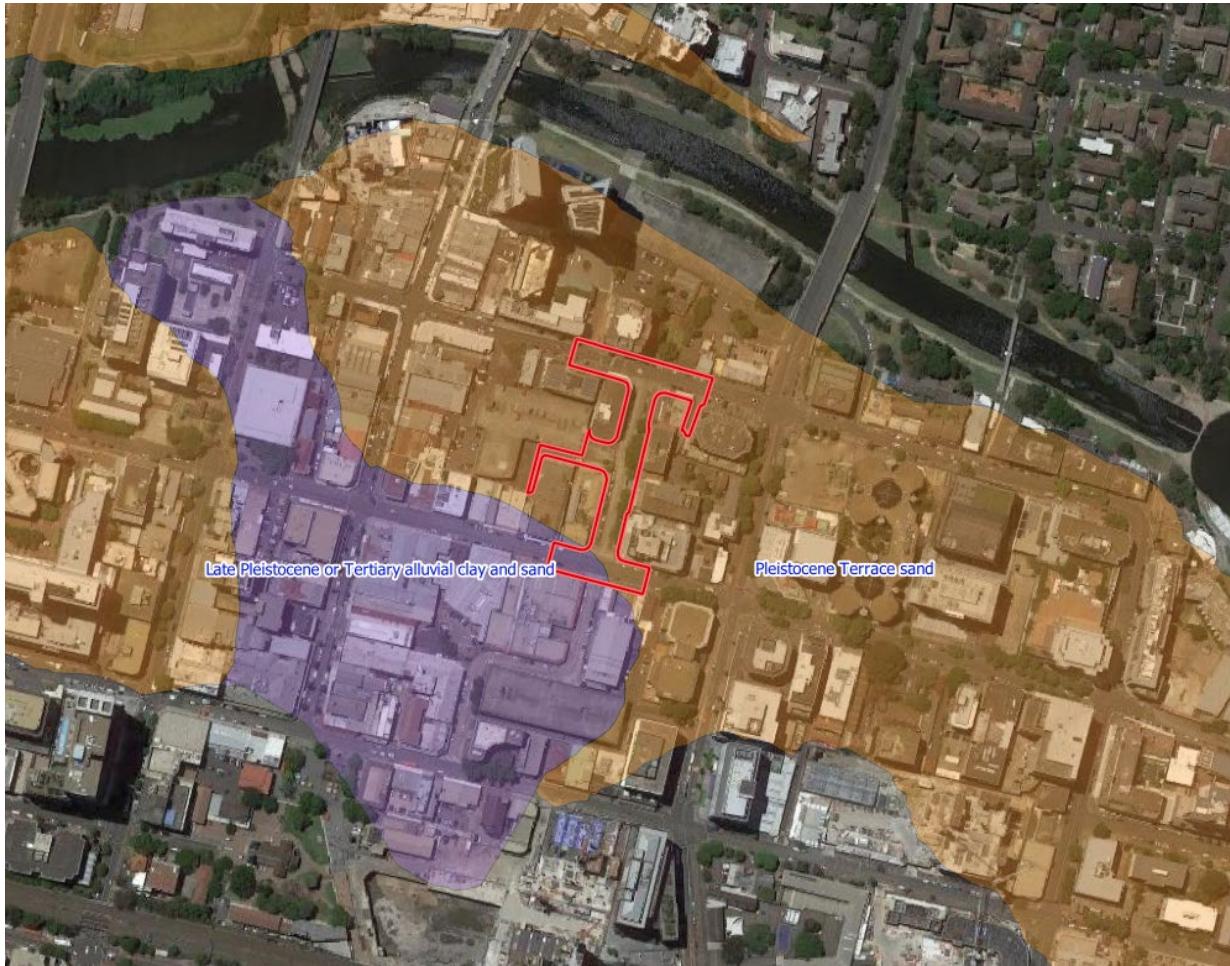
Figure 5. Extract of Parramatta Sand Body mapping, based on Groundtruth Consulting 2008. The Parramatta Sand Body deposit is indicated by the orange shaded Pleistocene Terrace sand unit.

Although the exact extent of the Pleistocene Terrace sand body is unknown, the mapping undertaken by Groundtruth Consulting, on behalf of Parramatta City Council, indicates that the study area is located within this deposit (Groundtruth Consulting 2008).

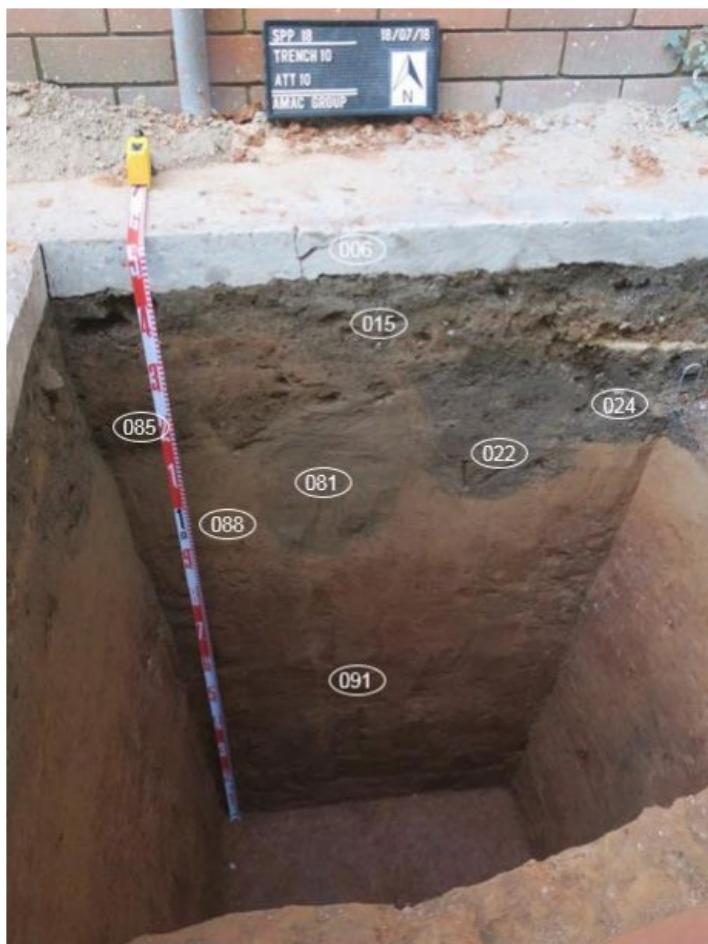
Figure 4.2 Final photograph north section Trench 10, sondage ATT10.
AMAC Group, IMG_5659, 18/07/18.

Figure 6. Natural soil profile of red clayey sands, (088) and (091), from AMAC excavations at 32 Smith Street & 93-95 Phillip Street.

2021). Whilst the Aboriginal archaeological excavation report is currently unavailable for review at the time of writing, the results of the historical archaeological excavation indicate that in at least one portion at the southeast of the site, a natural soil profile was encountered that consists of a series of red clayey sands, noted to be vastly different from the natural soils found in the other test trenches. This soil profile matches the descriptions of the Pleistocene sand terrace, suggesting that the study site is located across multiple geological formations. Truncated and reworked A1 and A2 soil horizons consistent with the Birrong soil landscape were identified elsewhere on the site, indicating that despite later historical disturbances, soil horizons with the potential to contain Aboriginal cultural heritage material are present in the vicinity of the study area.

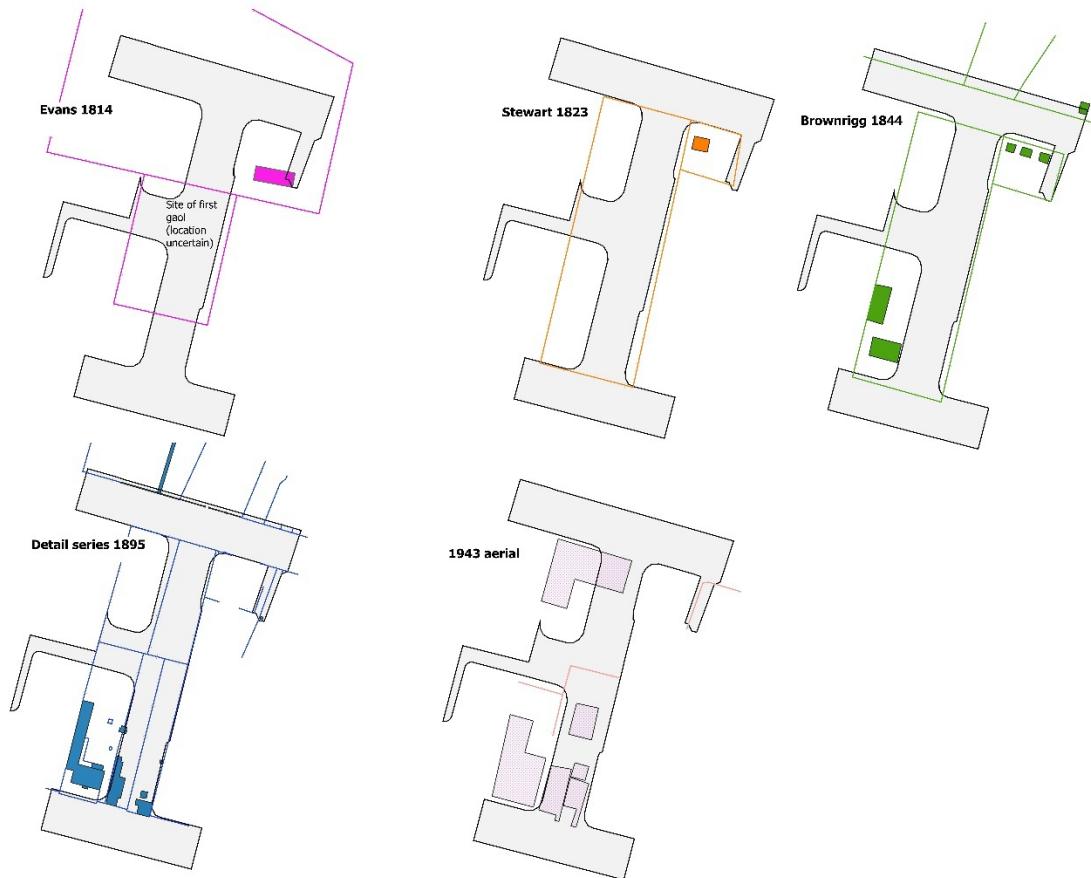
Figure 7. Preliminary overlays of historical buildings in relation to the study area, based on the Evans (1814), Stewart (1823), Brownrigg (1844), detail series maps (1895) and historical 1943 aerial imagery.

Figure 7 illustrates the historical development of the site based on overlays of a series of historical maps. The structures noted to primarily front George Street, with little to no development within the central portion of the study area. Further historical aerial imagery from the mid-twentieth

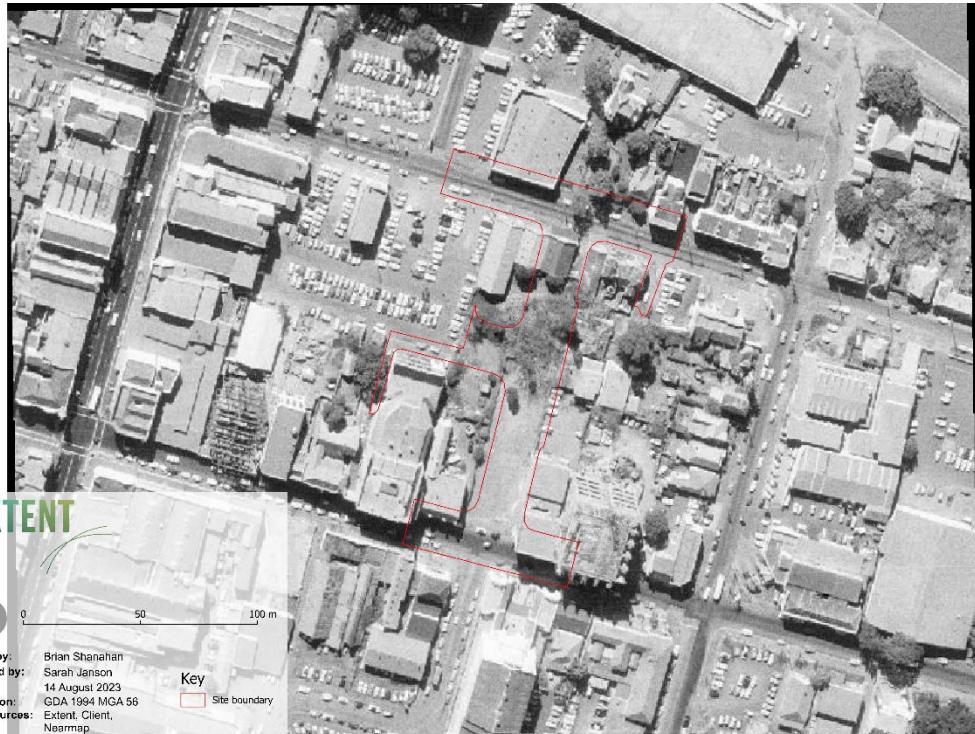
Figure 8. 1969 historical aerial showing the clearance of the study area, prior to the construction of Horwood Place.

century shows the development of Horwood Place as a roadway, starting with clearance of the site in 1969 (Figure 8; also shows further structures at the Phillip Street frontage at this time) and construction throughout the 1970s.

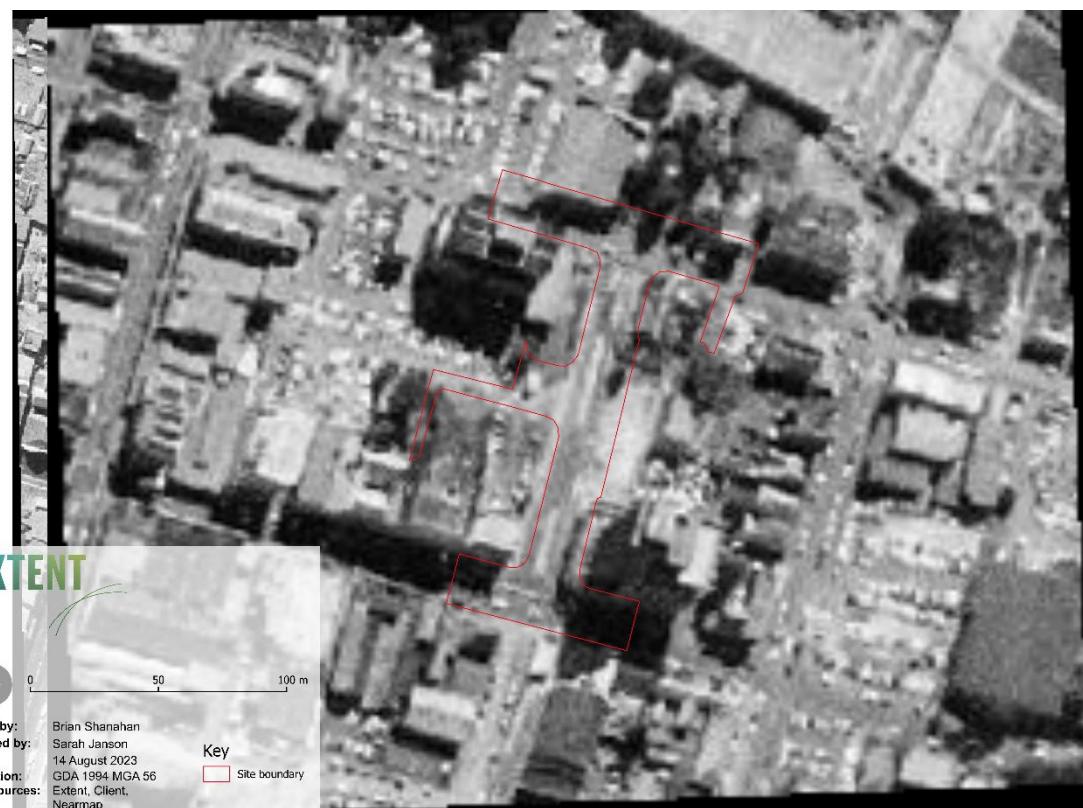
Figure 9. 1974 historical aerial showing Horwood Place as a roadway.

This development is likely to have affected the upper portion of the land surfaces, however there appears to be no significant large cut-and-fill events.

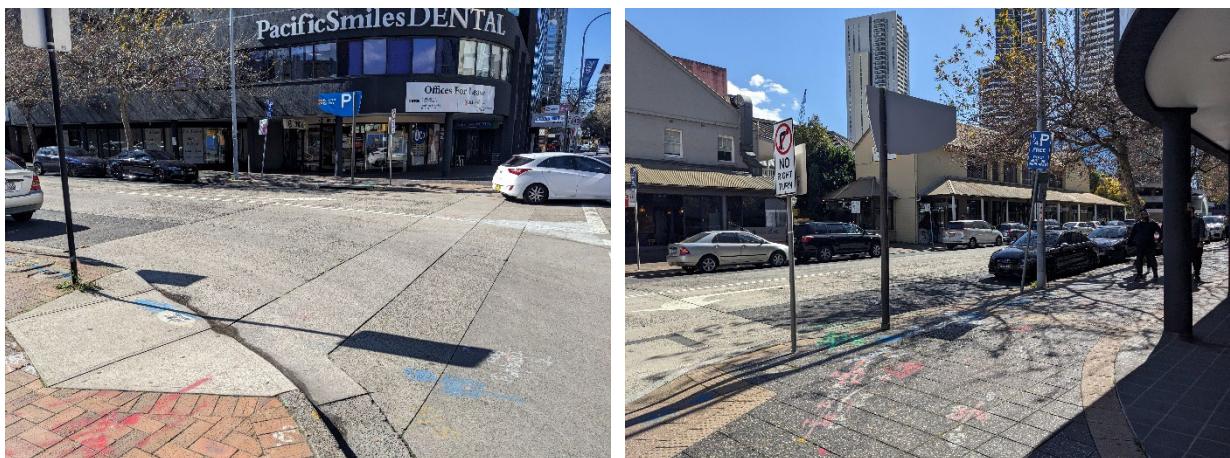
Figure 10. George Street, at southern most part of study area. Note service pits in footpath at left of image. View east, S. Janson, 10 August 2023.

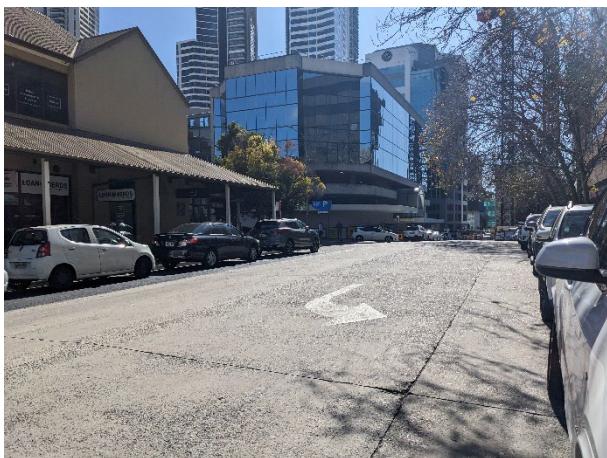
Figure 12. Horwood Place, note rising landscape towards central part of study area. View north, S. Janson, 10 August 2023.

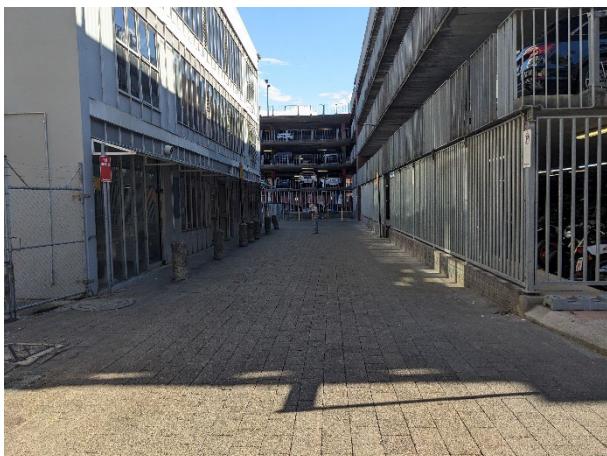
Figure 14. Auctioneer's Lane, with paved surface. Car park at right of shot, note different levels. View west, S. Janson, 10 August 2023.

The buildings adjacent to the study area on the eastern side were noted to have been cut slightly below street level. The Eat Street Carpark to the west of the study area at Auctioneer Lane also falls away below the street level. The construction of the road surface is considered to have caused some, but not extensive, impacts to the underlying soil profile, given the retention of the general topography of the area. Elsewhere, drains, footings for structures and street furniture and subsurface services represent localised areas of deeper impacts.

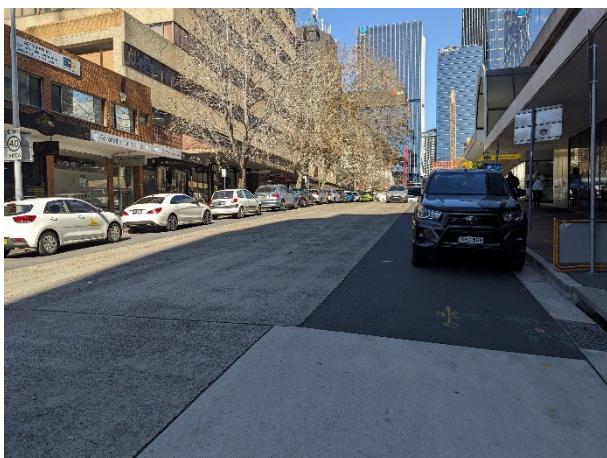
Figure 16. Horwood Place from Phillip Street, looking up slope towards top of rise and George Street. View south, S. Janson, 10 August 2023.

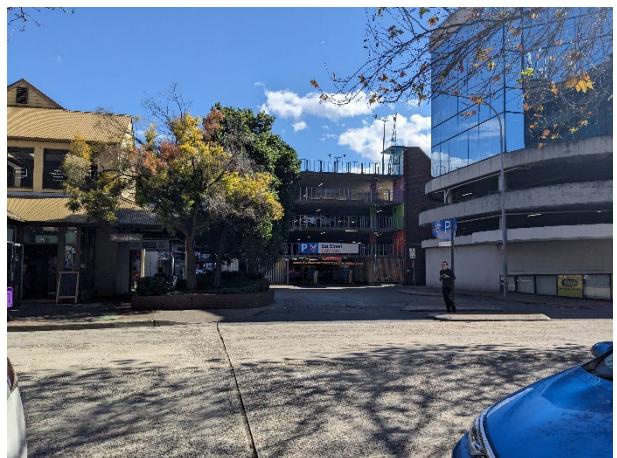
Figure 13. Eat Street Car Park entrance, at top of rise. View west, S. Janson, 10 August 2023.

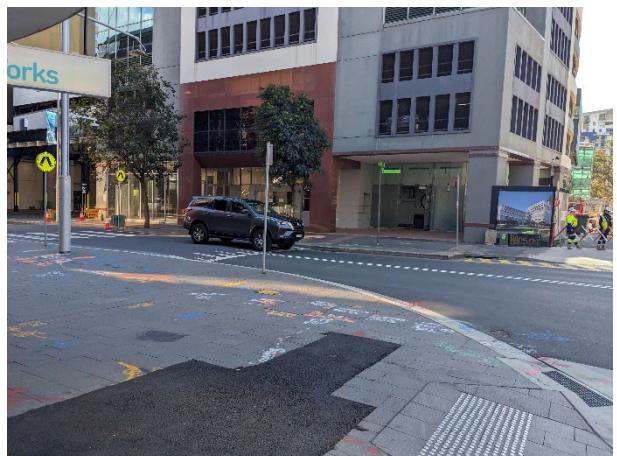
Figure 15. Phillip Street, note recent works in footpath area. View north, S. Janson, 10 August 2023.

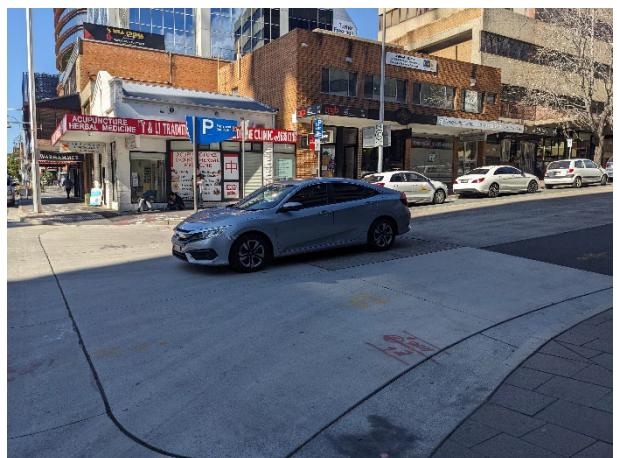
Figure 17. Sealed road at intersection of Horwood Place and Phillip Street, at location of 'not a site' AHIMS 75-6-3679. View east, S. Janson, 10 August 2023.

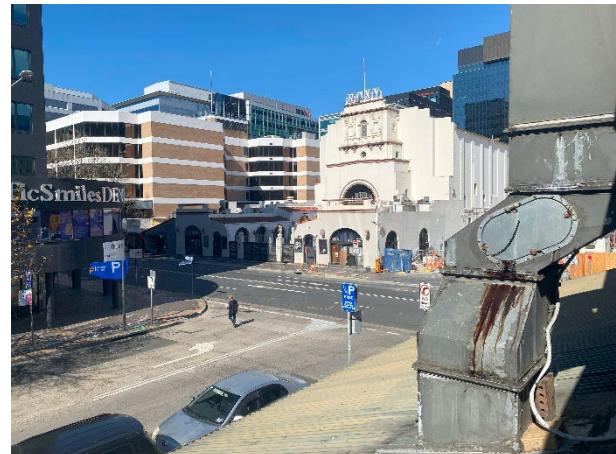
Figure 18. Redcoats Mess House, adjacent to study area. View north, L. Martin, 10 August 2023.
