PROJECT: Consulting Arboricultural Impact Assessment Report.

Parramatta Civic Link Block 3.

Horwood Place (between George & Phillip Street, Parramatta).

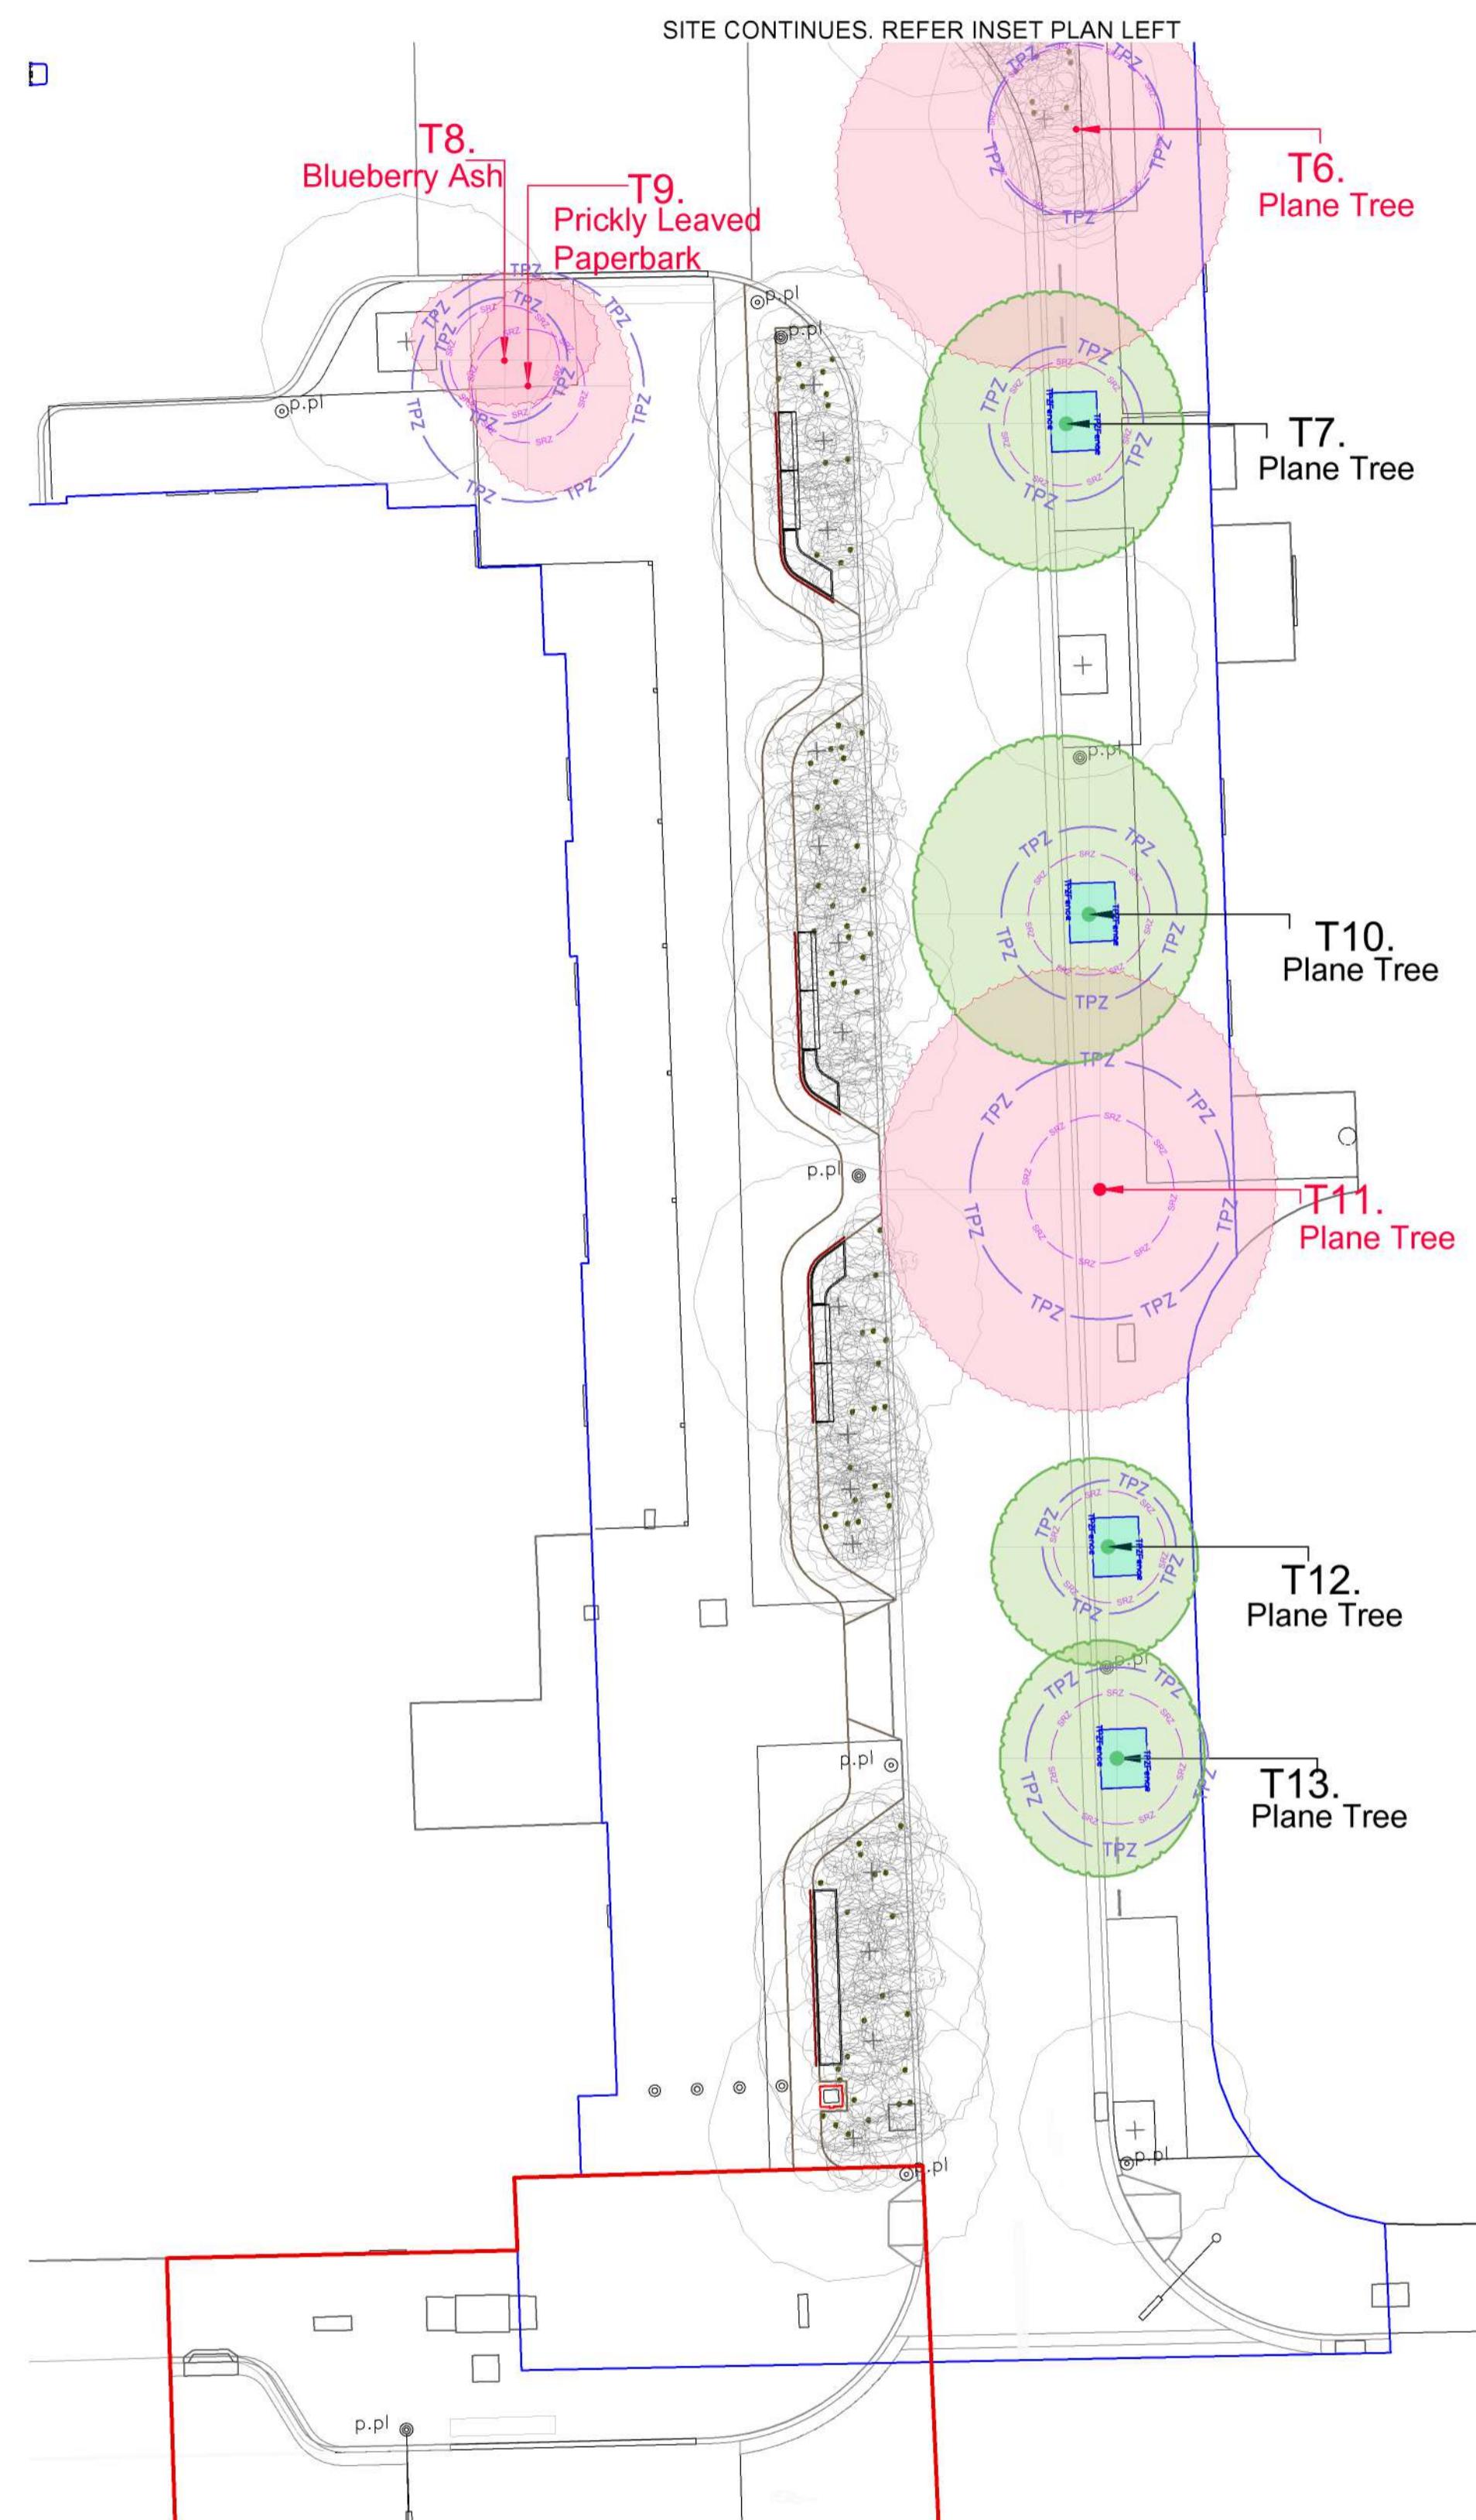
Design Development 100%	
Client: Parramatta City Council.	Drawing Name: Consulting Arboricultural Tree Impact Plan. (with proposal plan as base).
Project Lead, Urban Design and Landscape Architecture: McGregor Coxall.	This plan forms part of the consulting arboricultural Package

Scale: 1: 200 @A1	Job Number: 2307_a
Scale bar: 0 1 2 4 6 10m	Drawing Number: Arb_602 B
Drawn: EHT	Issued:
Job Number: 2307_a	Drawing Number: Arb_602 B

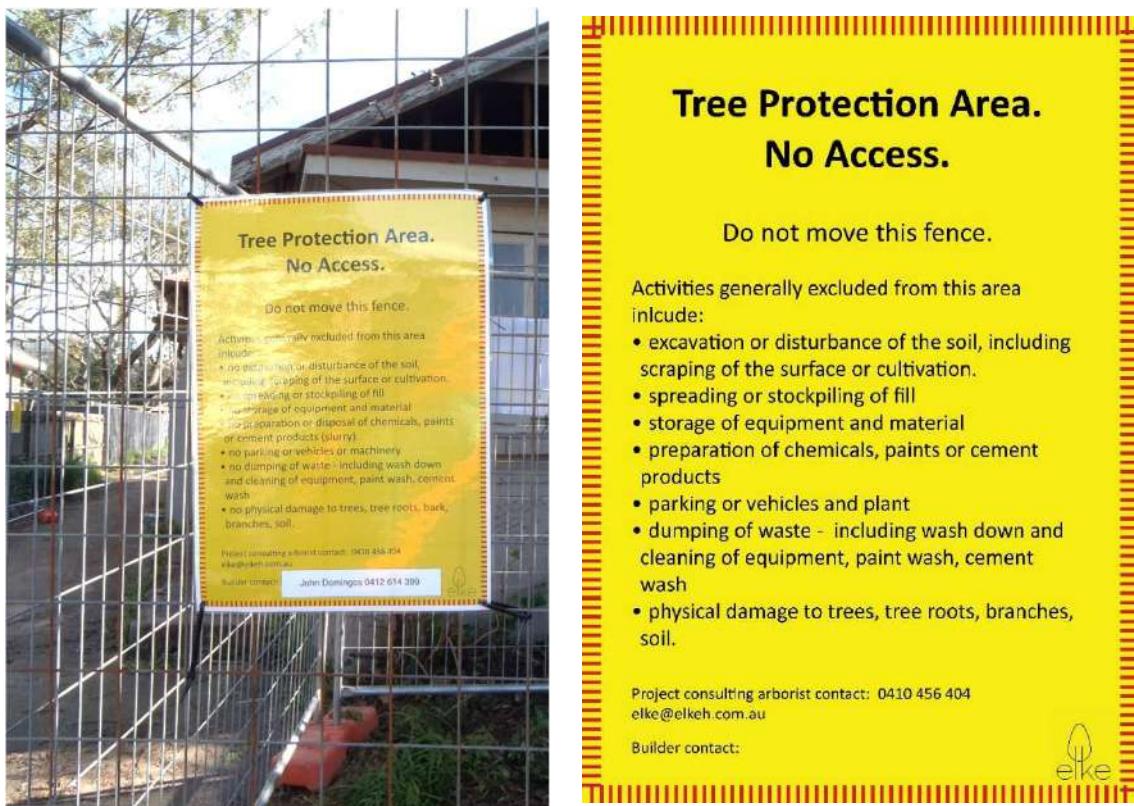
Figure 2 Example TPZ signage, printed at A3 or A2 and fixed to the TPZ fence. A printable TPZ sign is available in the Appendix of this report.

5.5 The TPZ signage is to be firmly fixed on the eastern and western faces of each of the TPZ fenced areas. That is: 2 signs per each of the 4 areas (**total of 8 x TPZ signs**, printed out at A3 or A2 size). An example of the TPZ fencing and TPZ signage is in Figures 2 and 3 and a printable version is in Appendix 7 (for printing onto core flute or laminated).

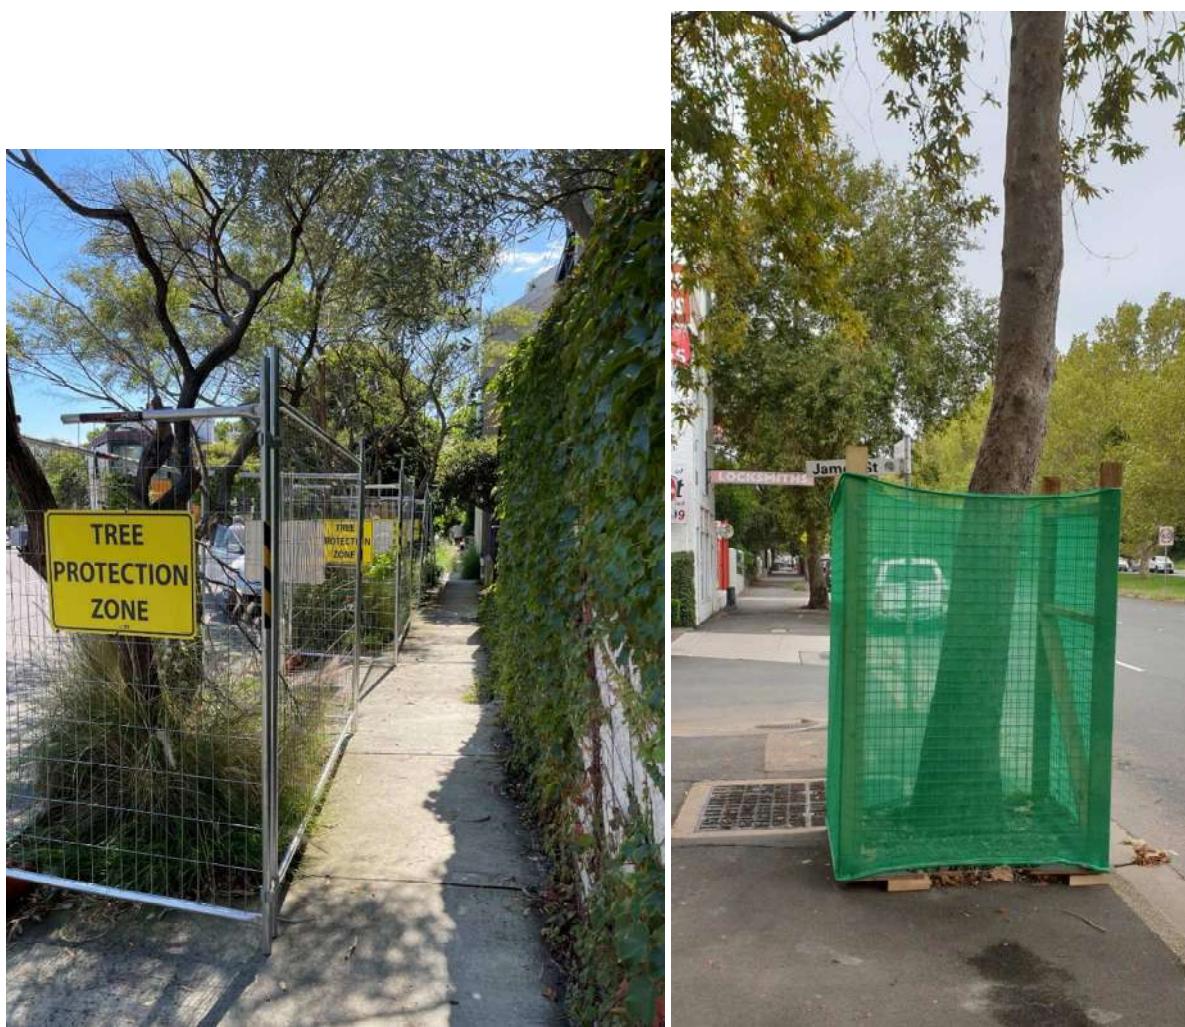
Figure 3 Examples of TPZ fencing. Note: shade cloth is not required for this project.

5.4 **Type of Fence:** Tree or trunk protection fences (TPZ Fences) are to comply with AS 4970-2009 and are recommended to be a minimum **1.8 m high**. This can be achieved with a 1.8 m high **(ATF) or chain link fence with non-penetrable footings. E.g., temporary site or event fencing with plastic or concrete pad footing pads (that do not penetrate the ground)**. The fencing panels are to be **bolt cleated** together so they cannot be easily/readily lifted out of place without the use of a wrench or other tools.

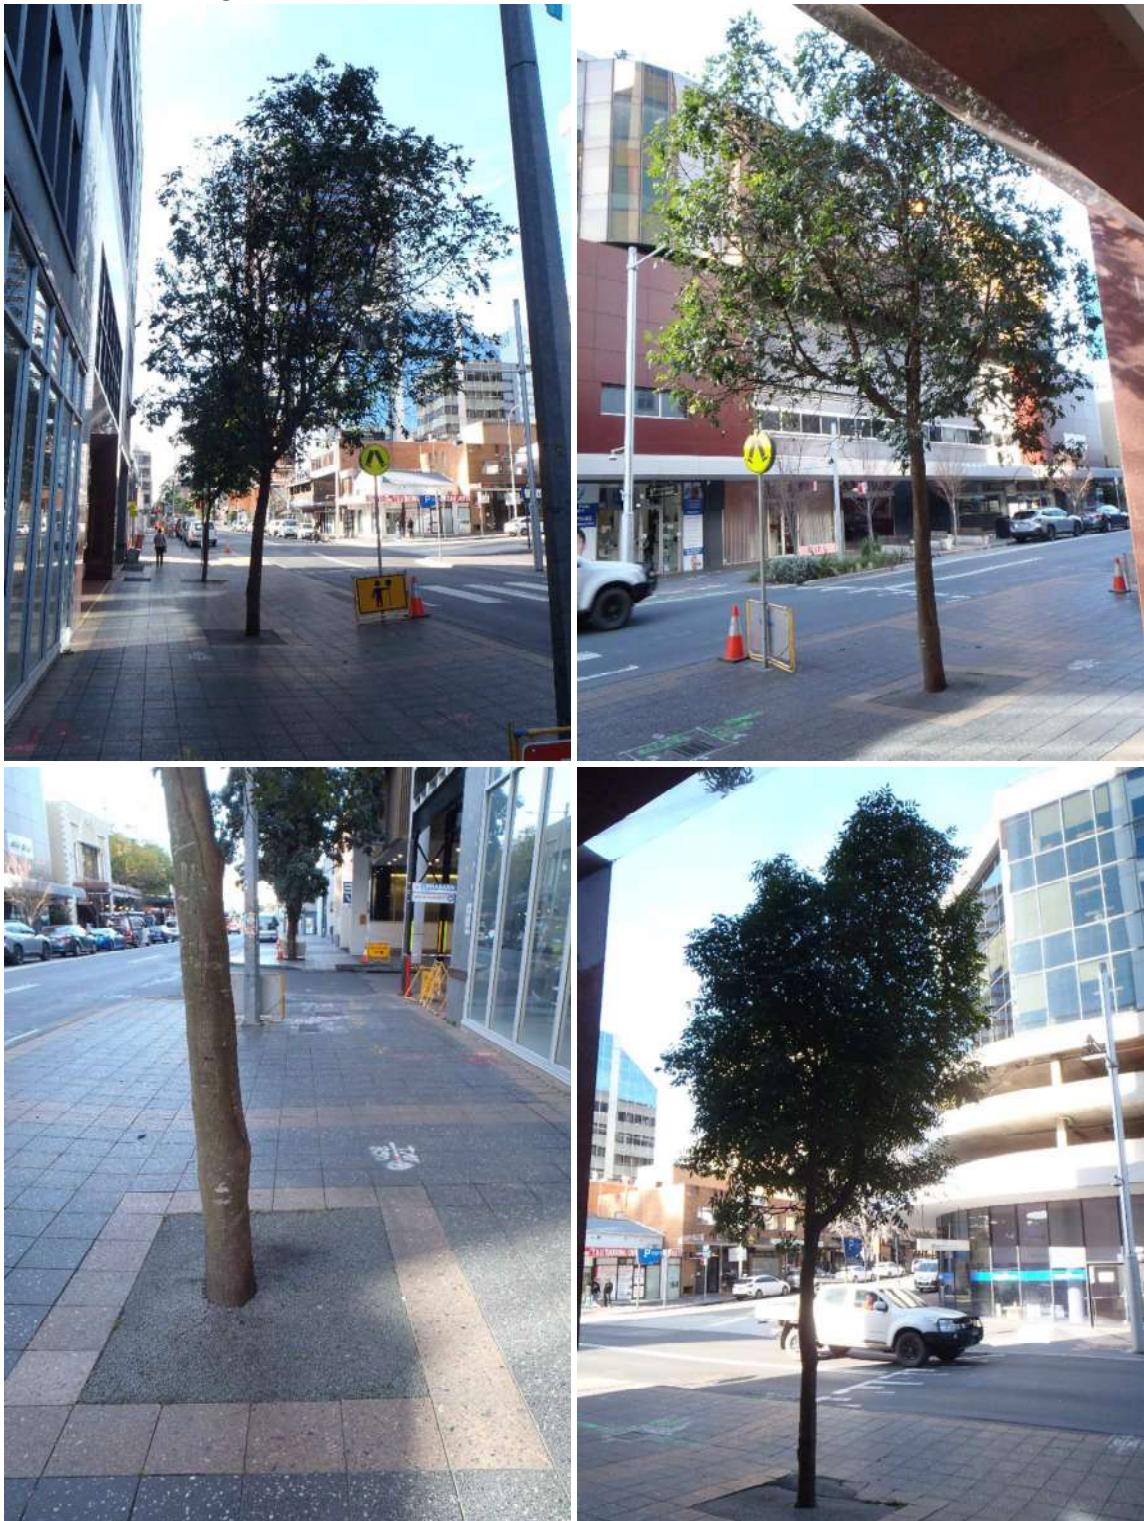
Figure 4. Trees **T1, T2 and T3** are located on Phillip Street and are adjacent to the proposed site works. These trees are proposed to be retained.

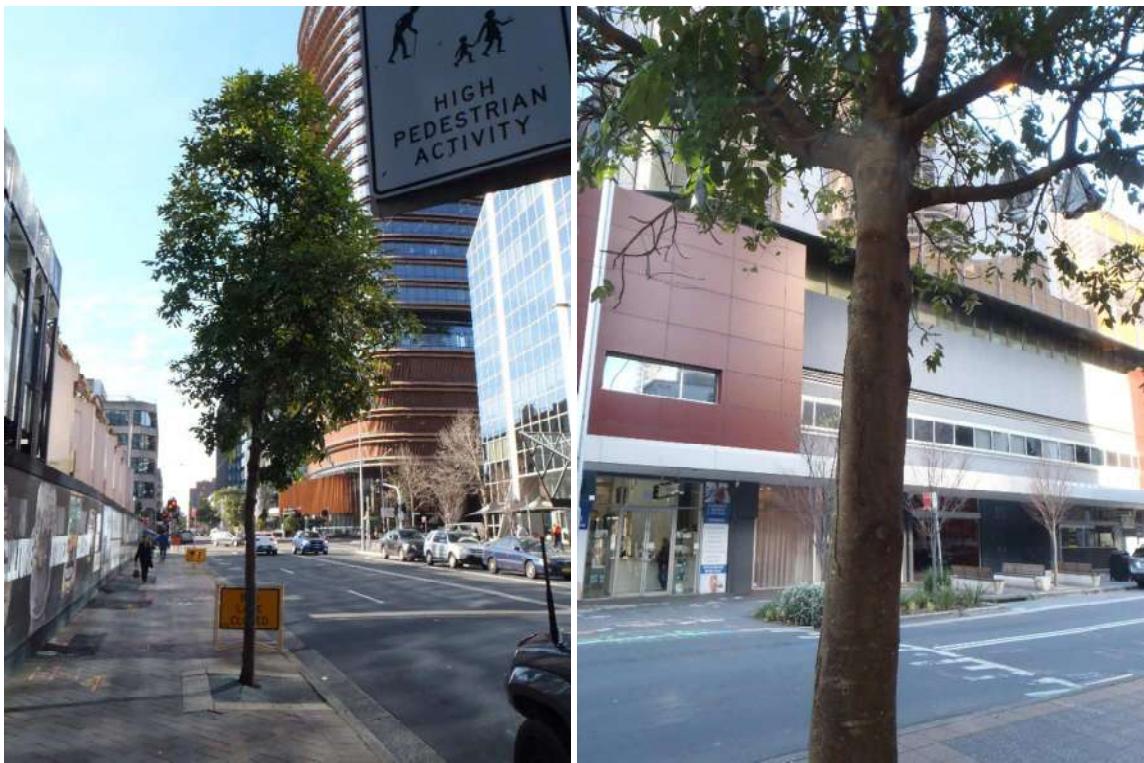
Figure 5. Trees **T1**, **T2** and **T3** are located on Phillip Street and are adjacent the proposed site works. These trees are proposed to be retained.

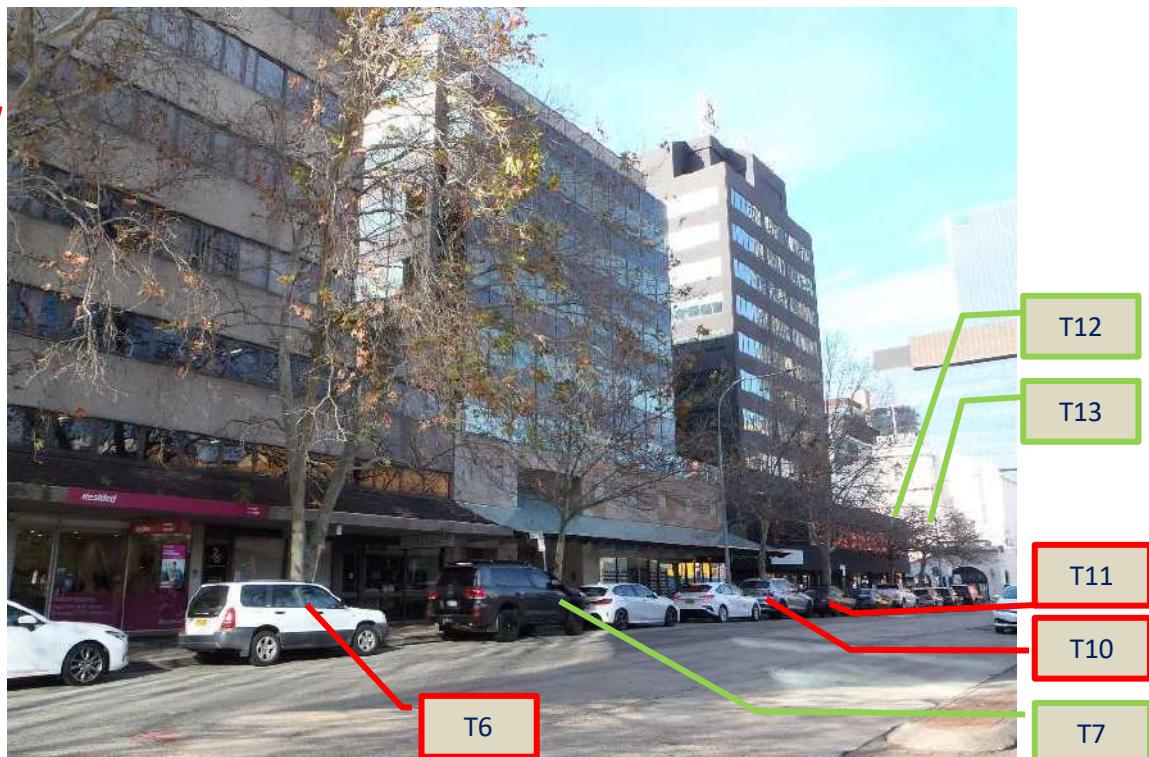
Figure 6. Trees along the eastern side of Horwood Place. The trees labelled with the red box are proposed for removal and the trees with the green boxes are proposed for retention.

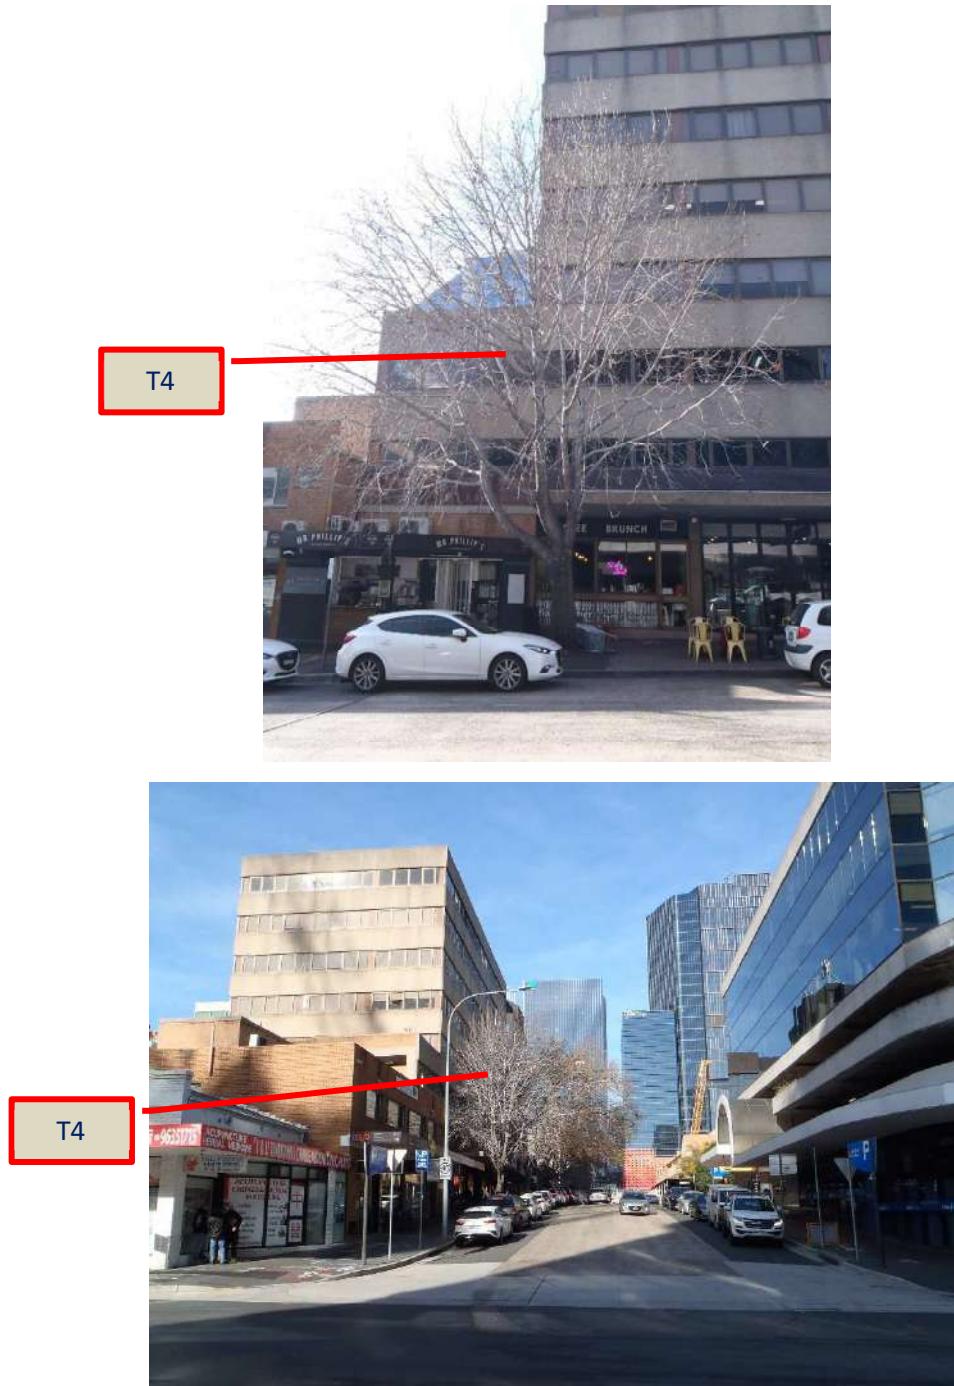
Figure 7. View from Phillip St, looking south towards Horwood Place. **T4** is on the left side in the foreground. Date: 8 August, 2023. Source: ELKE

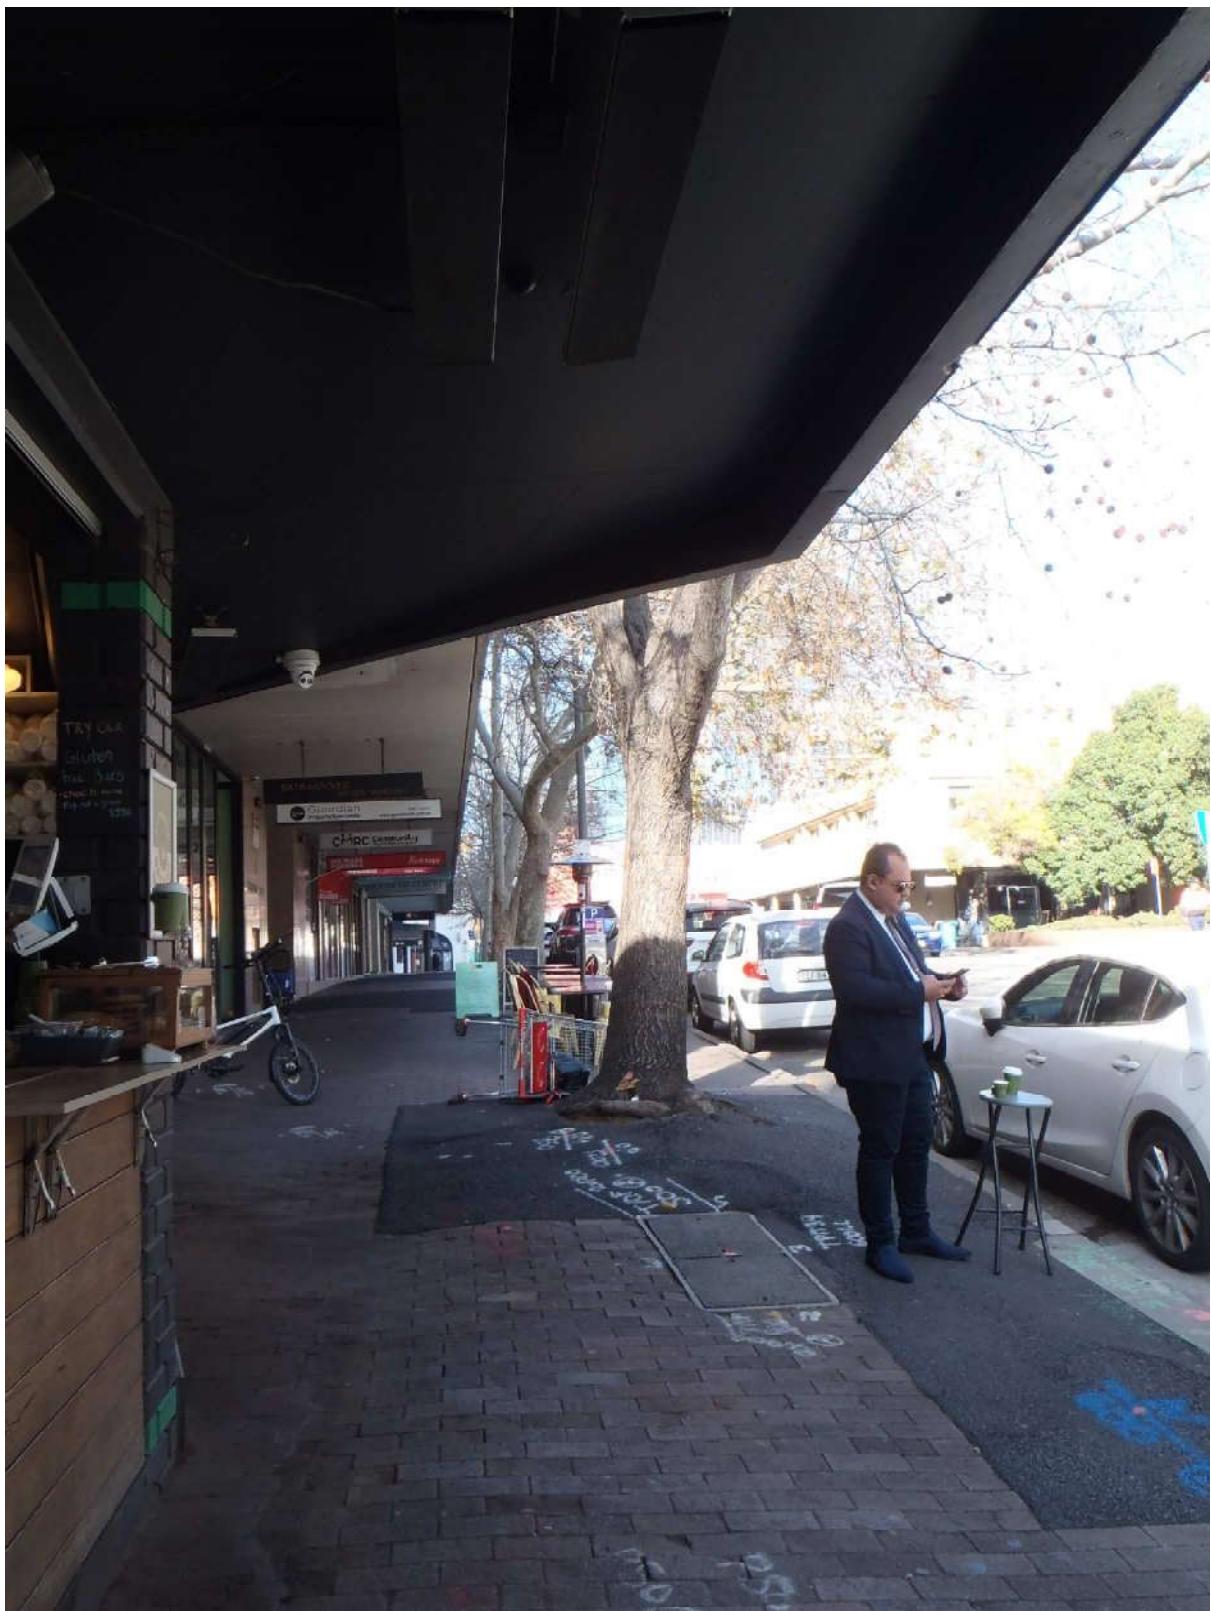
Figure 8. View looking south towards **T4** with surface mounding, multiple services and asphalt surround. Date: 8 August, 2023. Source: ELKE

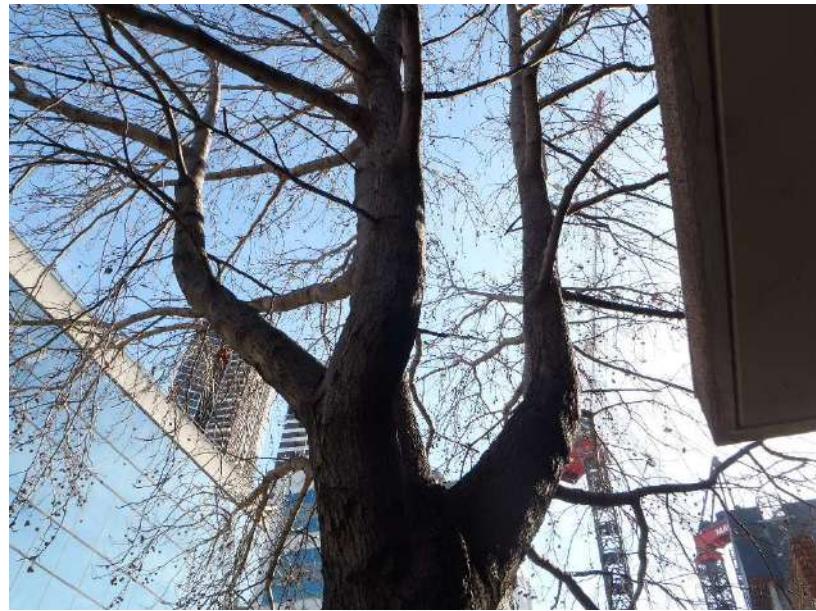
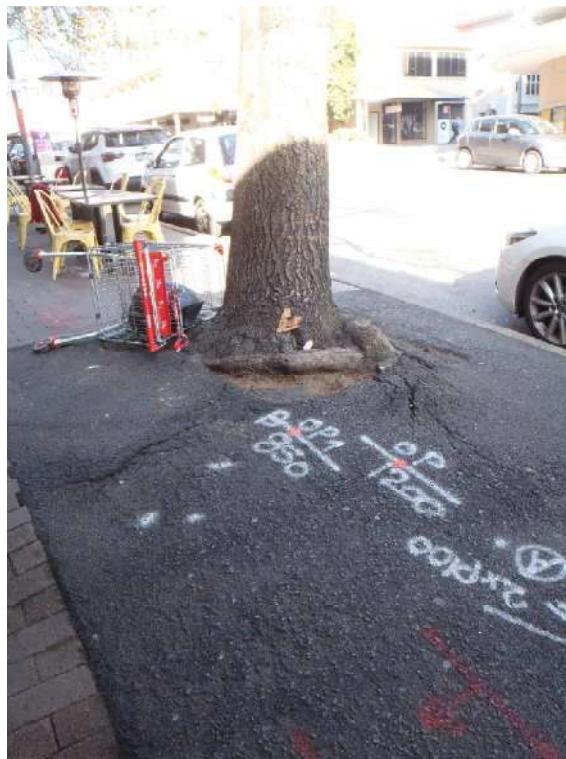
Figure 9. View looking south towards T4, proposed for removal with surface mounding, multiple services and asphalt surround. Photo at top is of the upper canopy of T4 Date: 8 August, 2023.

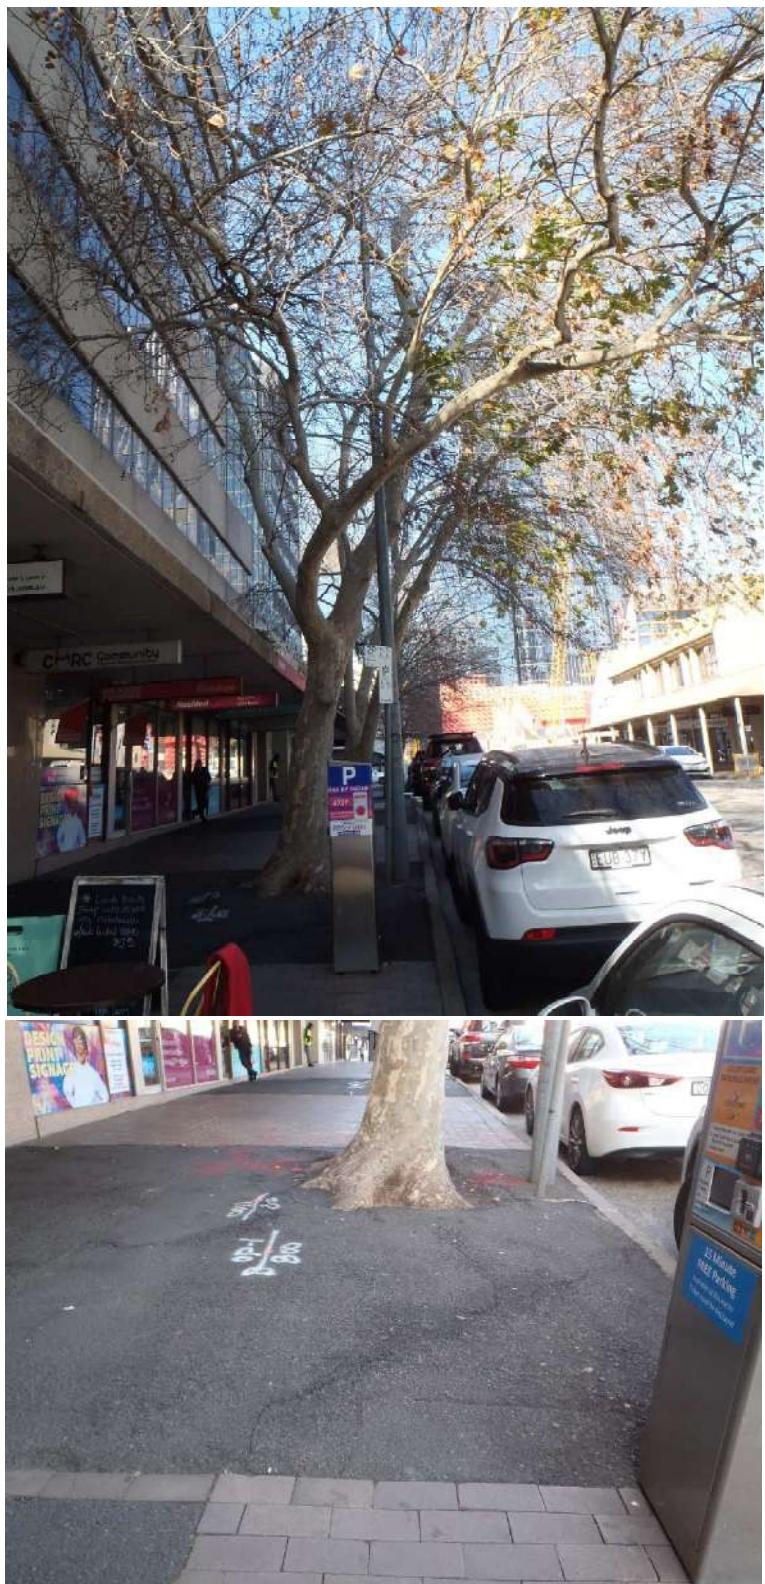
Figure 10. View looking south to **T5** with asphalt installed around the tree base. Surface cracks and uneven ground is visible and installed services and posts (e.g. parking meter). **T5** is proposed for removal. Date: 8 August, 2023. Source: ELKE

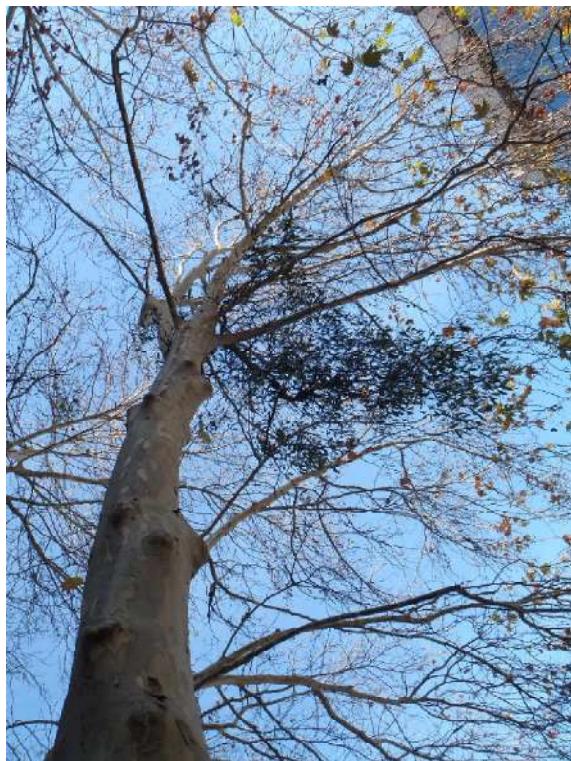
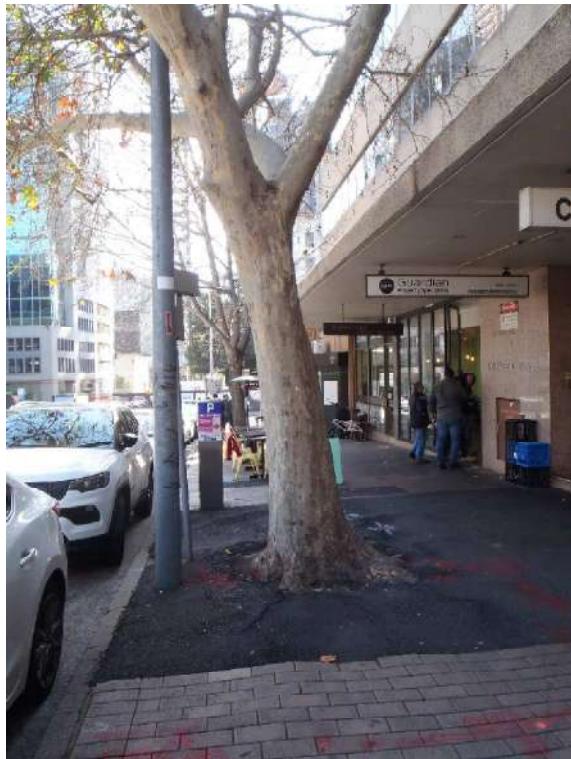
5	<i>Platanus x acerifolia</i>	M	21.8*	0.44	Proposal to remove (with approval)	9	6	9	7	1	Like T4, T5 also has a large asphalted zone around its base. Tree roots appear to have lifted and cracked asphalt in approximately 4 locations. Canopy tends west as well as extending over the fixed awning to the east. Established scale and canopy. A light pole is within the canopy and <1m from the base of the tree. Whilst the tree form appears visually sound, exposed roots are visible at the Root Crown Base. First branching is at 3.5m				M	M	5.28	87.58	3.31	34.41	over / full impact	over / full impact				
6	<i>Platanus x acerifolia</i>	M	20.3*	0.77	Proposal to remove (with approval)	5	5	8	8	0.72	co-dominant form at 1.5m high and tri-dominant form at 2m high, else the main trunks are clear /crown lifted of cars and fixed awning. Mistletoe present in canopy on west side. Form is established and tending slightly to the west (as would be expected). Some kerb lifting/shifting adjacent tree.				M	M	3.00	28.27	2.88	26.11	over / full impact	over / full impact

Figure 11 View looking north to **T5** with asphalt installed around the tree base. Surface cracks and uneven ground is visible and installed services and posts (e.g. parking meter). T4 is proposed for removal. Date: 8 August, 2023. Source: ELKE

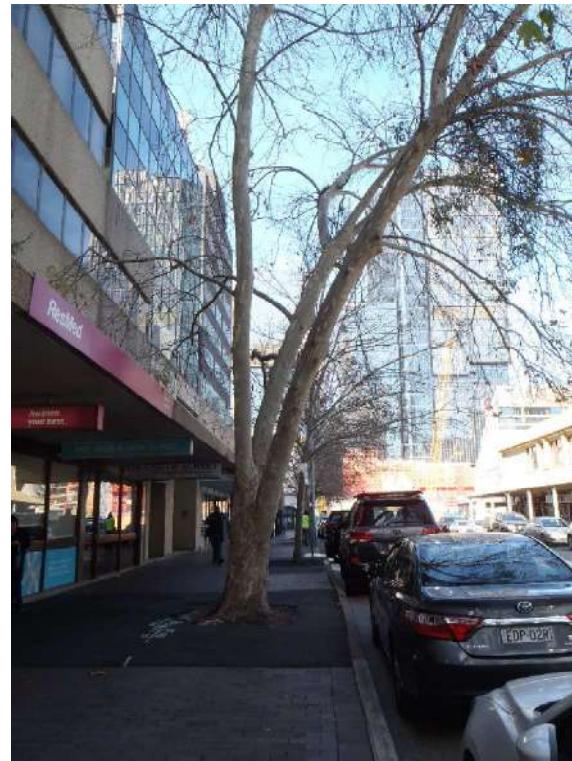
Figure 12 View looking south to **T6**. Proposed for removal. Date: 8 August, 2023. Source: ELKE

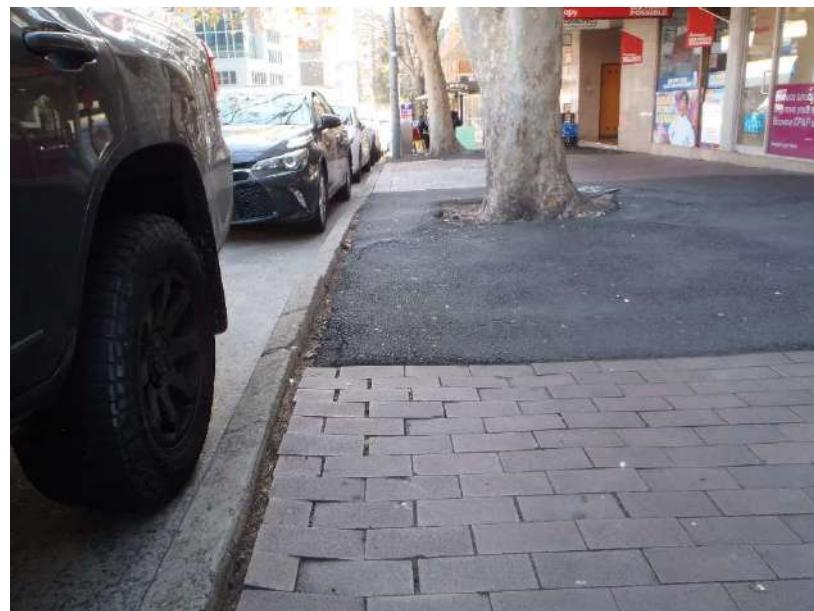
Figure 13 View looking north to **T6**. Proposed for removal. Photo shows ground condition. Date: 8 August, 2023. Source: ELKE

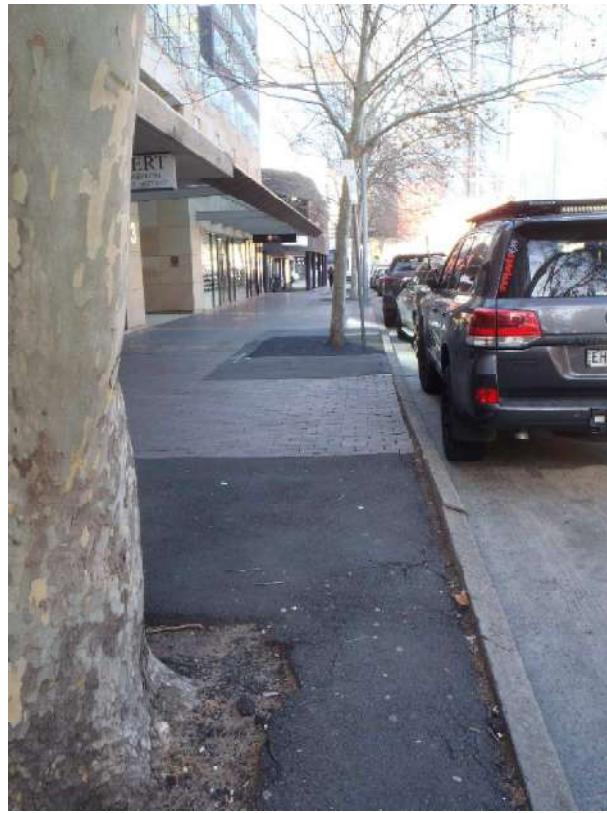
Figure 14. View looking south towards **T7**, proposed for retention. Tree T6 is in the foreground. Date: 8 August, 2023. Source: ELKE

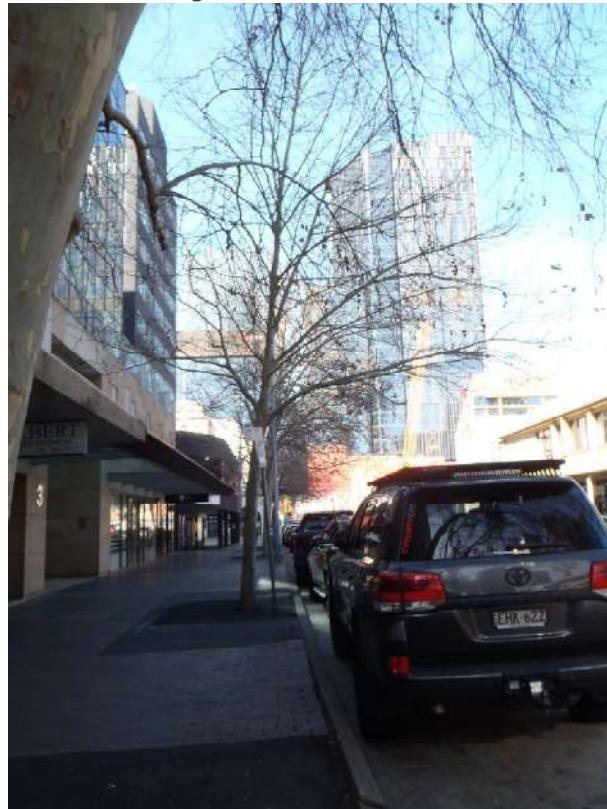
Figure 15 View looking south towards **T7**, proposed for retention. Date: 8 August, 2023. Source: ELKE

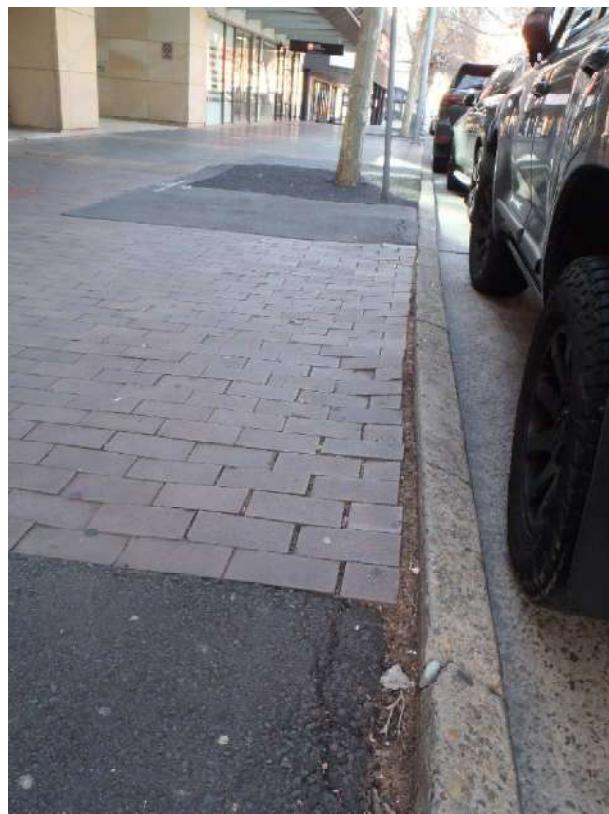
Figure 16 View looking south towards **T7**, proposed for retention and showing the ground conditions of both T6 (foreground) and **T7** in the distance with sign post installed within the SRZ. Date: 8 August, 2023. Source: ELKE

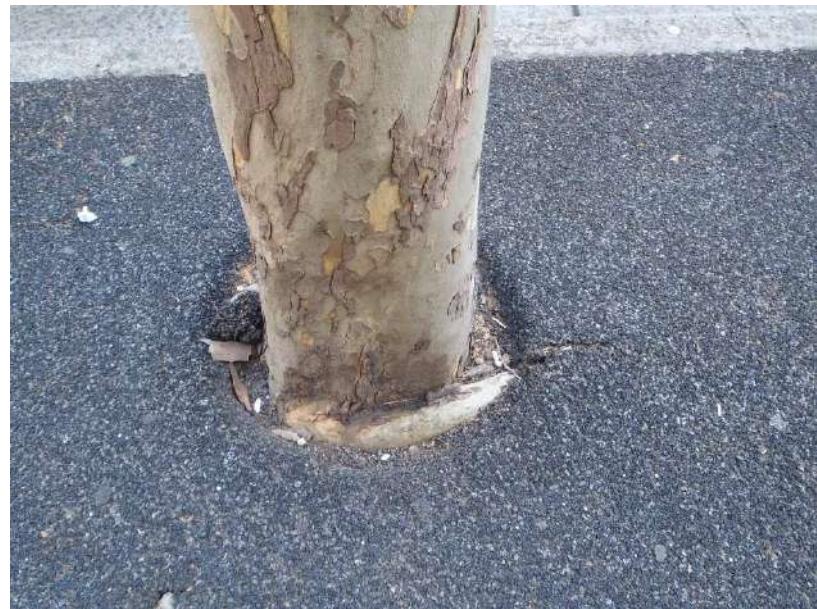
Figure 17. Base condition of **T10**. Proposed for retention. Root girdling present at base of trunk. Date: 8 August, 2023. Source: ELKE

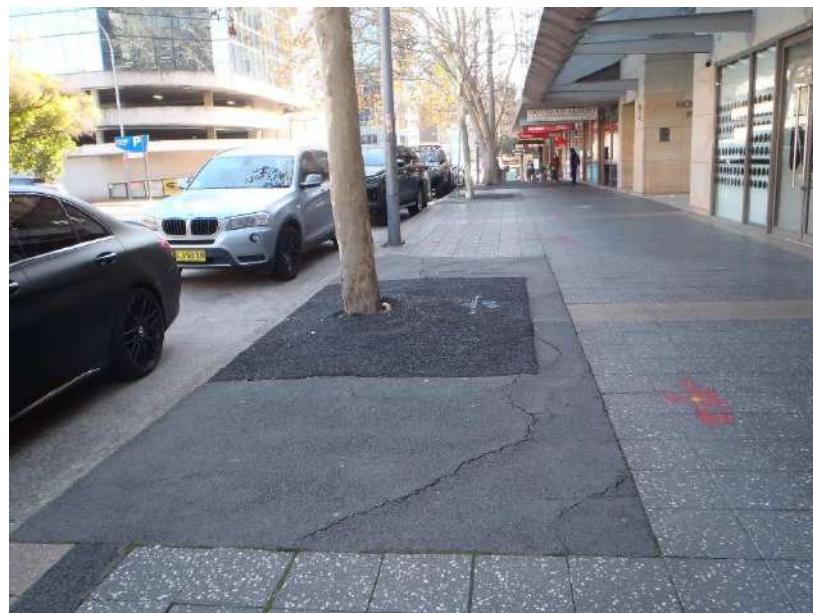
Figure 18. Base condition of **T10**. Proposed for retention. Surface cracking in asphalt visible. Date: 8 August, 2023. Source: ELKE

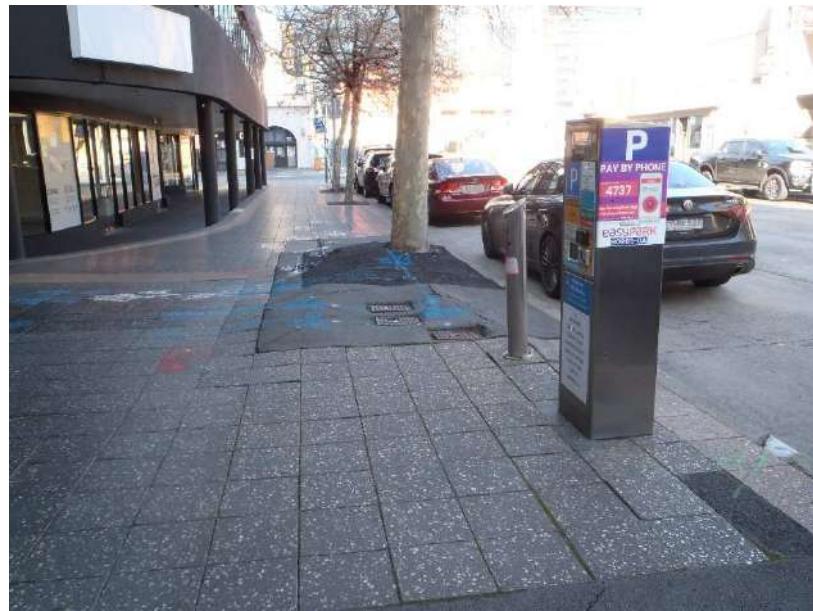
Figure 19. View looking south showing the base condition of **T11**. Proposed for Removal. Surface mounding and cracking and multiple services pits within close proximity of the tree. Date: 8 August, 2023. Source: ELKE

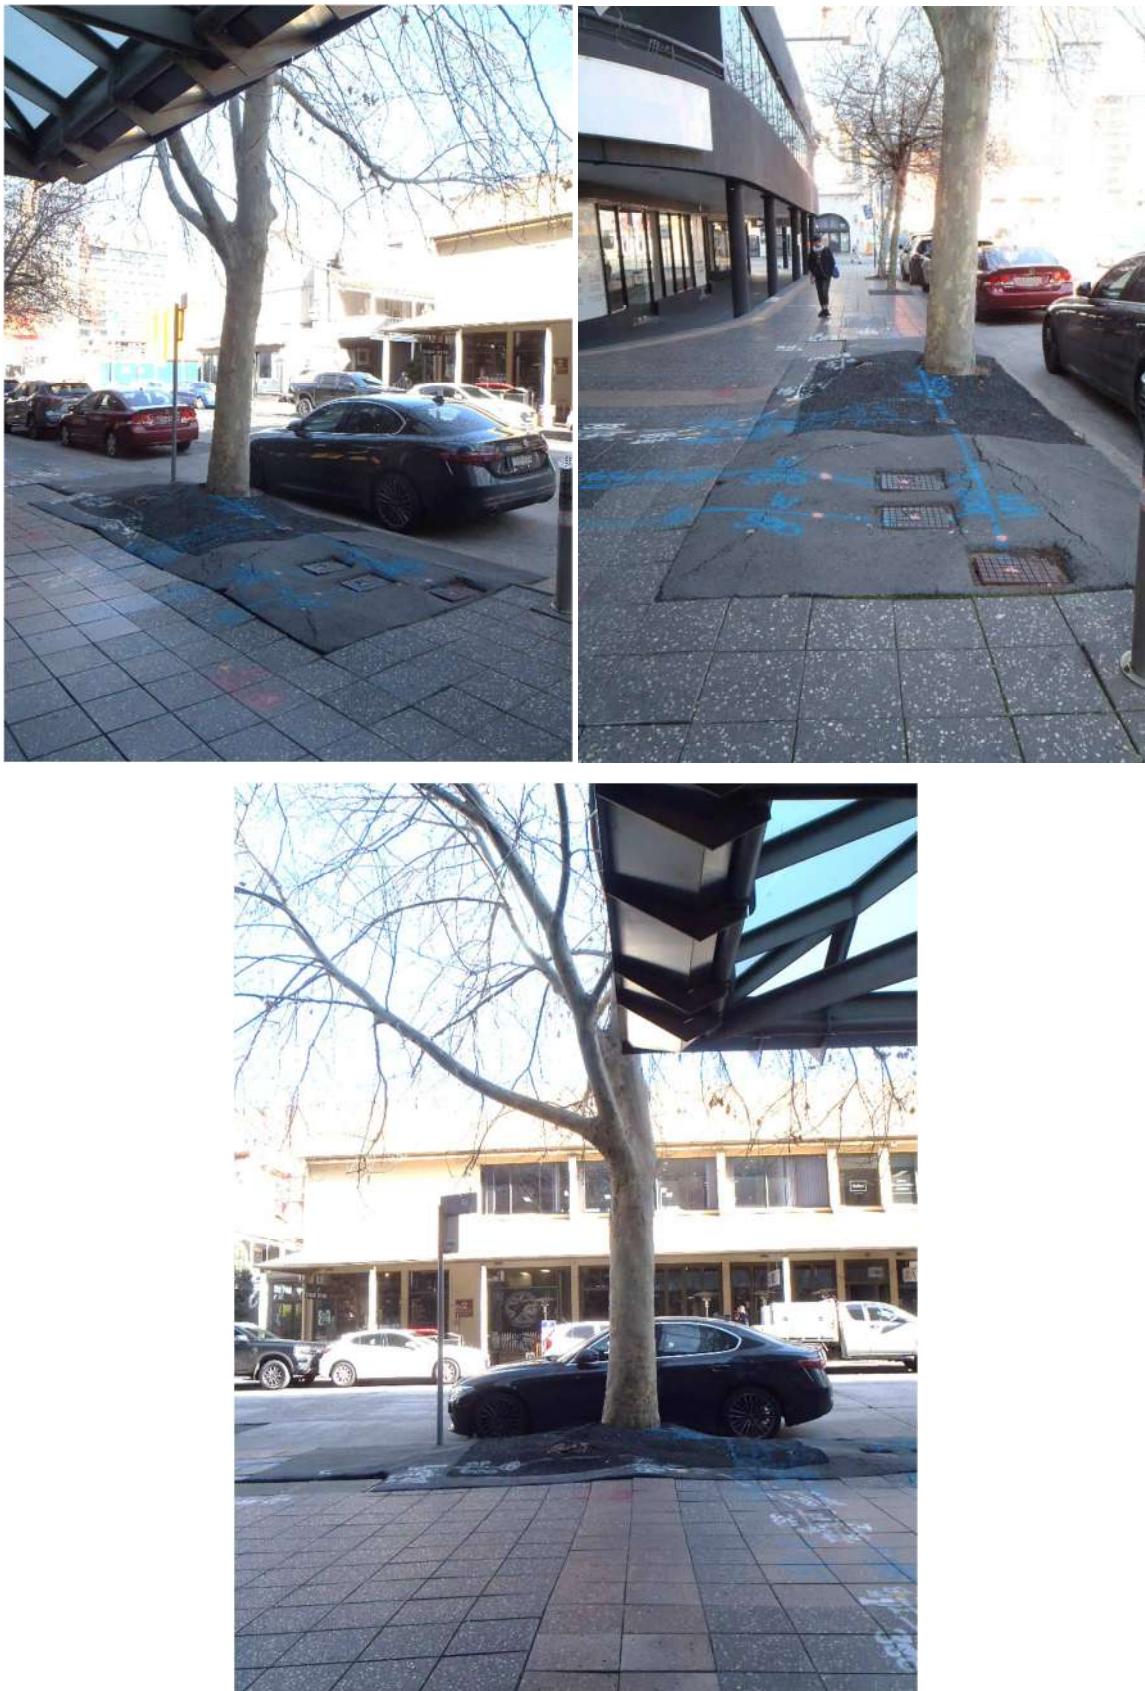
Figure 20. Photos above showing the base condition of **T11**. Proposed for Removal. Surface mounding and cracking and multiple services pits within close proximity of the tree. Date: 8 August, 2023.
