PROJECT: Consulting Arboricultural Impact Assessment Report.

Parramatta Civic Link Block 3.

Horwood Place (between George & Phillip Street, Parramatta).

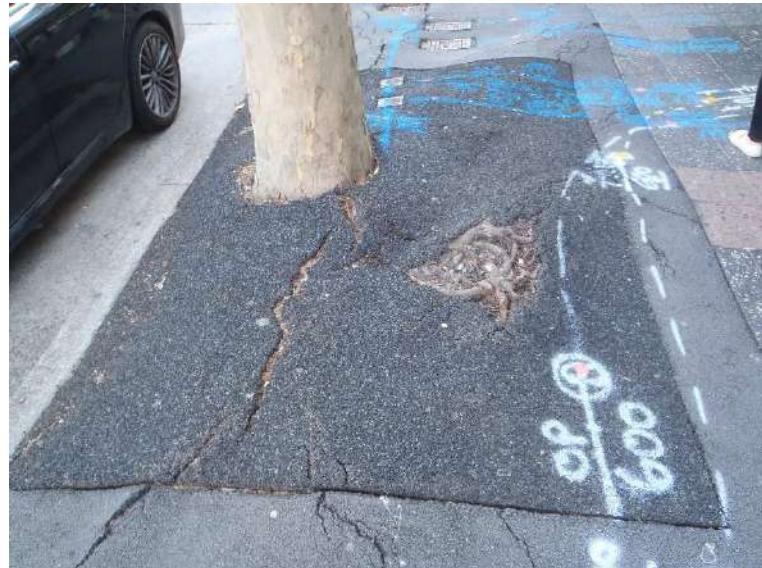
Figure 21. Photo above showing the base condition of **T11**. Proposed for Removal. Surface mounding, cracking, exposed roots (asphalt cover has gone), and multiple services pits within close proximity of the tree (top of photo) and survey marks showing services. Date: 8 August, 2023. Source: ELKE

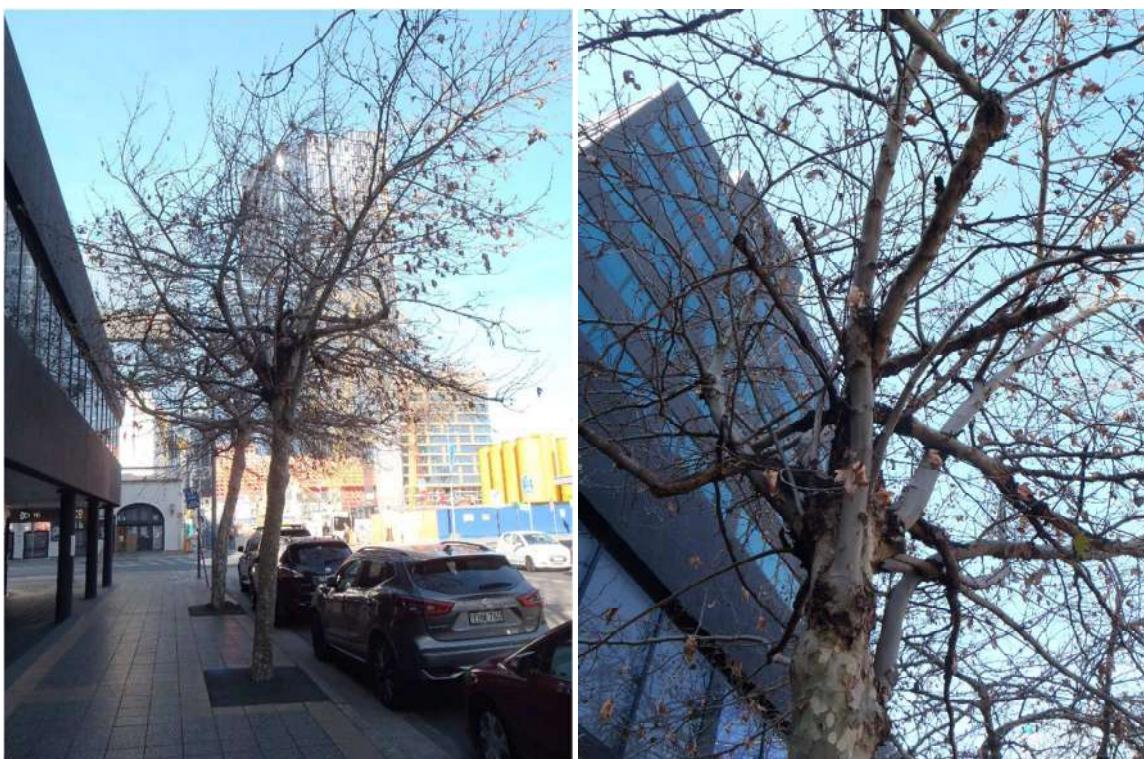
Figure 22. Photos showing **T12** and **T13** proposed for retention. These photos were taken on 8 August, 2023. It is understood these trees have since had formative pruning. Source: ELKE Date: 8 August, 2023. Source: ELKE

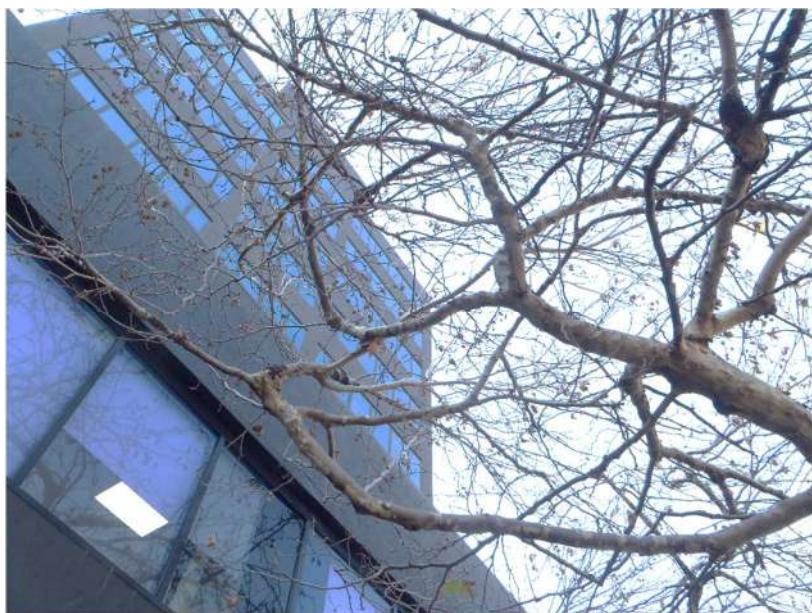
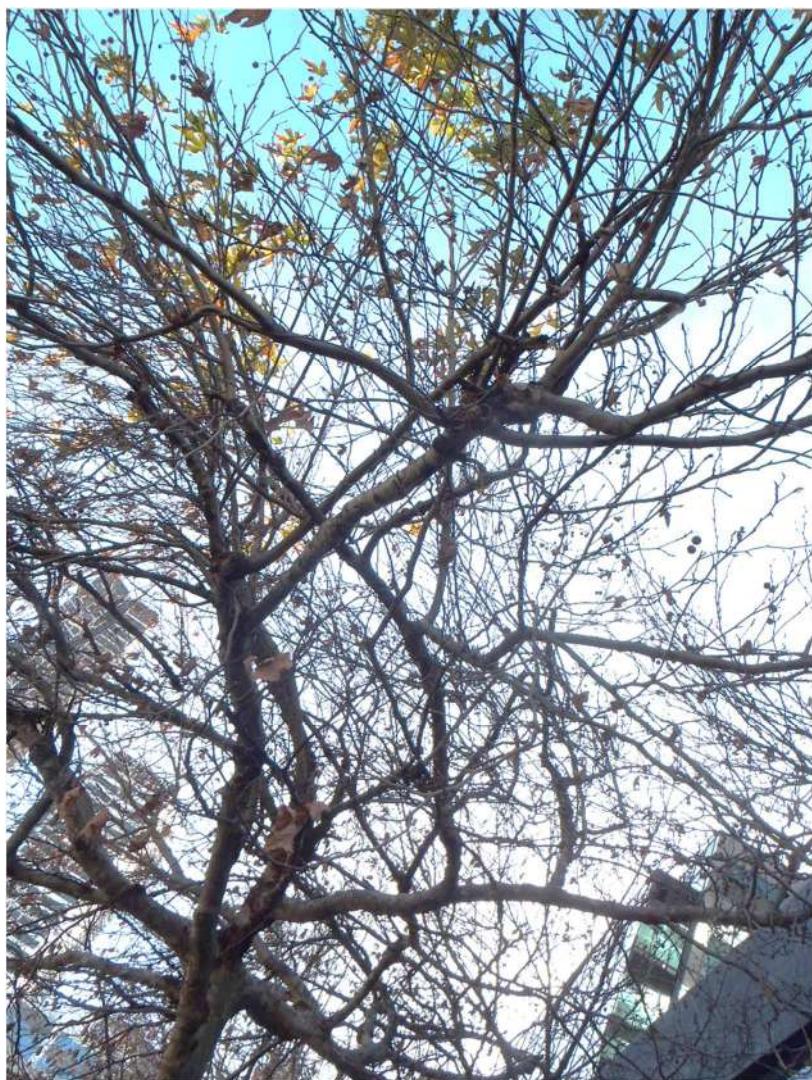
Figure 23. Photos showing **T12** and **T13** proposed for retention. Date: 8 August, 2023. Source: ELKE

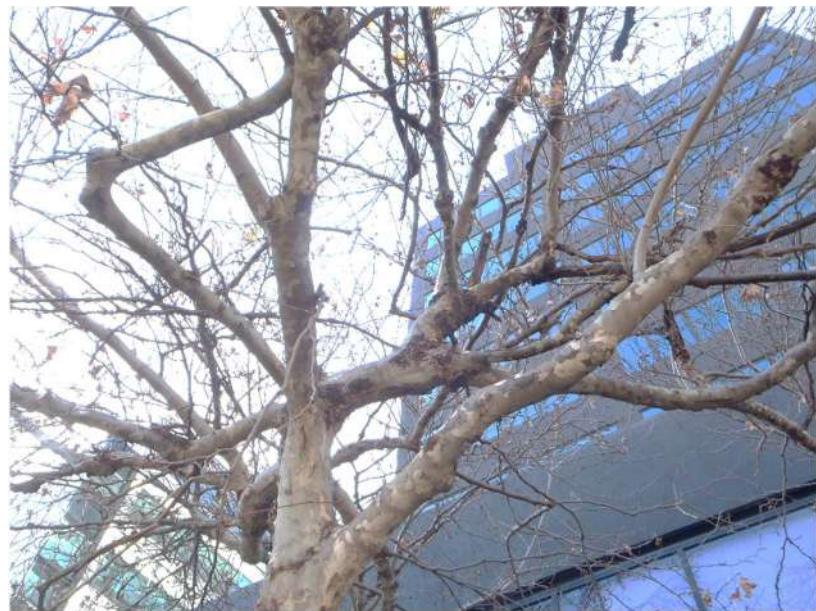
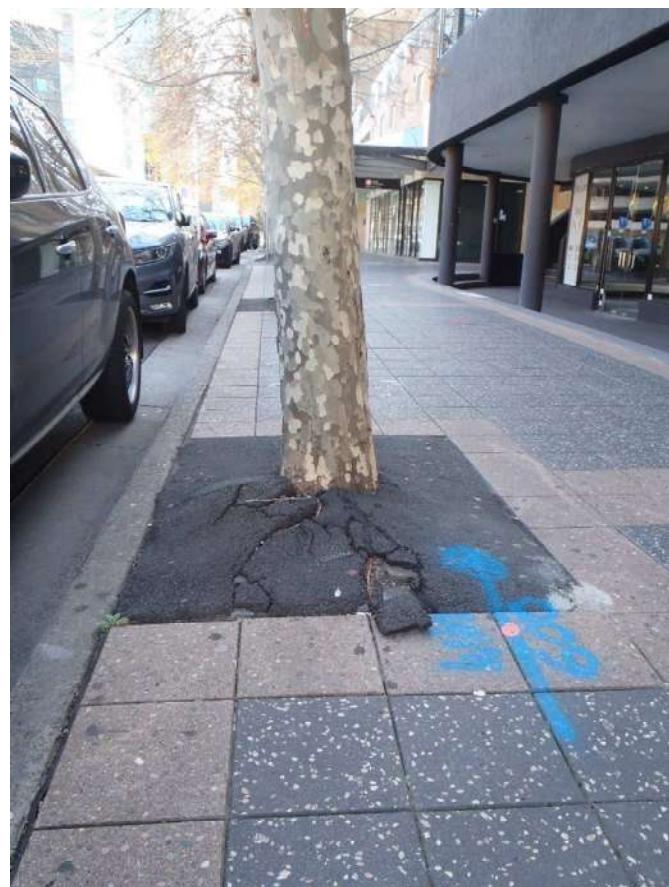
Figure 24. Photos showing **T12** and **T13** proposed for retention. Photo at the bottom shows displacement of asphalt indicating root zone upheaval indicating inadequate soil volume. Date: 8 August, 2023. Source: ELKE

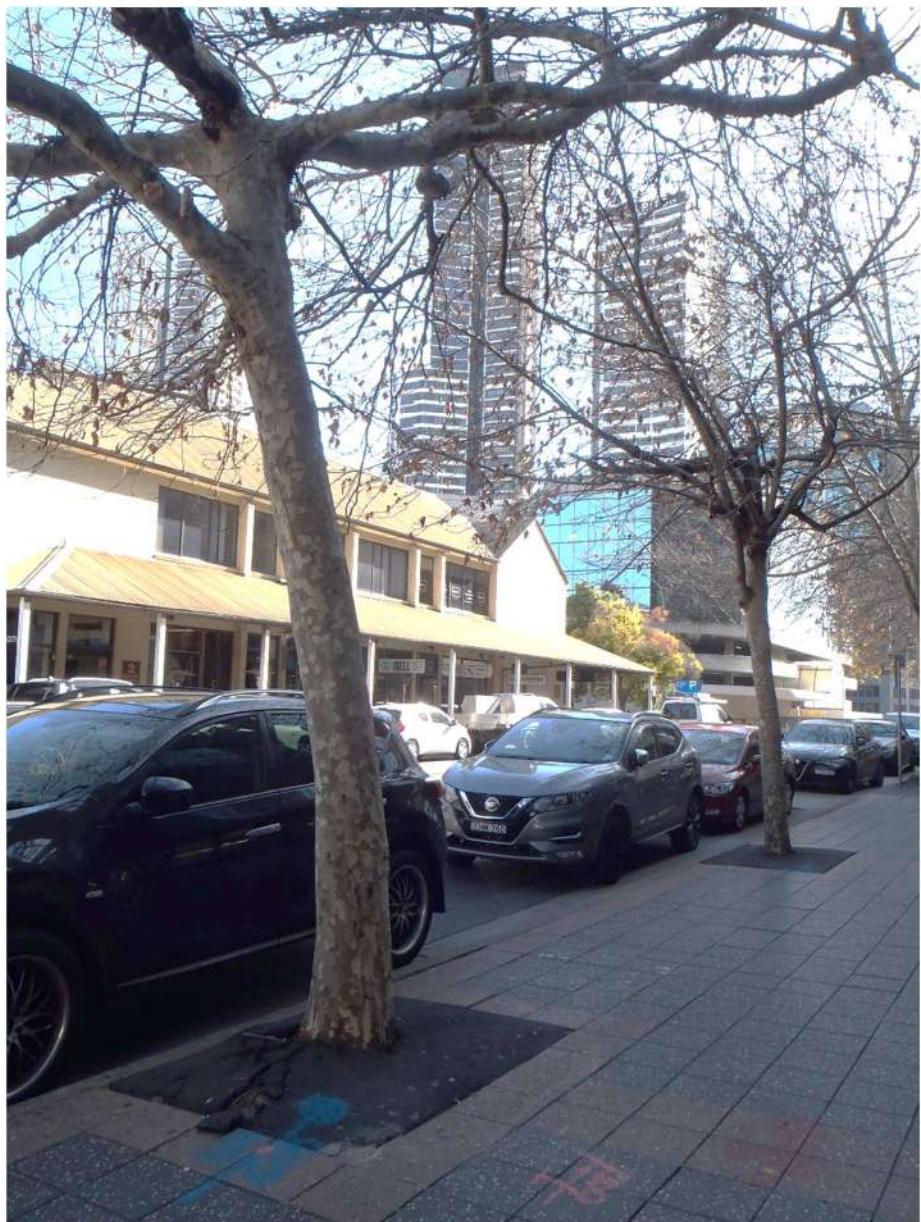
Figure 25. Photo showing **T12** and **T13** proposed for retention. Date: 8 August, 2023. Source: ELKE

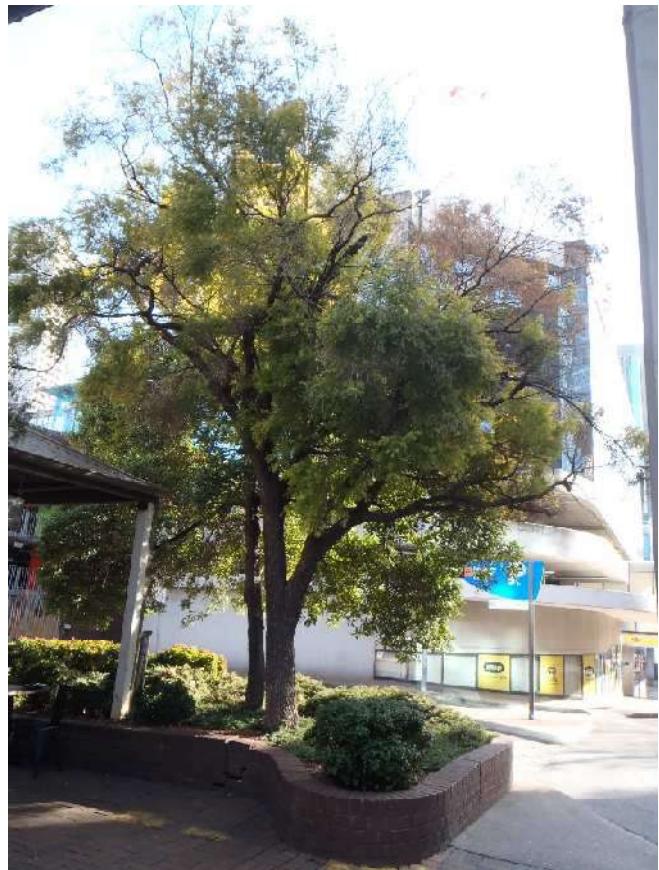
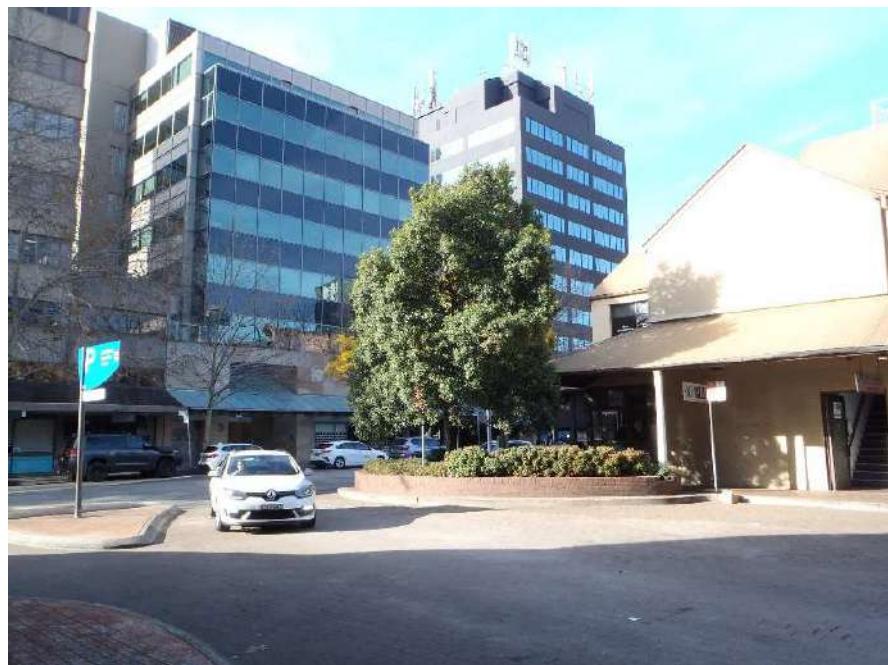
Figure 27. **T8** and **T9**. Proposed for removal. Date: 8 August, 2023. Source: ELKE

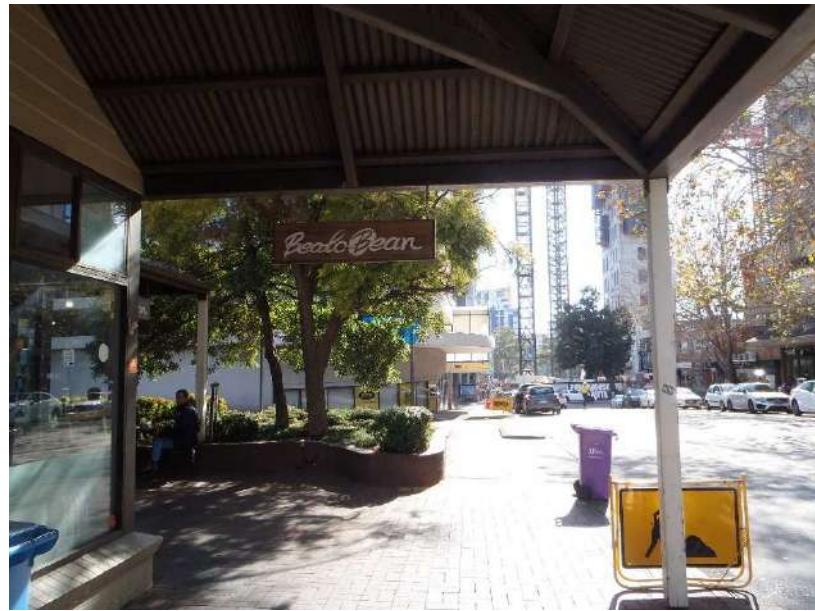
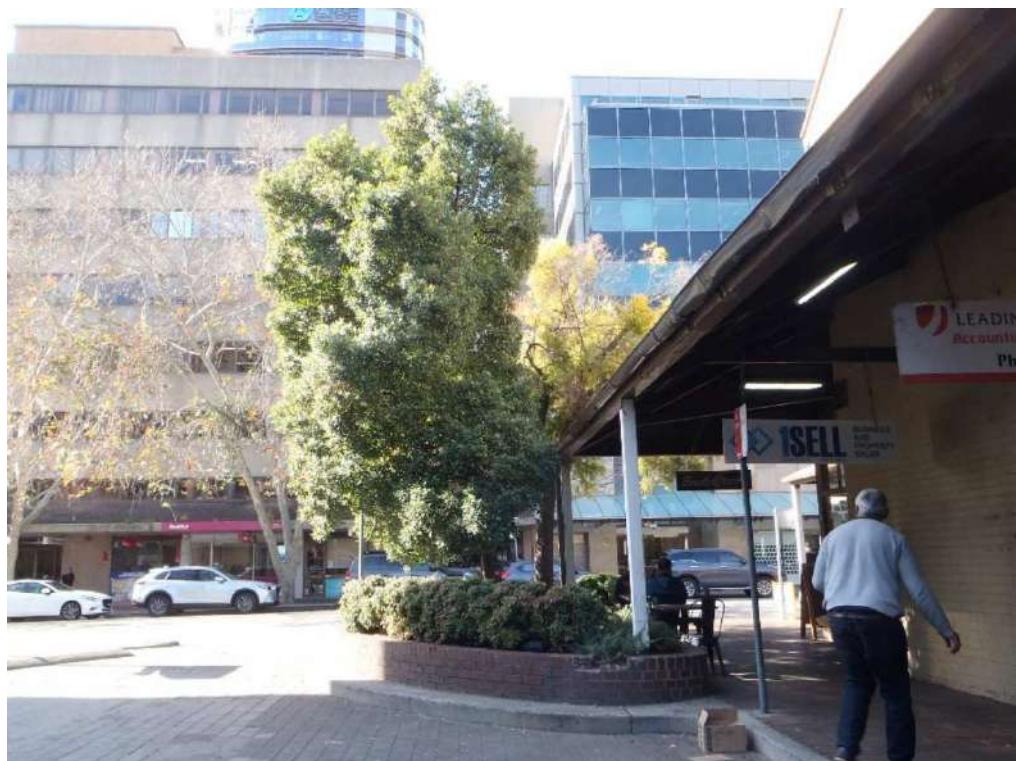
Figure 28. **T8** and **T9**. Proposed for removal. Date: 8 August, 2023. Source: ELKE

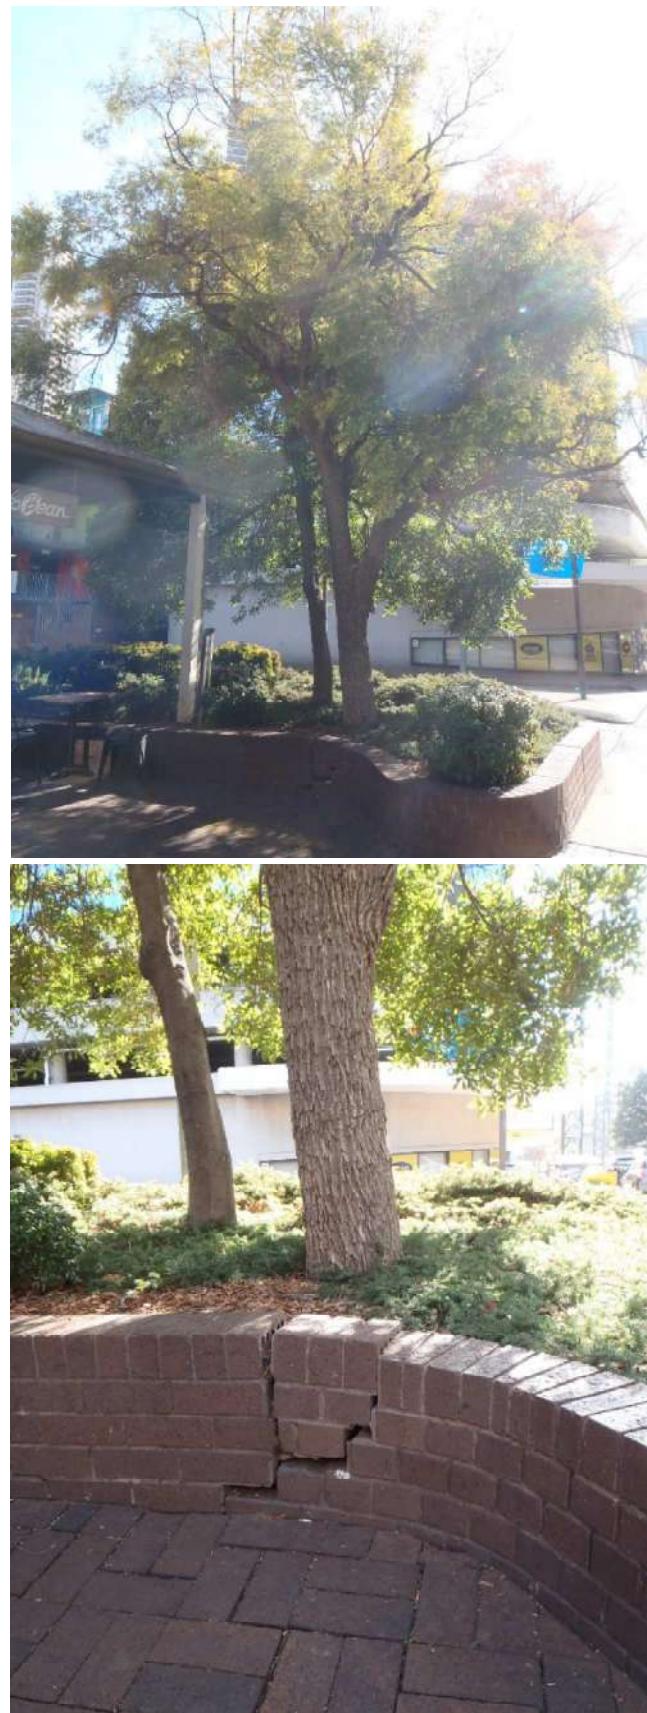
Figure 29. **T8** and **T9**. Proposed for removal. Date: 8 August, 2023. Source: ELKE

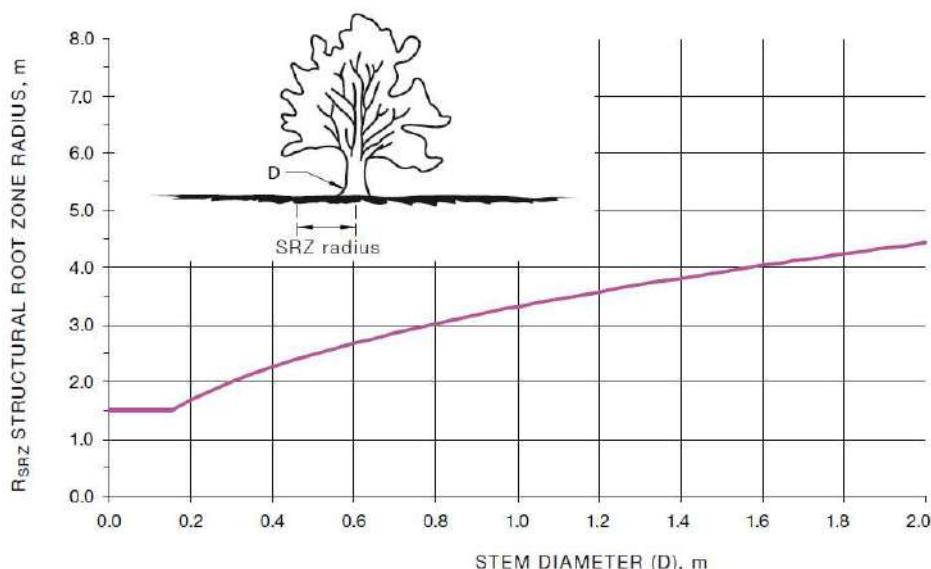
There are many factors that affect the size of the SRZ (e.g., tree height, crown area, soil type, soil moisture). The SRZ may also be influenced by natural or built structures, such as rocks and footings. An indicative SRZ radius can be determined from the trunk diameter measured immediately above the root buttress using the following formula or Figure 1.

SRZ radius = $(D \times 50)^{0.42} \times 0.64$ where D = trunk diameter, in m, measured above the root buttress

The curve can be expressed by the following formula:

$$R_{SRZ} = (D \times 50)^{0.42} \times 0.64$$

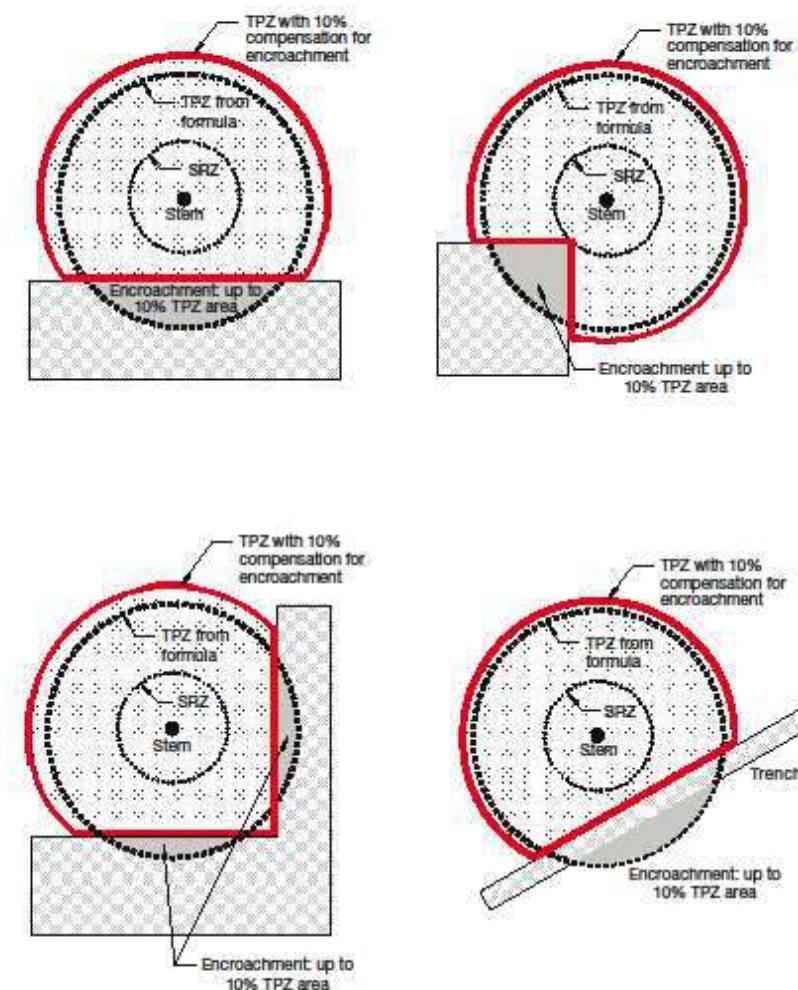
FIGURE D1 EXAMPLES OF MINOR ENCROACHMENT INTO TPZ

NOTE: Less than 10% TPZ area and outside SRZ. Any loss of TPZ compensated for elsewhere.

Encroachment into the tree protection zone (TPZ) is sometimes unavoidable. Figure D1 provides examples of TPZ encroachment by area, to assist in reducing the impact of such incursions.
