2.2 Proposed Stormwater Drainage Network

**Report on Detailed Site (Contamination)
Investigation**

Proposed Pedestrian and Cycleway

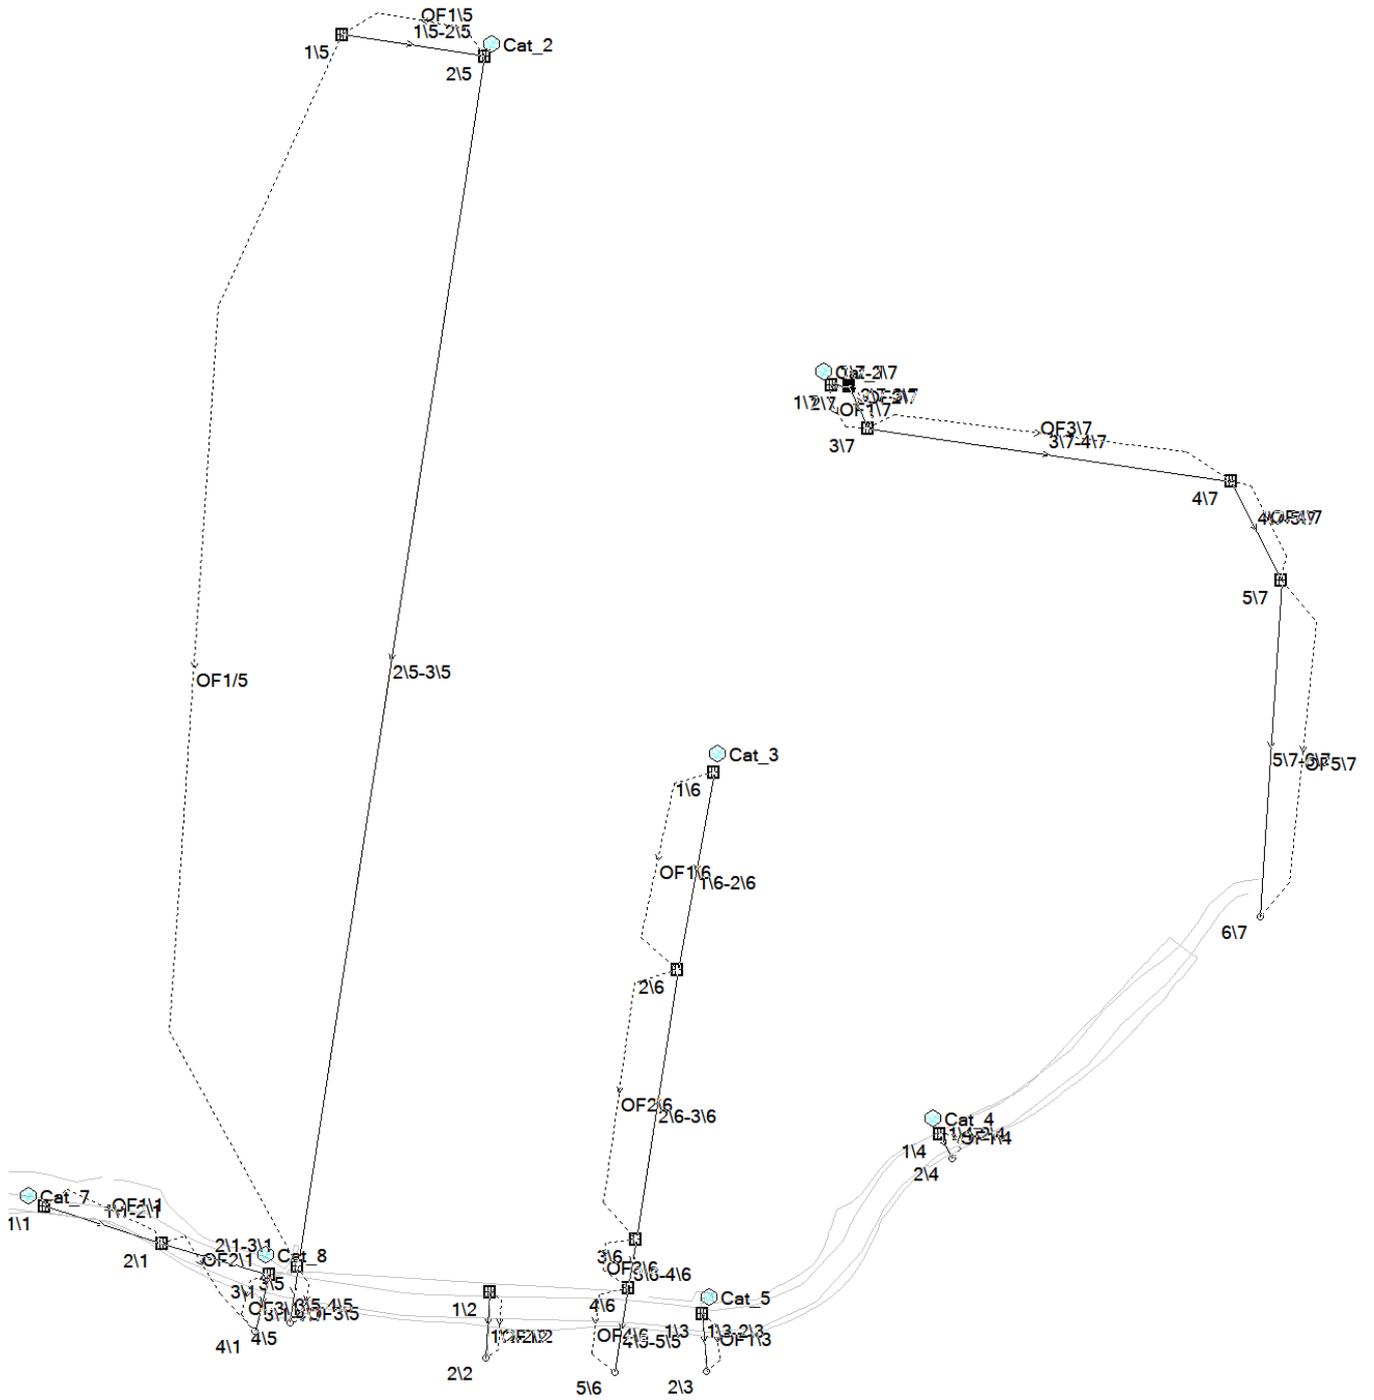
Figure 9: DRAINS Model Layout - Proposed Scenario

As part of the proposed development, modification and upgrades have been undertaken to improve the existing drainage system. These improvements include the installation of new stormwater pits and pipes, along with the connection of downpipes from the roof of 25 Pike Street to the existing drainage network.

1. Pit 3\1 is converted to junction pit and additional surface inlet pit has been proposed upstream of Pit 3\1 to capture upstream catchment.
2. Two additional 600x600mm stormwater pits (Pit 1\1 and 2\1) have been installed within the proposed concrete cycleway. These pits are connected to Pit 3\1 via a class 4 Ø300 RCP.
3. Pit 4\1 has been converted into a junction pit. Catchment 6, which represents roof runoff from 25 Pike Street, will now be collected via newly installed downpipes and directed to this junction pit.
4. Pit 1\3 has also been removed, and an additional upstream pit has been introduced to improve capture of upstream runoff.
5. Pit 1\2 has been removed, and additional surface inlet pit has been proposed upstream of Pit 1\2.

The DRAINS model layout for proposed scenario is presented in Figure 9 below.

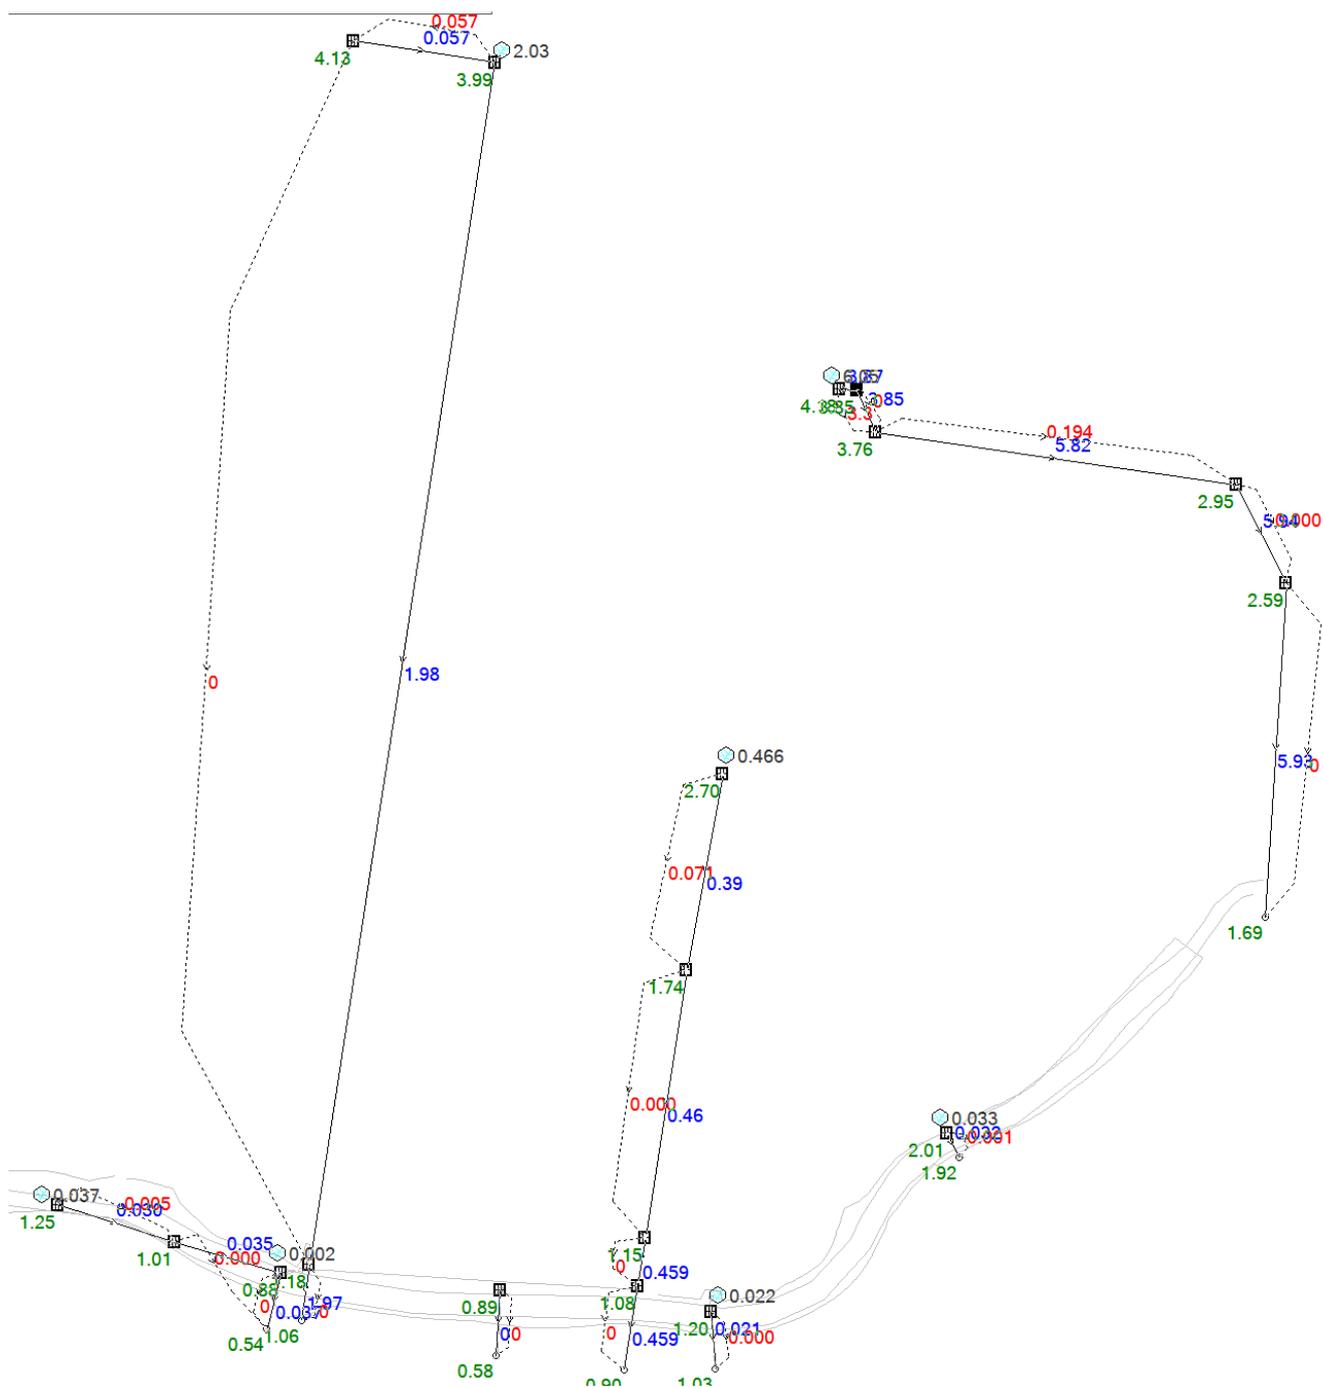
Figure 10: 5% AEP (20-year ARI) DRAINS Results - Proposed Scenario

The results from DRAINS model for 20-year ARI event is shown in Figure 10 below.

Key Outcomes from the DRAINS model for the existing scenario are summarised below:

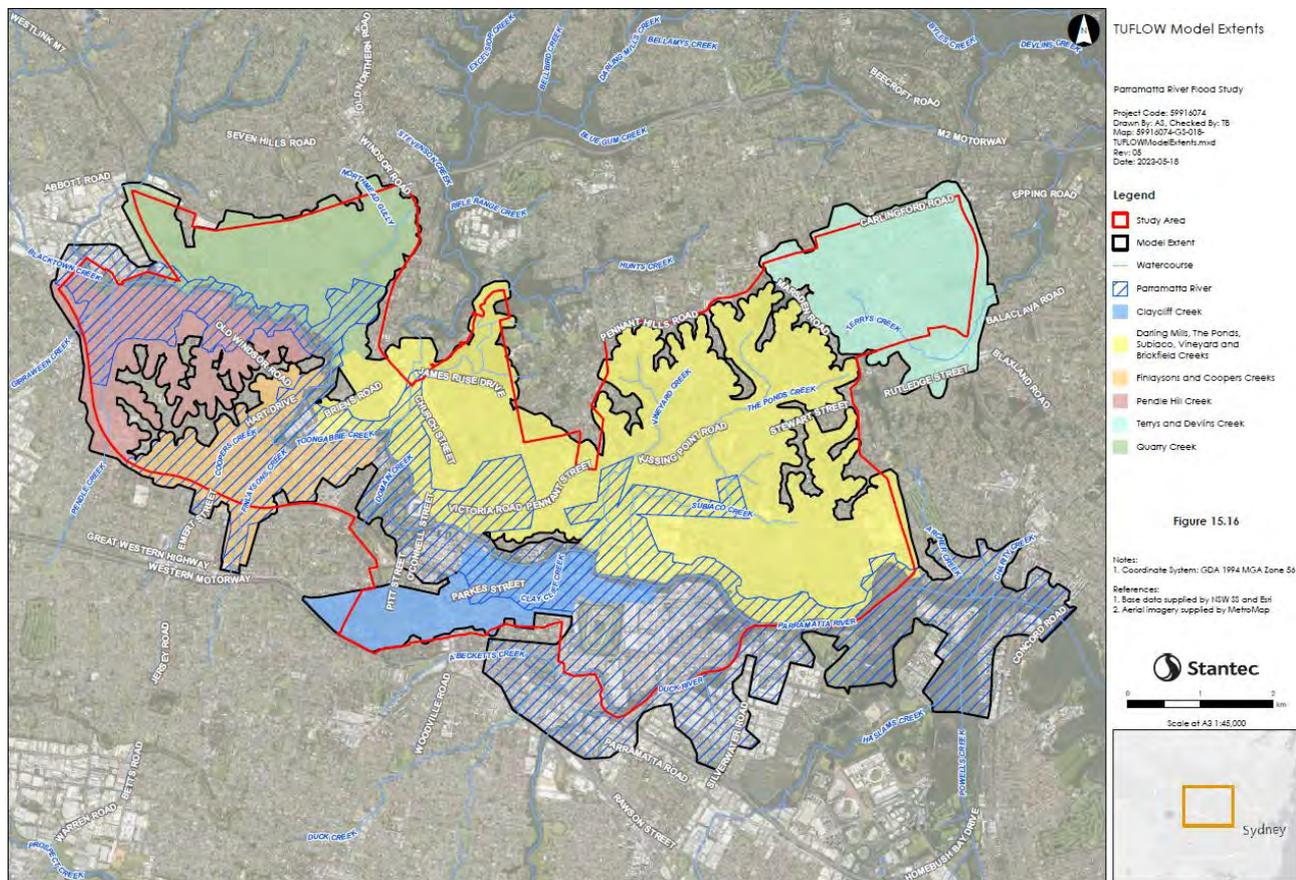
Figure 11: Parramatta River and Tributaries Study Area Extent

The study area highlighting Parramatta River and its tributaries is shown in Figure 11 below.

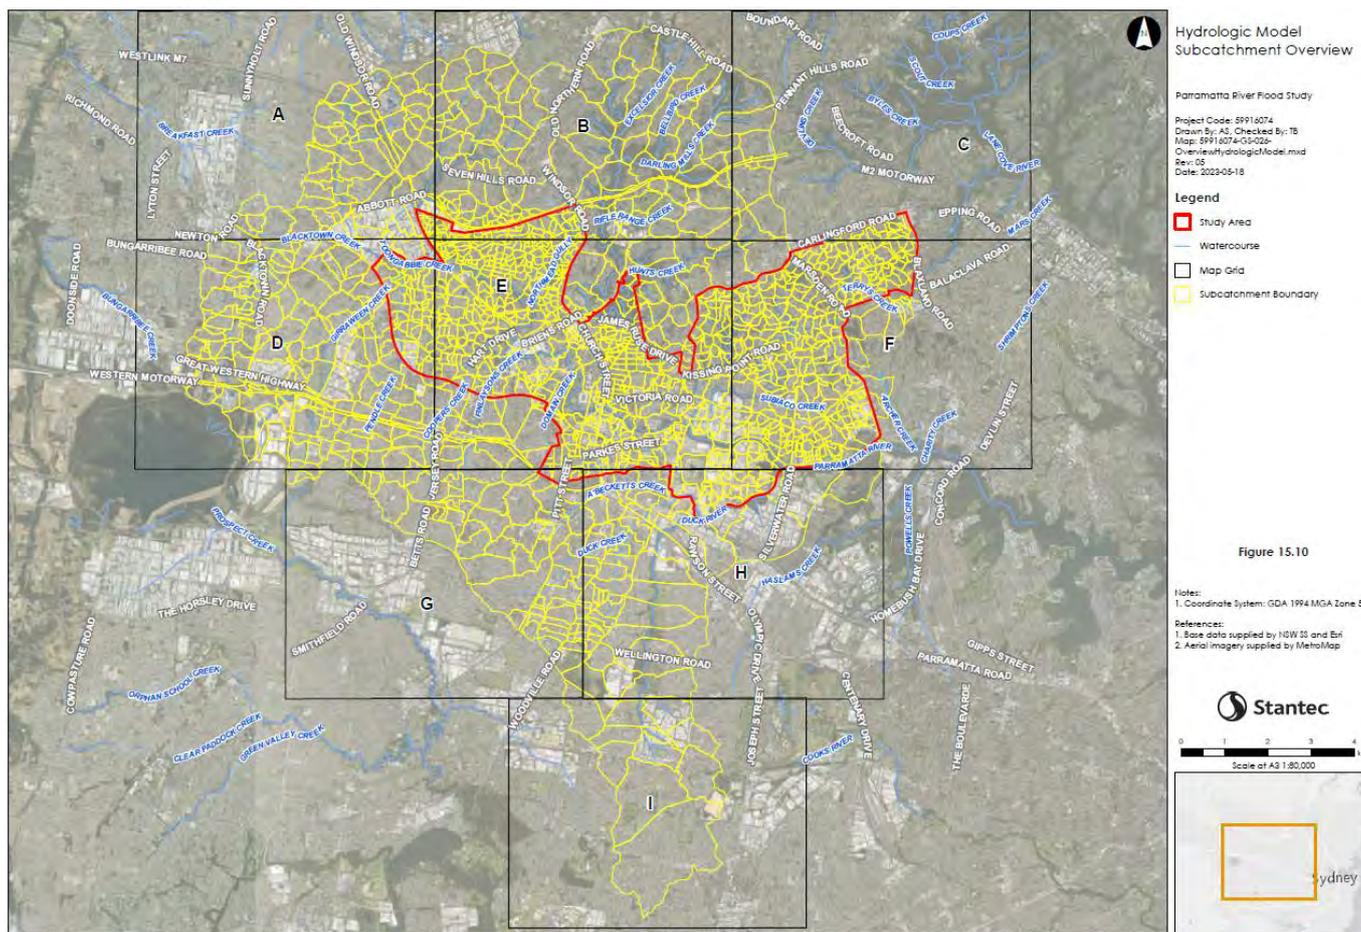
Figure 12: Sub-catchment Overview for the Parramatta River Flood Study

The sub-catchment associate with Parramatta River and Tributaries TUFLOW Model shown in Figure 11 is presented in Figure 12 below.

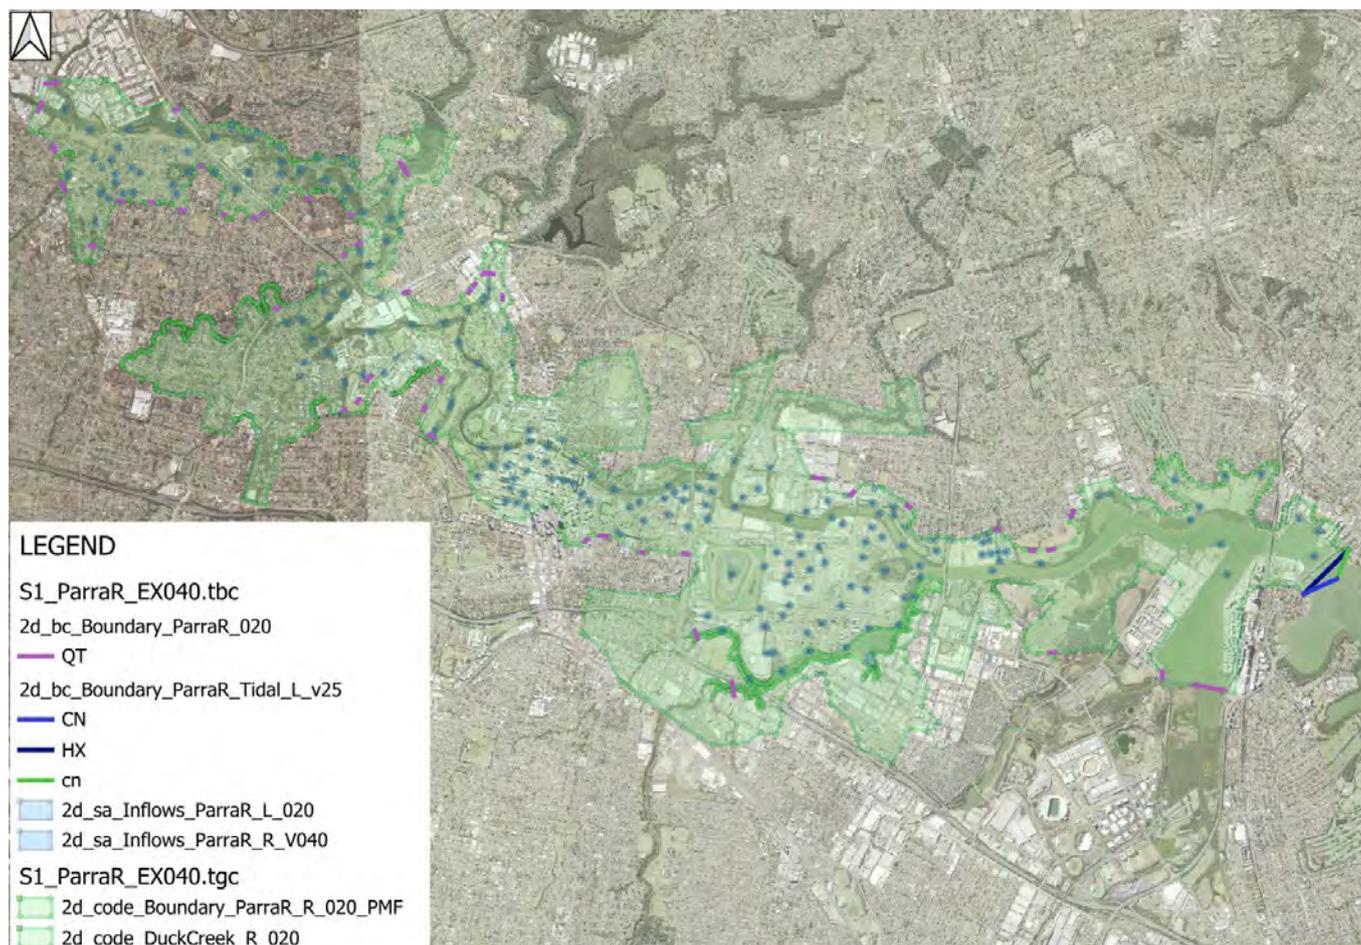
Figure 13: Boundary Conditions and Study Area

Inflow hydrographs were extracted from the hydrologic model and applied in the hydraulic model as inflow polygons. This approach assumes that runoff from a sub-catchment is concentrated into a small area with the sub-catchment, typically at the catchment outlets. In general, flows are applied at the downstream low points of each sub-catchment, except for the most upstream sub-catchments where a flow is applied at the centroid of the sub-catchment along the main drainage line. At the upstream boundaries, flows are input as a total flow from the hydrologic model derived for the upstream catchments. These are input as either a 1d inflow for 1d channels or as a rectangular 2d_SA polygon and lines for 2d areas to distribute flow behaviour. For sub-catchments within a model, a local flow from that sub-catchment is applied to the hydraulic model. The inflows applied for this analysis is shown in Figure 13

In areas where the Mainstream and Tributary models overlap, inflow locations were adjusted to maintain hydraulic consistency and avoid artificial flow anomalies.

The downstream boundary condition is listed as Tidal Constant represented by 2d_bc_Boundary_ParraR_Tidal_L_v25 in Figure 13 is used for this analysis.

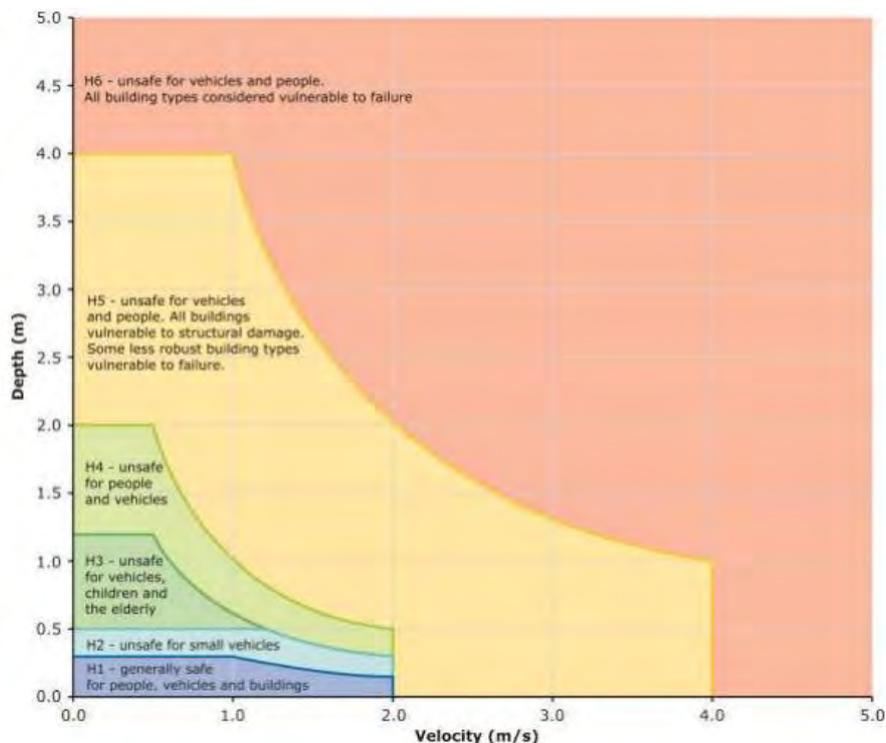
Figure 14: Flood Hazard Curve as per ARR Guideline

The flood hazard also known as product of flood depth velocity generally provides baseline information for floodplain assessment study. In such a preliminary assessment of risks or as part of a constraint’s analysis for strategic land use planning, a combined set of hazard vulnerability curves presented in Figure 14, Figure 15 and Table 5 can be used as general classification of flood hazard on site.

The combined flood hazard curves presented in Figure 14 and Figure 15 sets hazard thresholds that relate to the vulnerability to the community when interacting with flood waters. Table 5 below shows the limits for the classifications provided in Figure 14.

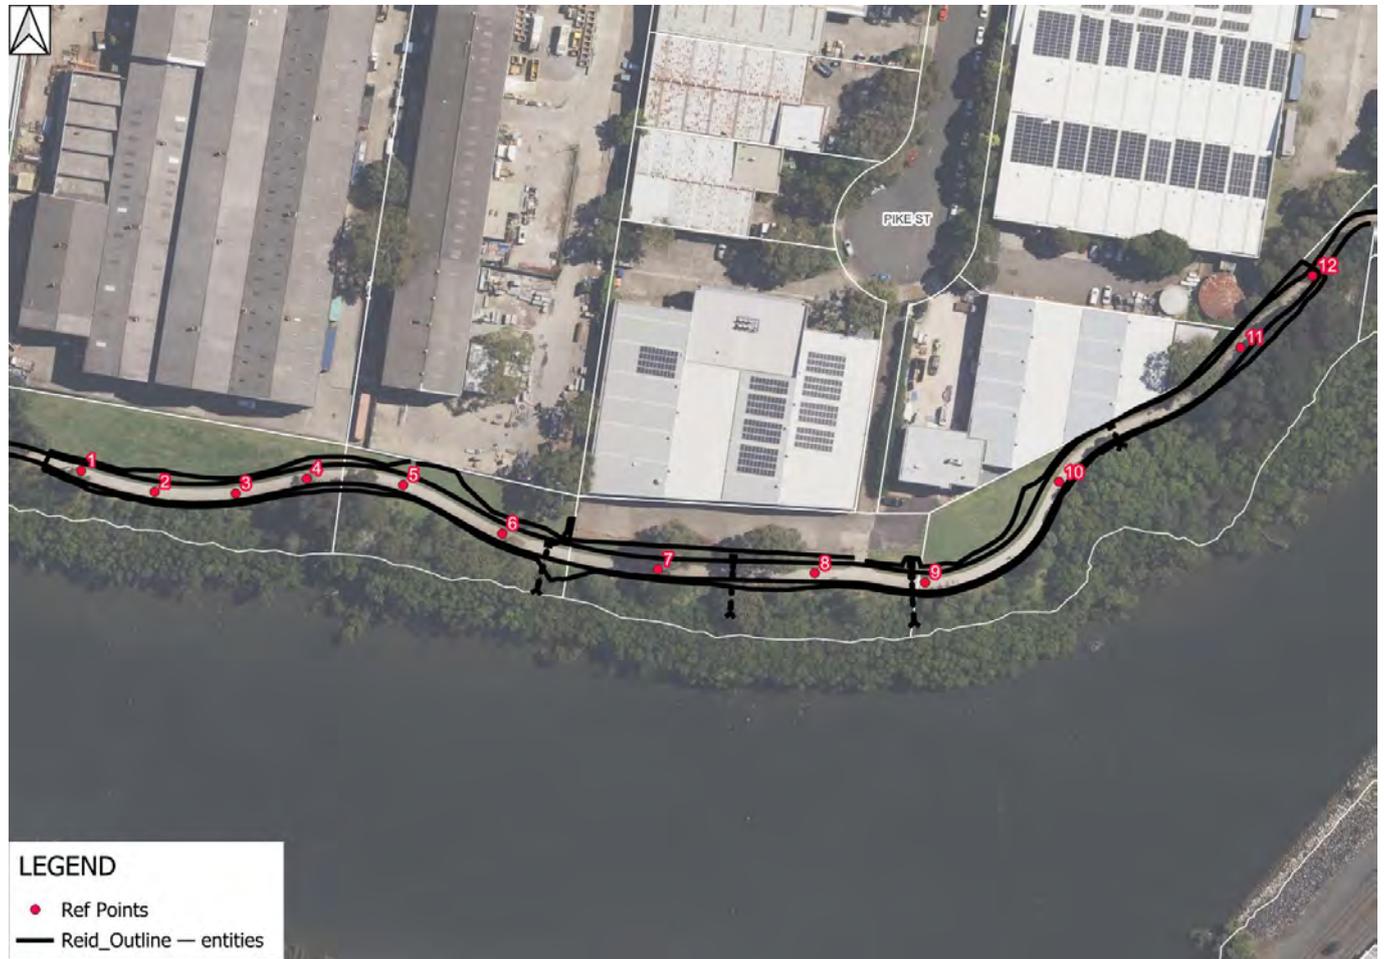
Figure 16: Comparison Points for Flooding Parameters

To determine the effect of the proposed development on the existing flooding scenario, the parameters of flood have been abstracted at comparison points shown in Figure 16. Table 6 show comparison of parameters (Water Surface Elevation, Depth, Velocity and Hazard) at these points during the existing and proposed scenarios.

Points	Plan	W.S. Elev (m)	Depth (m)	Velocity (m/s)	Hazard (D x V)	Hazard Category (FDM)	Hazard Category (ARR Guidelines 2016)
1	Existing	3.09	0.61	0.21	0.1281	LOW	H3
1	Proposed	3.09	0.58	0.21	0.1218	LOW	H3
2	Existing	3.09	0.72	0.12	0.0864	LOW	H3
2	Proposed	3.09	0.69	0.11	0.0759	LOW	H3
3	Existing	3.09	0.58	0.26	0.1508	LOW	H3
3	Proposed	3.08	0.54	0.24	0.1296	LOW	H3
4	Existing	3.08	0.55	0.15	0.0825	LOW	H3
4	Proposed	3.08	0.56	0.12	0.0672	LOW	H3
5	Existing	3.08	1.22	0.21	0.2562	HIGH	H4
5	Proposed	3.08	1.21	0.21	0.2541	HIGH	H4
6	Existing	3.08	1.41	0.82	1.1562	HIGH	H4
6	Proposed	3.07	1.37	0.89	1.2193	HIGH	H4
7	Existing	3.06	1.33	0.55	0.7315	HIGH	H4
7	Proposed	3.06	1.28	0.51	0.6528	HIGH	H4
8	Existing	3.04	1.24	0.68	0.8432	HIGH	H4
8	Proposed	3.04	1.24	0.65	0.806	HIGH	H4
9	Existing	2.99	1.02	0.99	1.0098	HIGH	H4
9	Proposed	2.98	0.95	0.94	0.893	HIGH	H4
10	Existing	2.87	0.08	0.04	0.0032	LOW	H1
10	Proposed	2.85	0.07	0.02	0.0014	LOW	H1

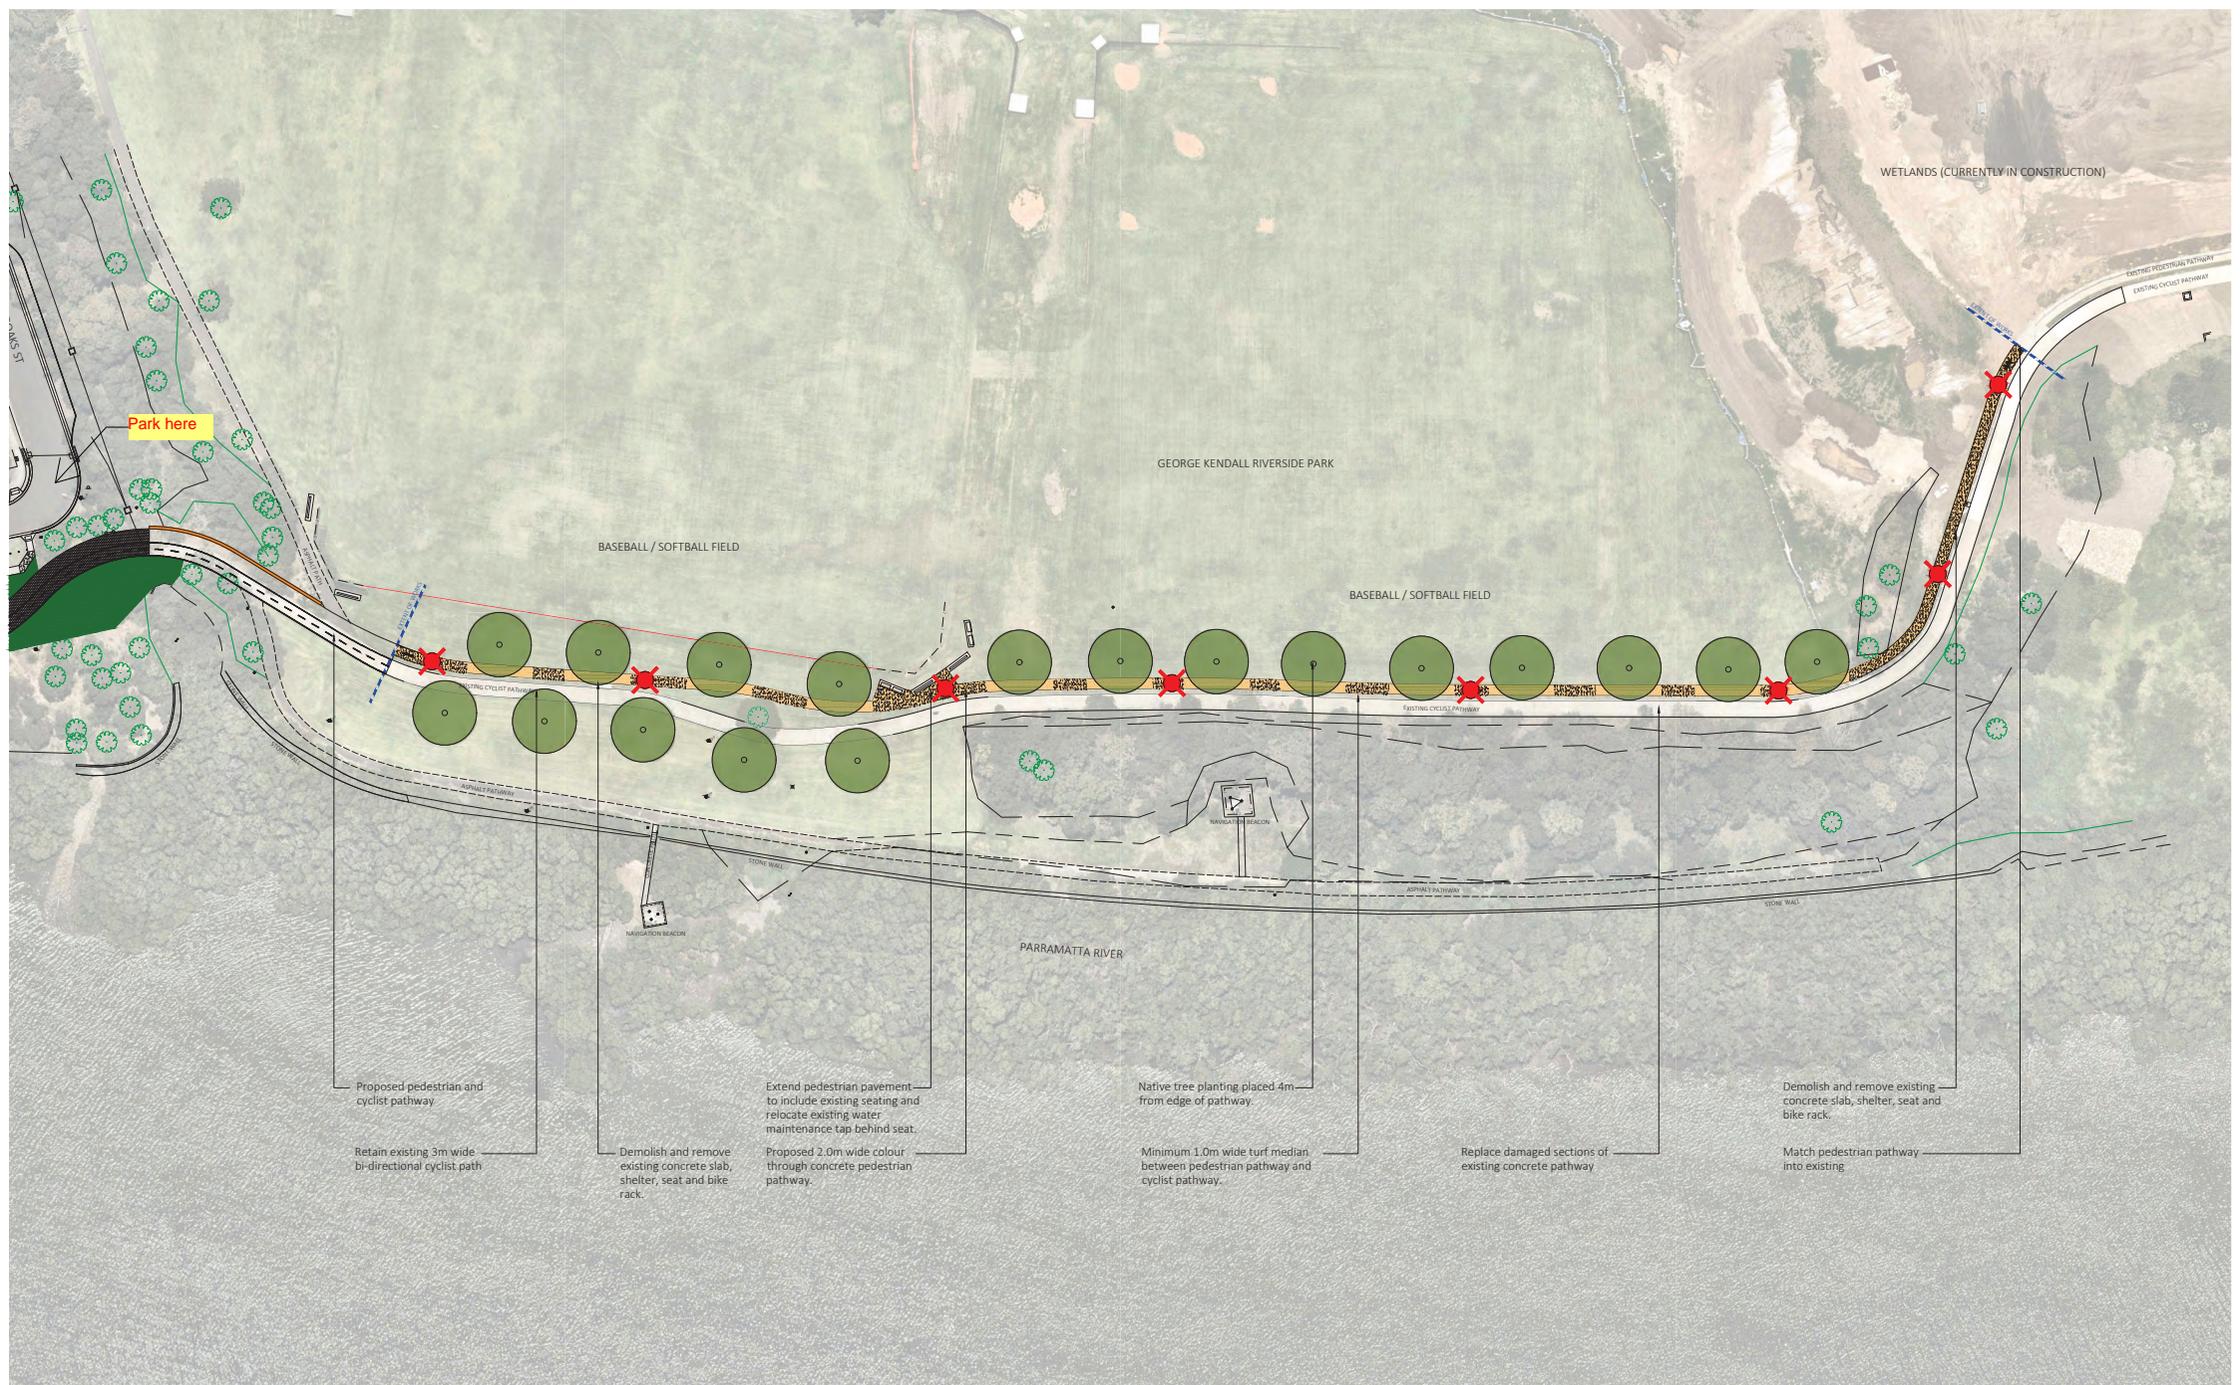
Proposed pedestrian and cyclist pathway

Retain existing 3m wide bi-directional cyclist path

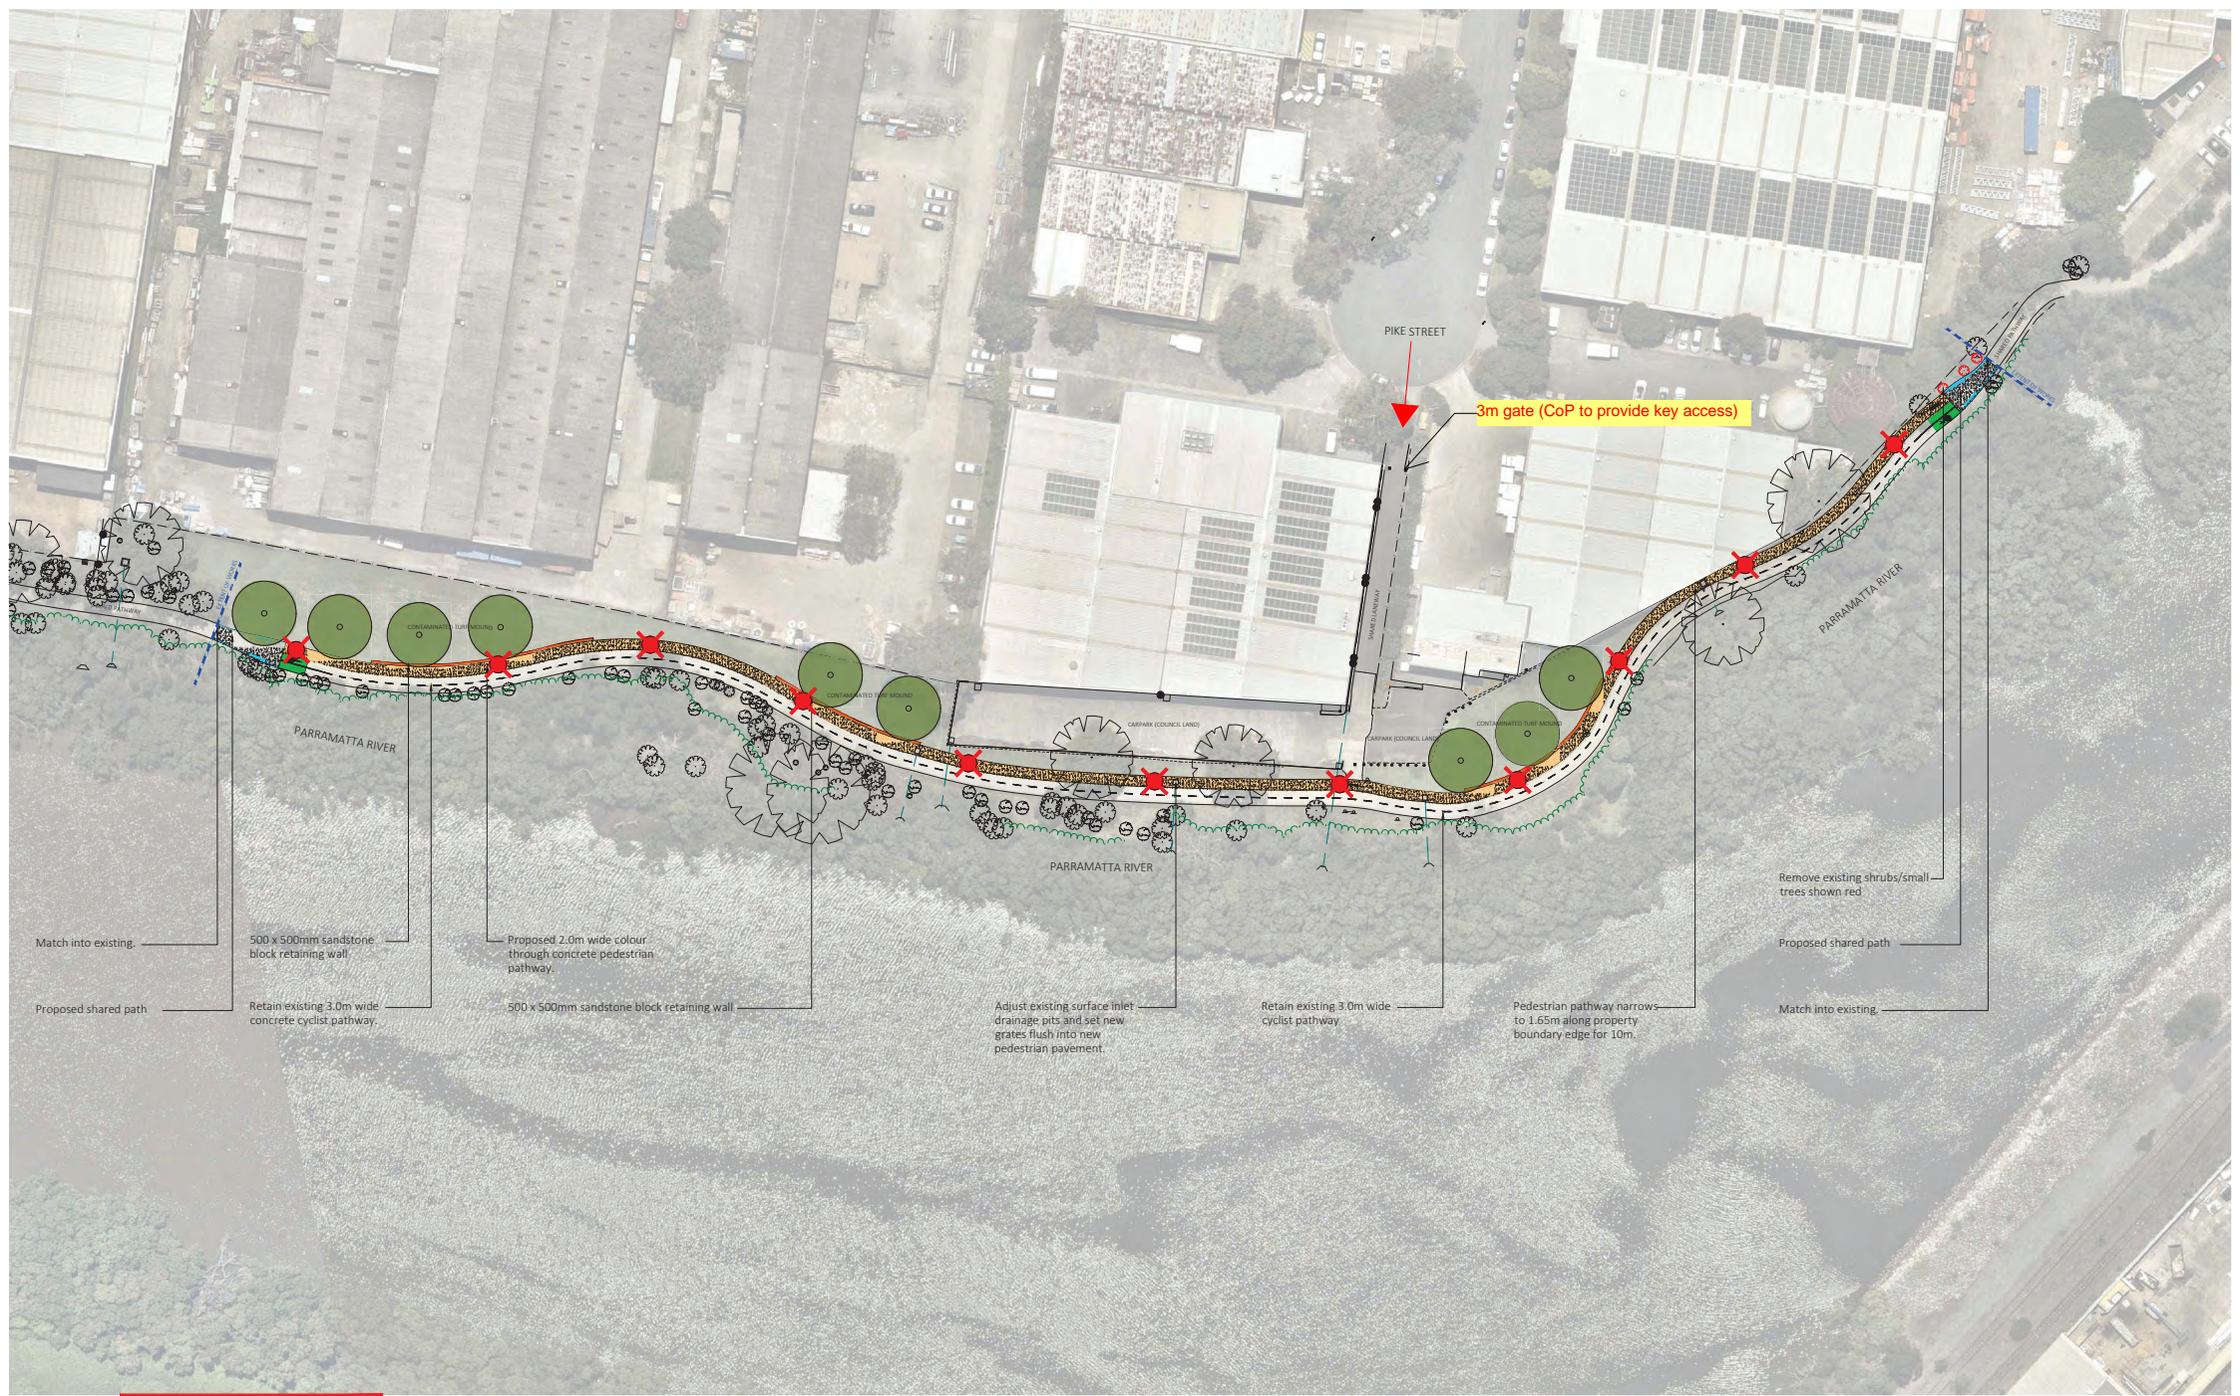
Match into existing.
Proposed shared path

500 x 500mm sandstone block retaining wall
Retain existing 3.0m wide concrete cyclist pathway

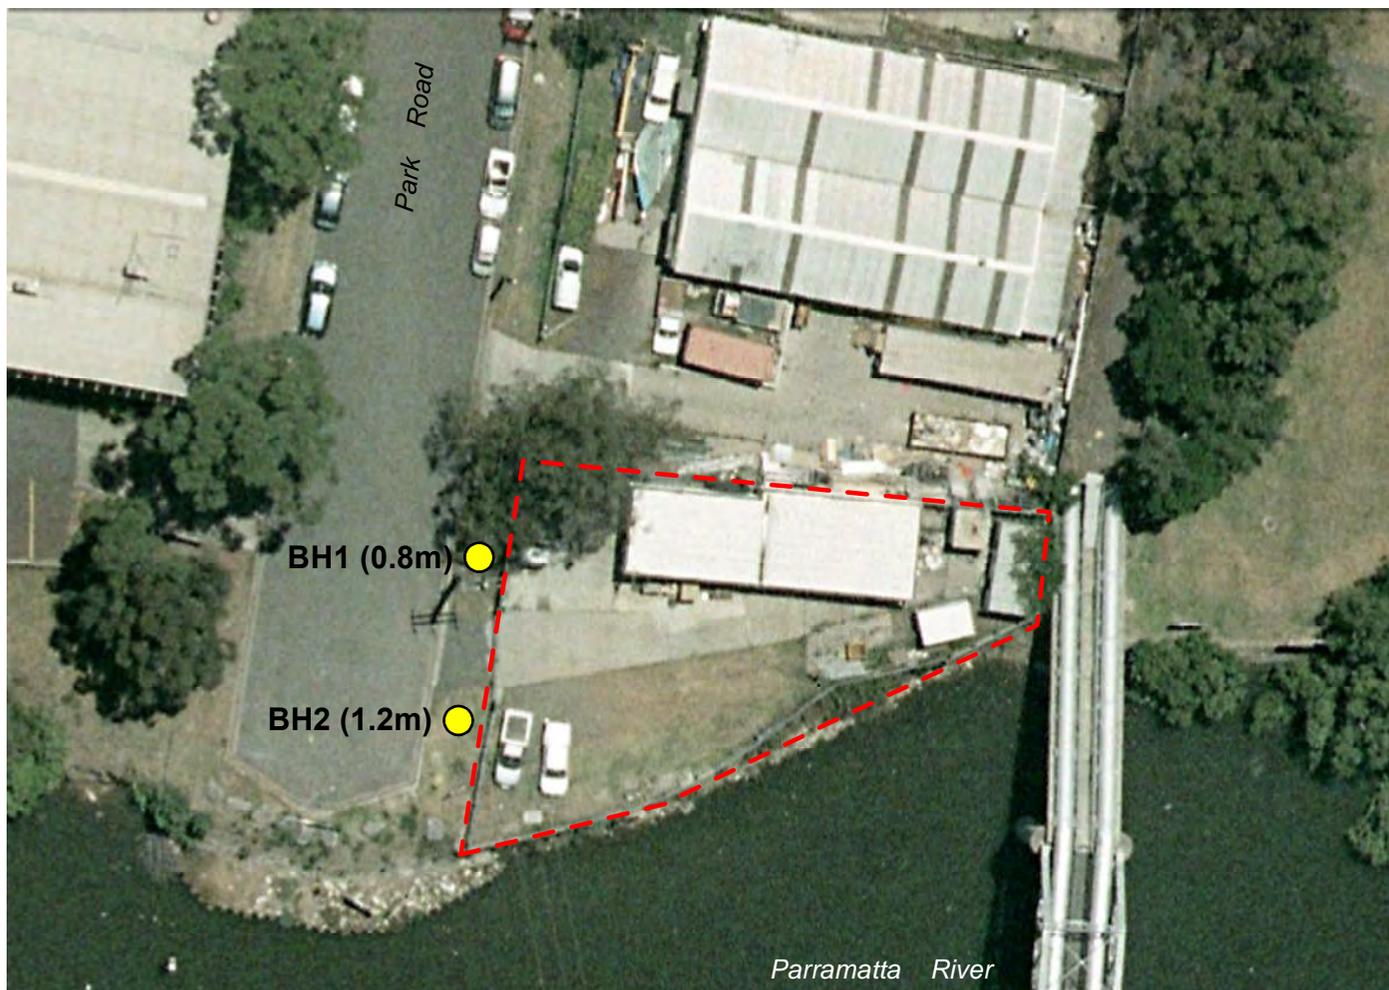
Project Number: E25326K	Title: BOREHOLE LOCATION PLAN
	Figure: 2	Address: 1 PARK ROAD RYDALMERE, NSW, 2116

- BH1 (0.8m) Borehole location, number and depth of fill
- Approximate site boundary
