Client Reference: E25326K, Proposed Cycleway Rydalmere

## **Remediation Action Plan**

CBD Cycleway Project: Reid Park, Rydalmere

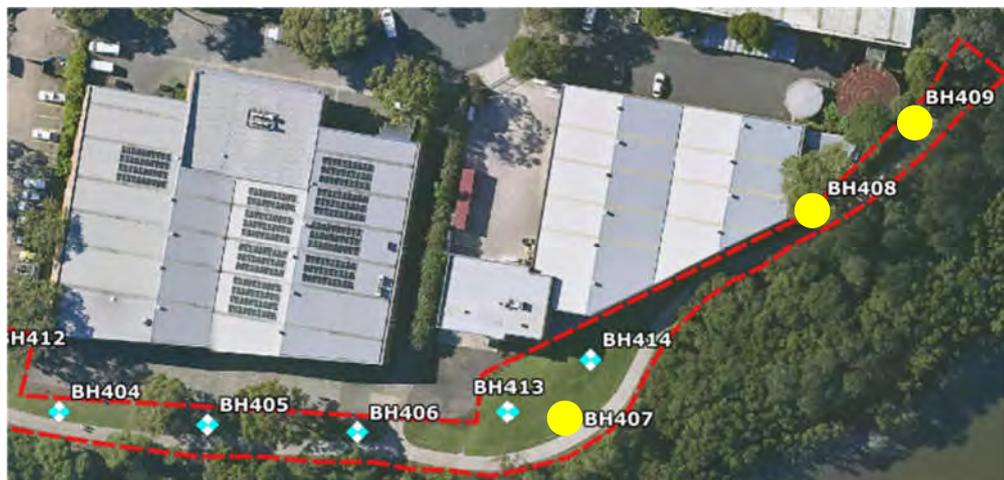
During the ASS Assessment (PRM, 2025) a blue powder was identified in three sampling locations (BH407, BH408 and BH409 as shown on **Plate 2** below). Upon identification, discussions with Council revealed that this soil was encountered previously and it was to be determined to be residual waste paint pigment. However, no documentation was able to be provided to PRM to support this.

**Plate 3: Extract from PRM 2025, blue powder locations in yellow circles**

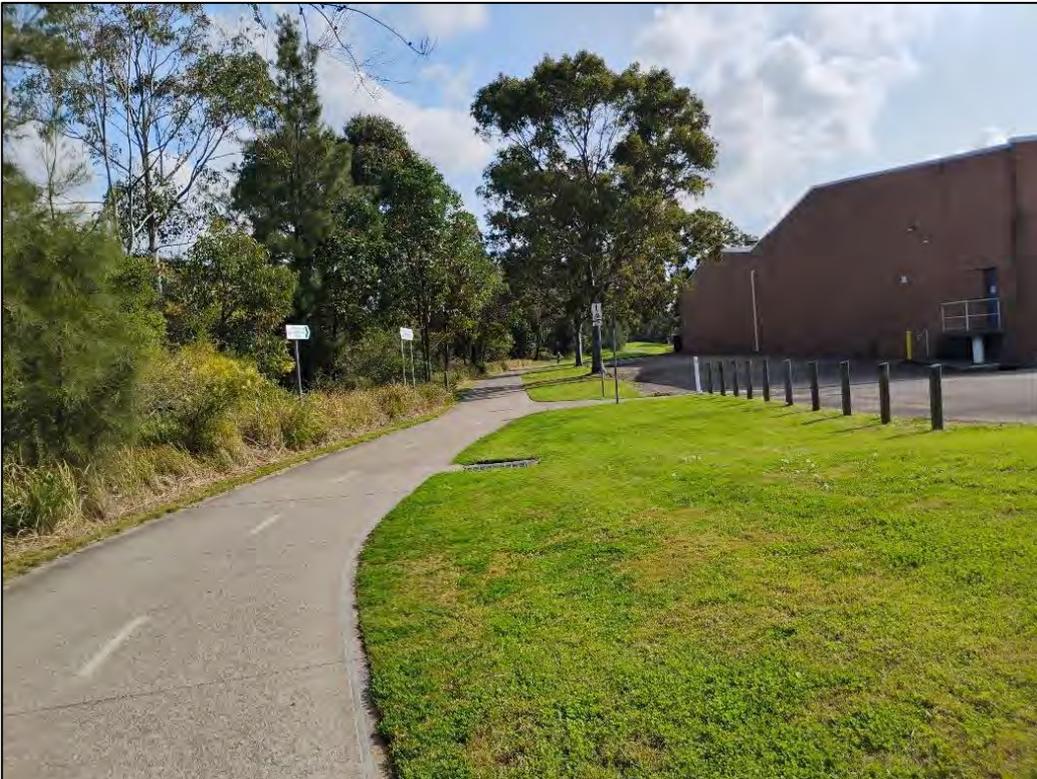
**Figure 1: View of existing pathway adjacent to Pike Street accessway, view looking west.**

The location of the site and nearby features are also shown on Drawing 1C in Appendix B. Figure 1 shows a typical view of the existing pathway at the time of the investigation.

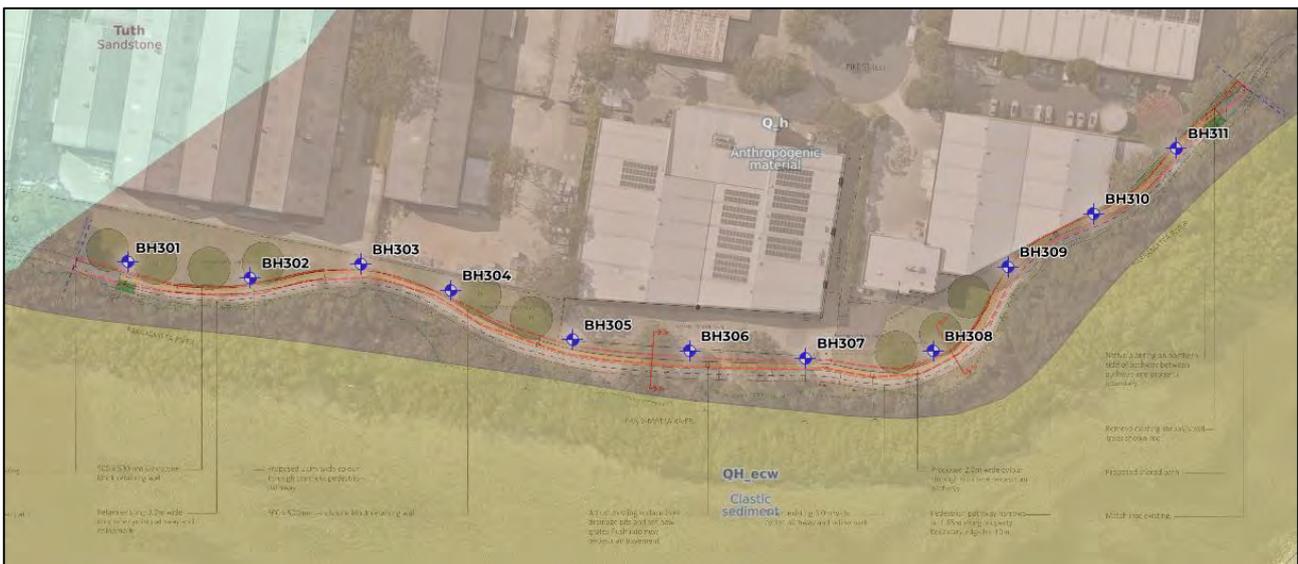
Reference to the NSW seamless geology mapping (Colquhoun, et al., 2021) indicates the site is generally underlain by Anthropogenic deposits (Q<sub>h</sub>, shown as brown area in Figure 2), with Estuarine channel deposits (QH<sub>ecw</sub>, brown-yellow mapped area) in the river to the south and Ashfield Shale (Twia, shown in green) to the north. The Anthropogenic deposits are described to varying from large man-made clasts (concrete blocks to building demolition rubble) to quarried natural boulders, with interstitial matrix of sand and clay. The shale unit, and possible the estuarine soils, are expected to underlie the anthropogenic deposit.

**Figure 2: Geological mapping at the proposed development site. Sourced from NSW seamless geology mapping (Colquhoun, et al., 2021).**

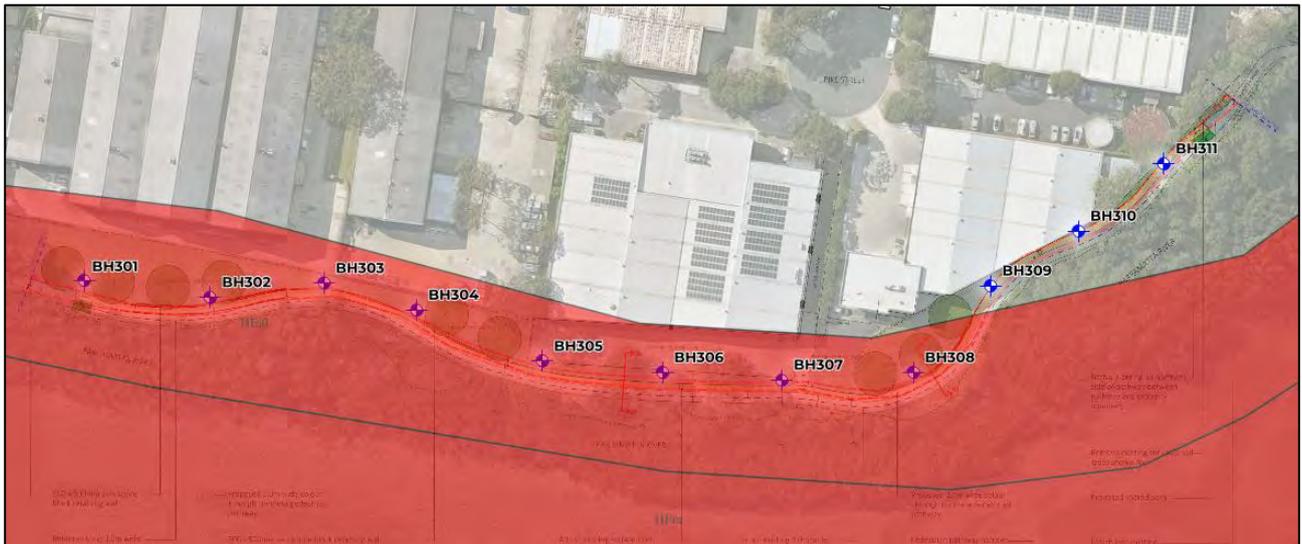
Acid Sulfate Soil (ASS) Risk Mapping published by NSW Department of Climate Change, Energy, the Environment and Water (NSW DCCEEW, 1998) indicate a high risk of ASS typically being present across the site at or near to the ground surface, as is shown in Figure 3 (in red).

**Figure 3: Acid sulfate soil mapping of site area, source from NSW DCCEEW (1998).**

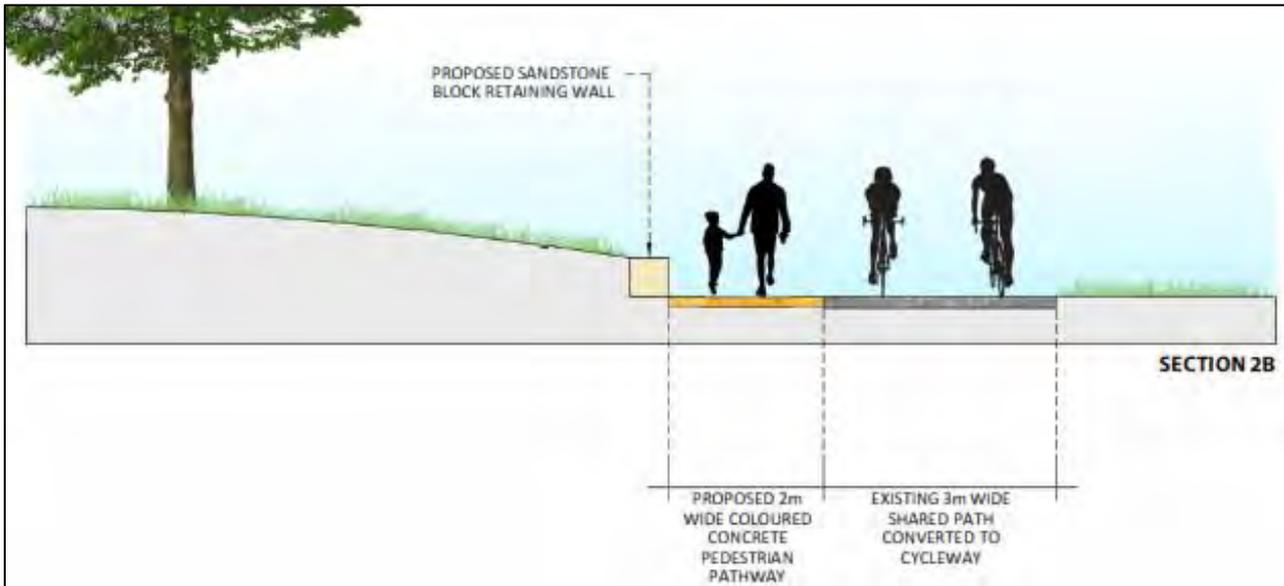
A typical cross section of the proposed works with retaining wall is shown in Figure 4.

**Figure 4: Cross section showing proposed works.**

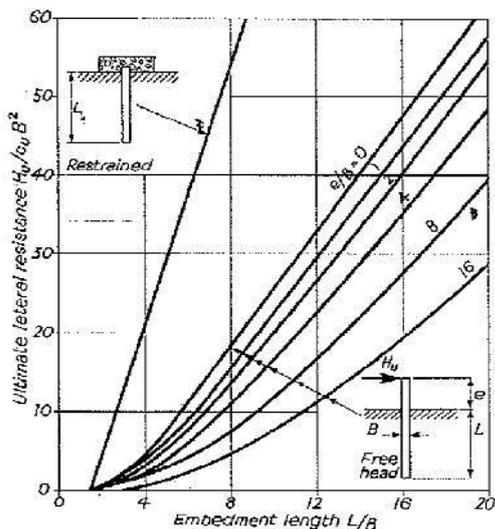
values on the y-axis, multiply this by  $c_u B^2$  for cohesive soil or  $K_p B^3 \gamma$  for cohesionless soil to obtain the ultimate lateral load,  $P_u$ .

Fig 1: Ultimate lateral resistance for cohesive soil, short pile (Ref 1)

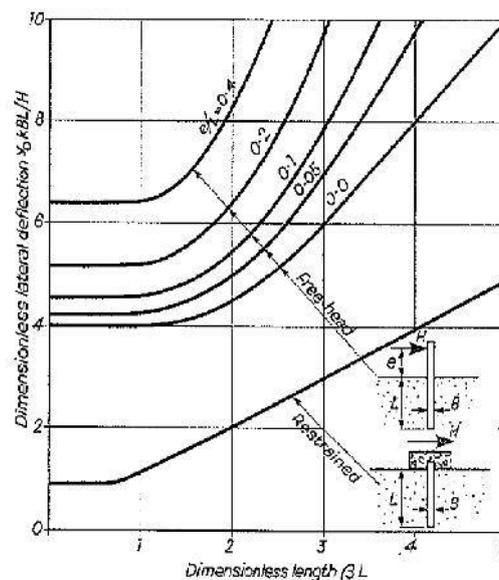
After entering the x-axis on Figure 5 with the  $\beta L$  value, select the line appropriate to the restraint condition, and, in the case of a 'free-head' pile, the load eccentricity to pile depth,  $e/D$ , ratio. The lateral deflection at ground surface due to the applied working load,  $H$ , is then calculated by dividing the y-axis value by  $k_h B L / H$ .

Fig 5: Lateral deflection at ground surface for cohesive soil

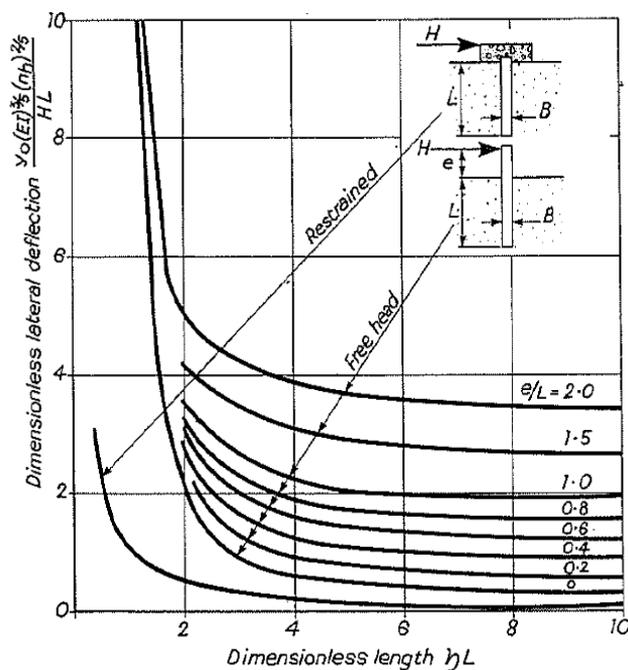
After entering the x-axis on Figure 6 with the  $\eta L$  value, select the line appropriate to the restraint condition, and, in the case of a 'free-head' pile, the load eccentricity to pile depth,  $e/D$ , ratio. The lateral deflection at ground surface due to the applied working load,  $H$ , is then calculated by dividing the y-axis value by  $(EI)^{3/5} \cdot (\eta_h)^{2/5} / (HL)$ .

Fig 6: Lateral deflection at ground surface for cohesionless soil

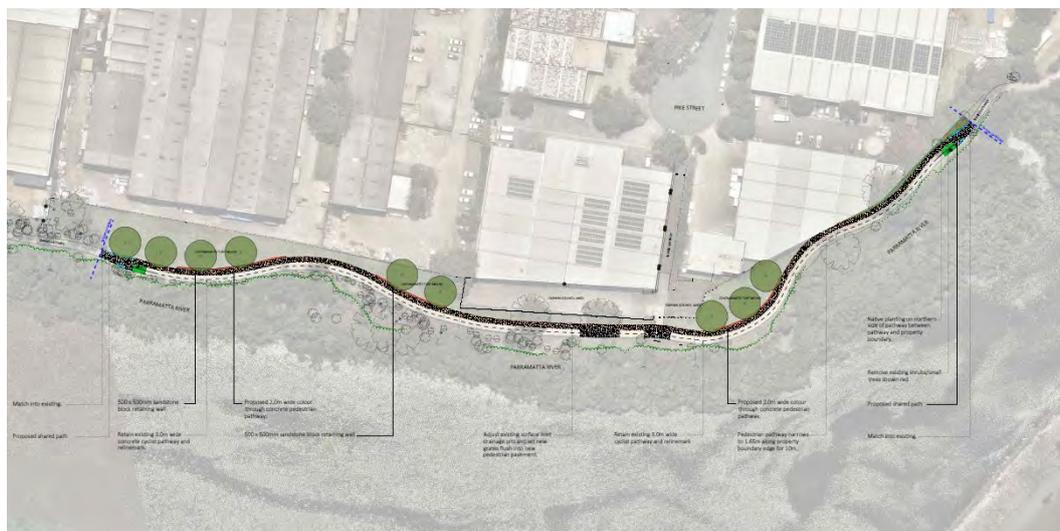
Figure 10 Proposed Site Plan. Source: City of Parramatta

**Figure 9** is an extract of the proposed Landscape Plan.

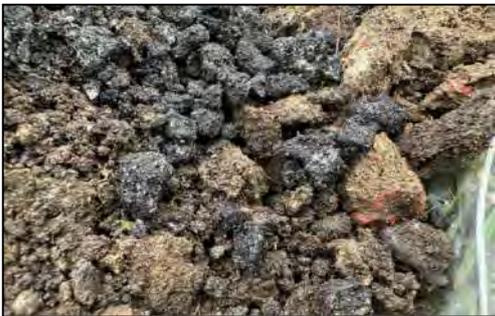
**Photo 5:** Overview of material observed at sampling location for BH401, with road base.

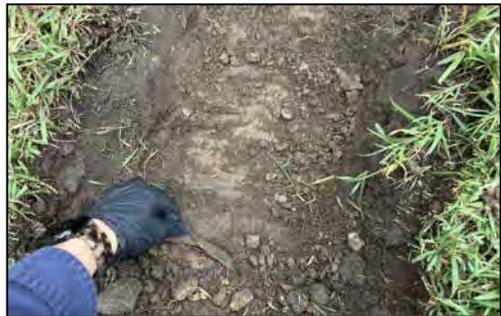
**Photo 6:** Woven fabric identified at sampling location BH406.

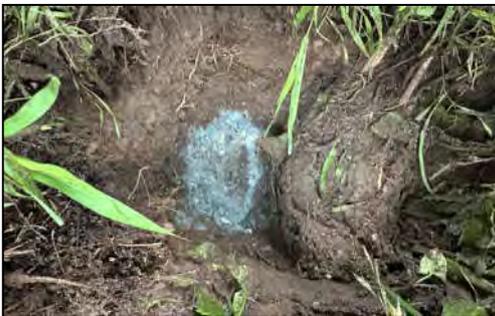
**Photo 7:** Suspected hazardous substance (blue powder) identified at 0.3 mg/l at BH409.
