Remediation Action Plan

CBD Cycleway Project: Rangihou Reserve, Parramatta

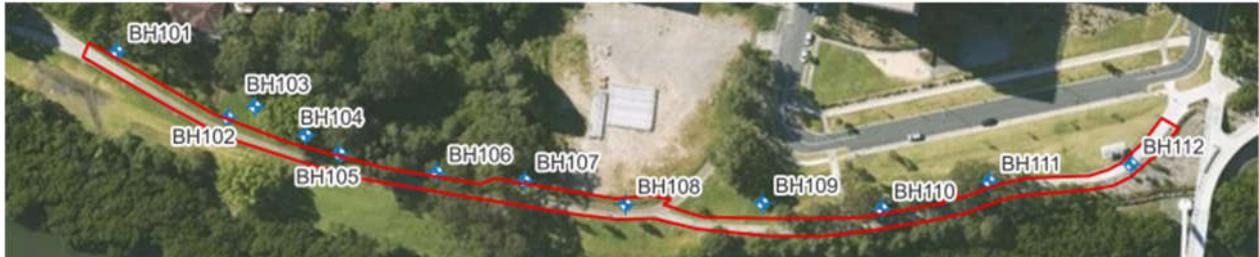
Image 1: Extract from DP DSI showing sample locations.

- Drilling of 12 boreholes which were augered to a target depth of 2.0m. These boreholes were identified as BH101 to BH112 from west to east.
- Analysis of collected samples for contaminants of potential concern.
- Preparation of the DSI report.

- A comparable profile was observed in the western boreholes (BH101 to BH106) and concentrations of contaminants in soil did not exceed the site assessment criteria.
- BH107 and BH108 (both noted to be within Area B) had asbestos contamination as follows:
 - BH107: Fill material to 1.7mbgl with asbestos (AF/FA) identified in analysis from sample collected from 0.4-0.5m depth.
 - BH108: Fill material to 0.2 mbgl and borehole terminated at this depth due to visible asbestos contamination.
- BH109 to BH112 (noted to be within Area C) displayed evidence of a marker layer / capping ranging between 0.2 and 1.0m within and concentrations in soil above the marker layer below the adopted site assessment criteria.

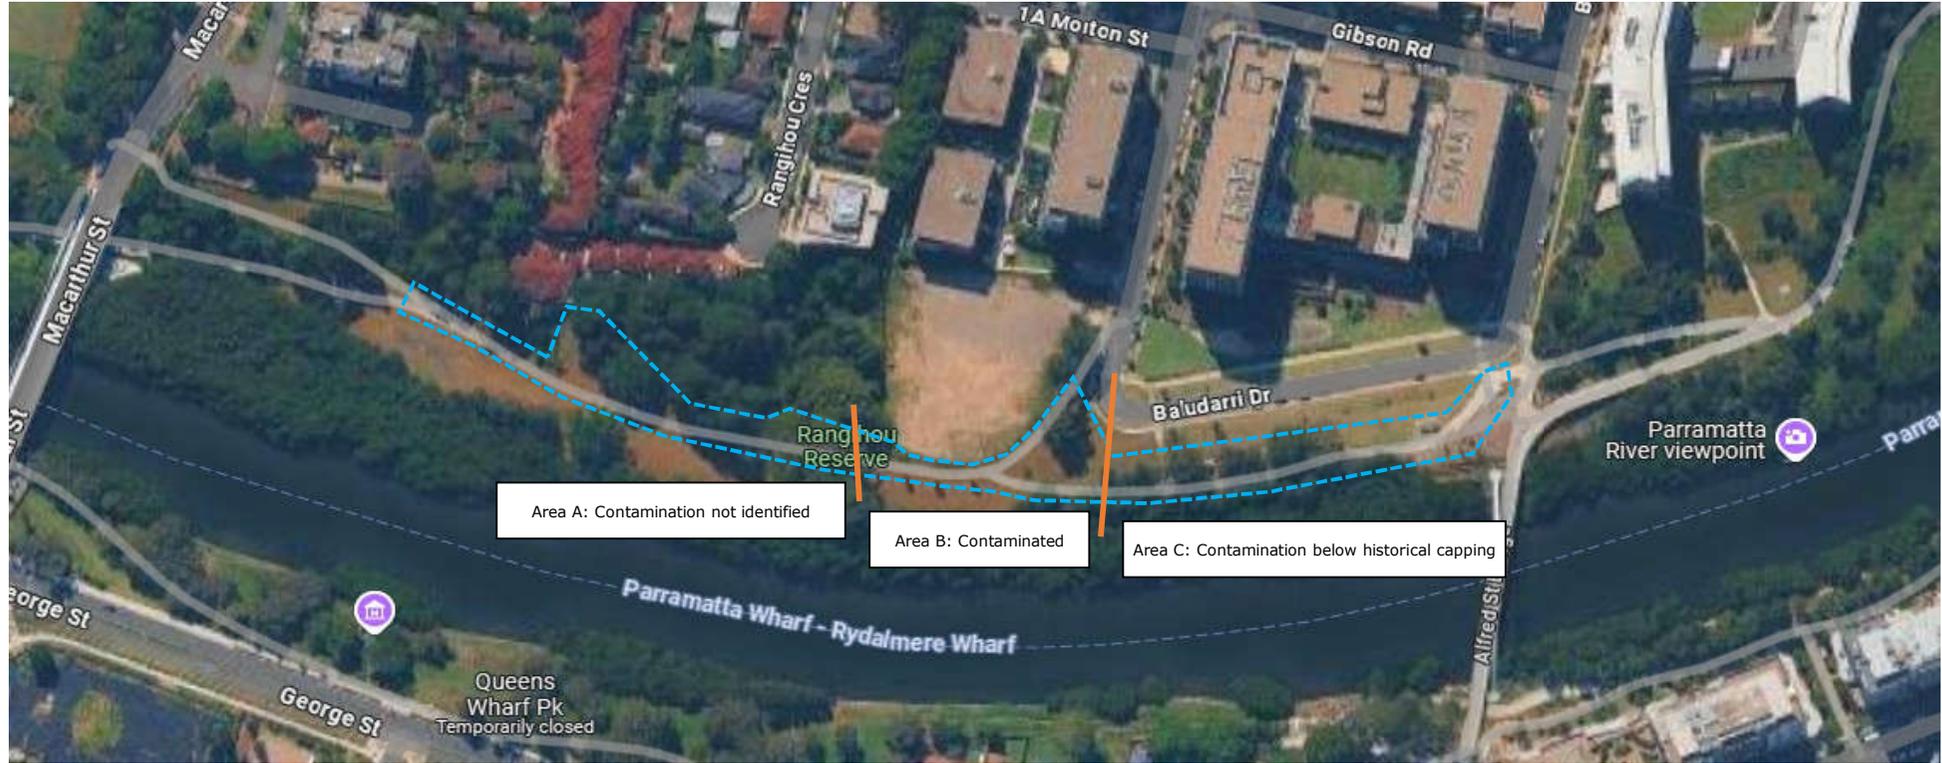
Area A: Contamination not identified

Area B: Contaminated

LEGEND		Report Name:	Remediation Action Plan
	Approximate area of works	Site Details:	CBD Cycleway Project: Rangihou Reserve - Baludarri Drive, Parramatta NSW
	Approximate extent of areas (Refer Fig 3a, 3b, 3c)	Client Name:	City of Parramatta Council
		PRM Reference:	P037382.011 / C0018
		Figure Number:	2
		Figure Name:	Site Layout Map

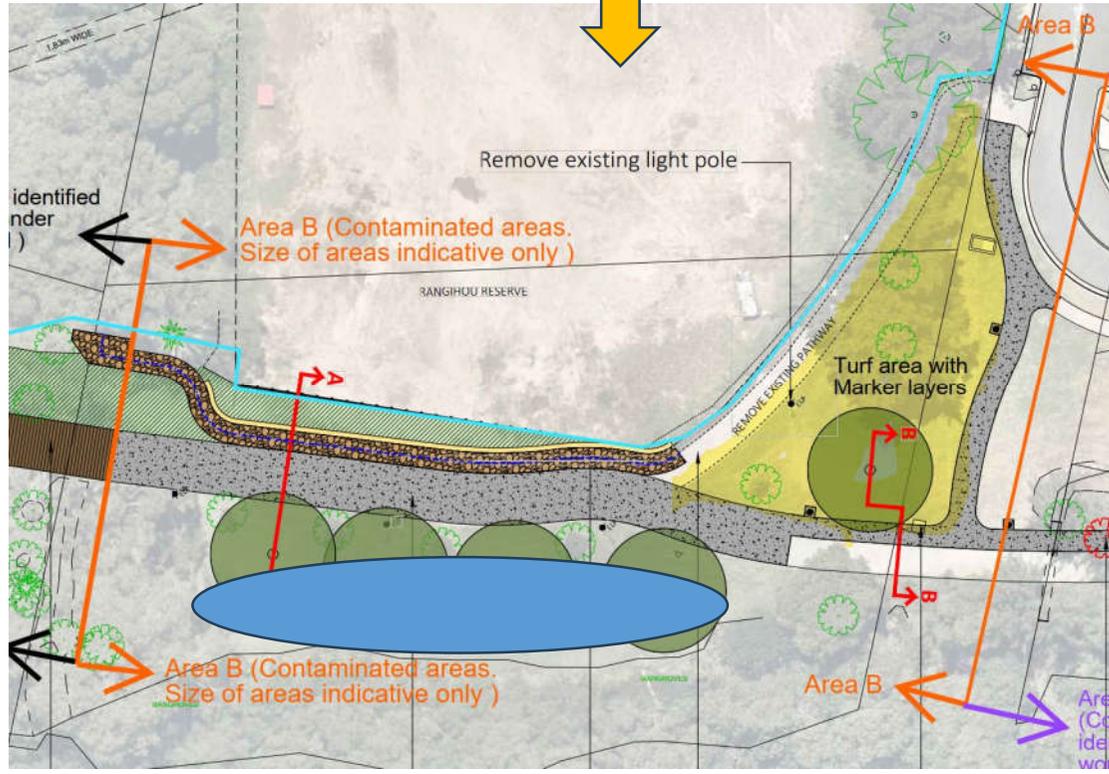
Proposed stockpile area for contaminated material

Report Name:	Remediation Action Plan
Site Details:	CBD Cycleway Project: Rangihou Reserve - Baludarra Drive, Parramatta NSW
Client Name:	City of Parramatta Council
PRM Reference:	P037382.011 / C0018
Figure Number:	3b: Area B
Figure Name:	Site Layout Map

- As required, soil is to be excavated under Class A asbestos removal conditions. Soil is to be stockpiled in a designated area, a waste classification is to be completed and the soil is to be disposed of offsite. Refer Figure 3b for details of stockpile location.

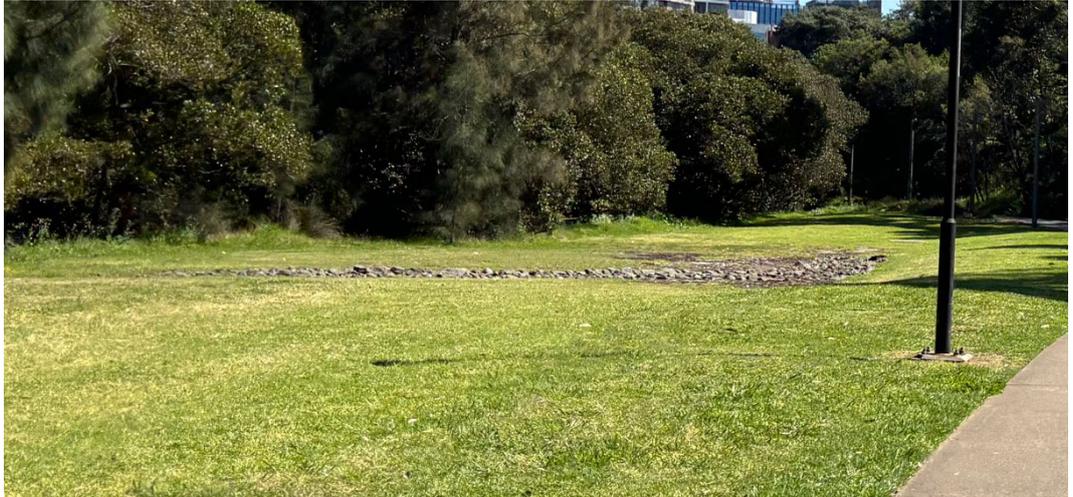
Figure 10 Photograph of rubble stone wall within Rangihou Reserve

A photograph of the rubble stone wall on the northern side of the river is provided at **Figure 10** below.
