# RANGIHOU RESERVE PARRAMATTA

## PEDESTRIAN AND CYCLIST PATHWAYS

**Report Name:** Acid Sulfate Soil Assessment

# Environmental Management Plan, Lot 301, Morton St Parramatta NSW

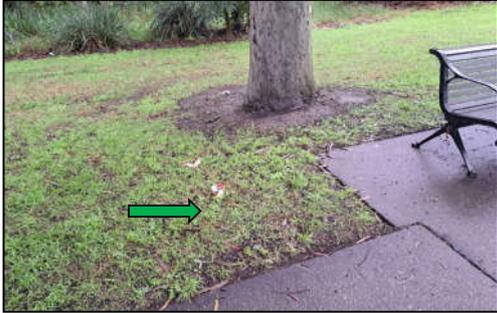
**Photo 1:** Location of BH01.

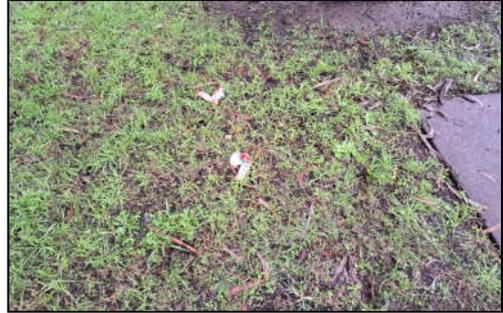
**Photo 2:** Site surface at BH01.

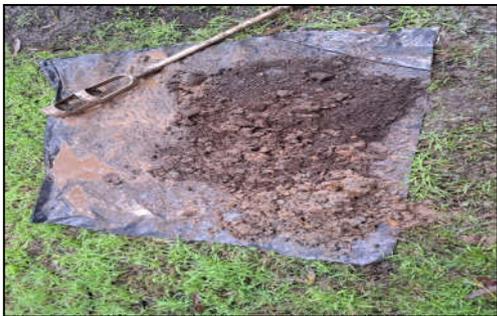
**Photo 3:** Material identified at BH01.

Depth (m)	Samples	Graphic Log	Material Description	Additional Observations
0.5	BH01_S		Silty CLAY, dark brown, heterogeneous, slightly moist, medium plasticity, firm with trace inclusions of rootlets.	No odours, staining, nor asbestos.
	BH01_0.5			
1	BH01_1.0			
1.5	BH01_1.5		sandy CLAY, light brown, heterogeneous, no inclusions.	No odours, staining, nor asbestos.
2	BH01_2.0		Termination Depth at: 2.0 mbgl

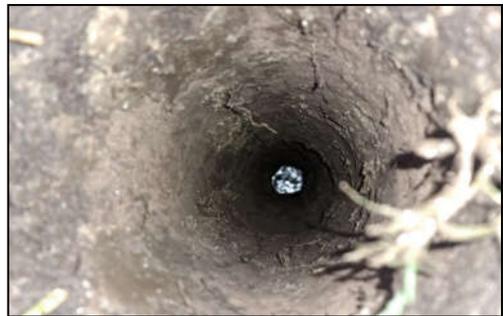
**Photo 4:** BH01, groundwater at 2mbgl.

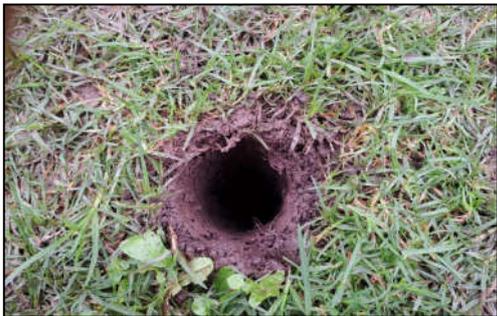
**Photo 5:** Site surface at BH02.

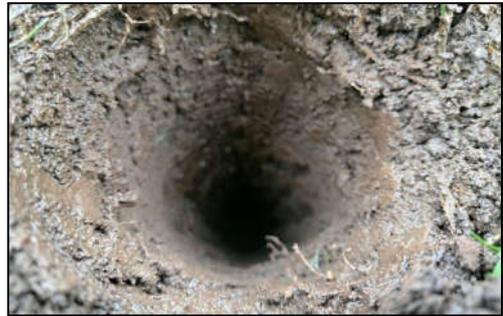
**Photo 6:** material within BH02.

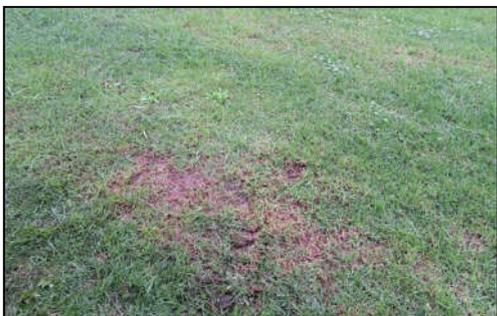
**Photo 7:** Location of BH03.

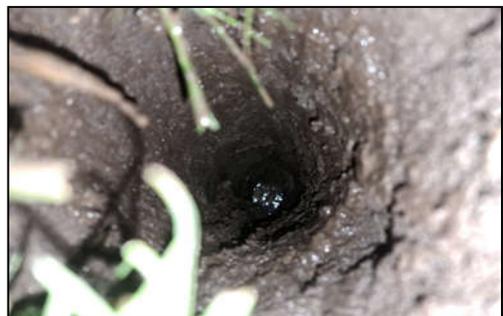
**Photo 8:** Material within BH03.

Depth (m)	Samples	Graphic Log	Material Description	Additional Observations
0.5	BH03_S  BH03_0.5		Silty CLAY, brown, heterogeneous, moist, medium plasticity, firm with trace inclusions of rootlets	No odours, staining, nor asbestos.
1	BH03_1.0		clayey SAND, brown heterogeneous, very moist, fine to coarse grain, no inclusions.	No odours, staining, nor asbestos.
1.5			Termination Depth at: 1.0 mbgl	
2

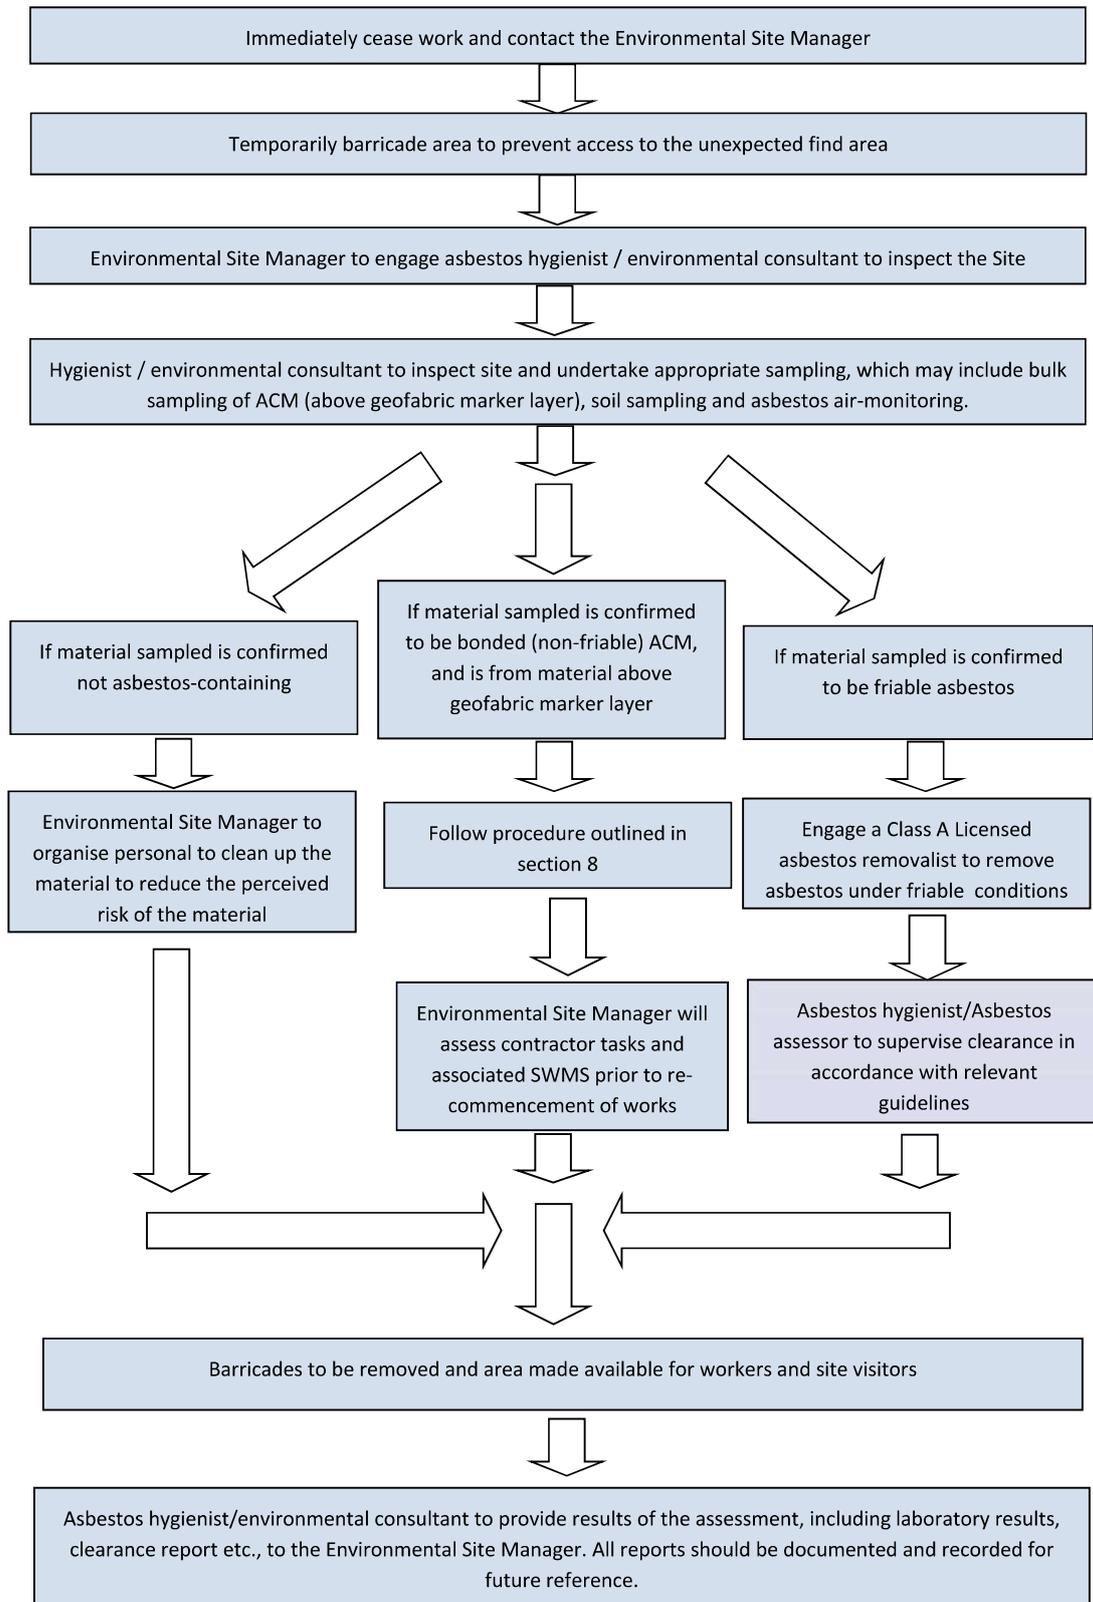
**Unexpected Finds Protocol**

If suspected contamination and/or hazardous material is encountered the “Unexpected Findings Protocol Proforma” should be completed, with a brief description of the material reported and the location of the material identified with a sketch. An example UFP proforma has been provided in Appendix D.

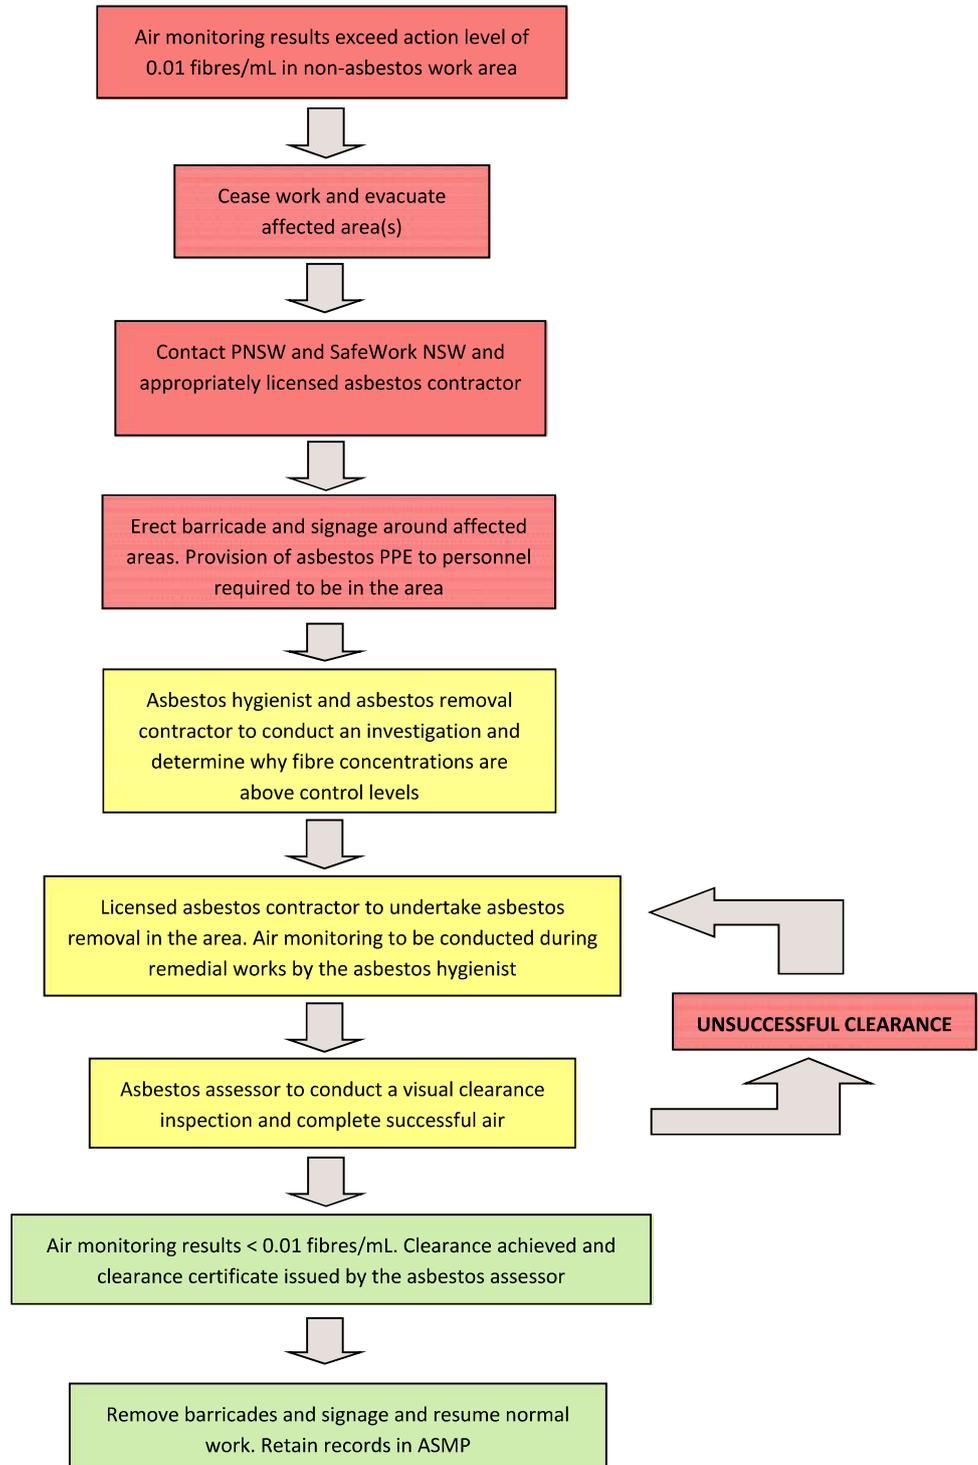
## Emergency procedure when air monitoring control levels are exceeded

The following procedure shall be followed if elevated asbestos air monitoring results are obtained during remediation works

Works must cease if the air monitoring results are found to be above the laboratory limit of detection of 0.01 f/ml of air. Emergency procedures must be followed when air monitoring control levels are exceeded as outlined in **Appendix C**.
