PROJECT:
 RANGIHOU RESERVE SHARED PEDESTRIAN AND CYCLIST PATHWAY

DRAWING TITLE:
 EXISTING SCENARIO
 5YR ARI STORM EVENT
 MAXIMUM FLOOD DEPTH-VELOCITY

15.	Conclusions and recommendations	24
16.	References	25
17.	Limitations.....	26

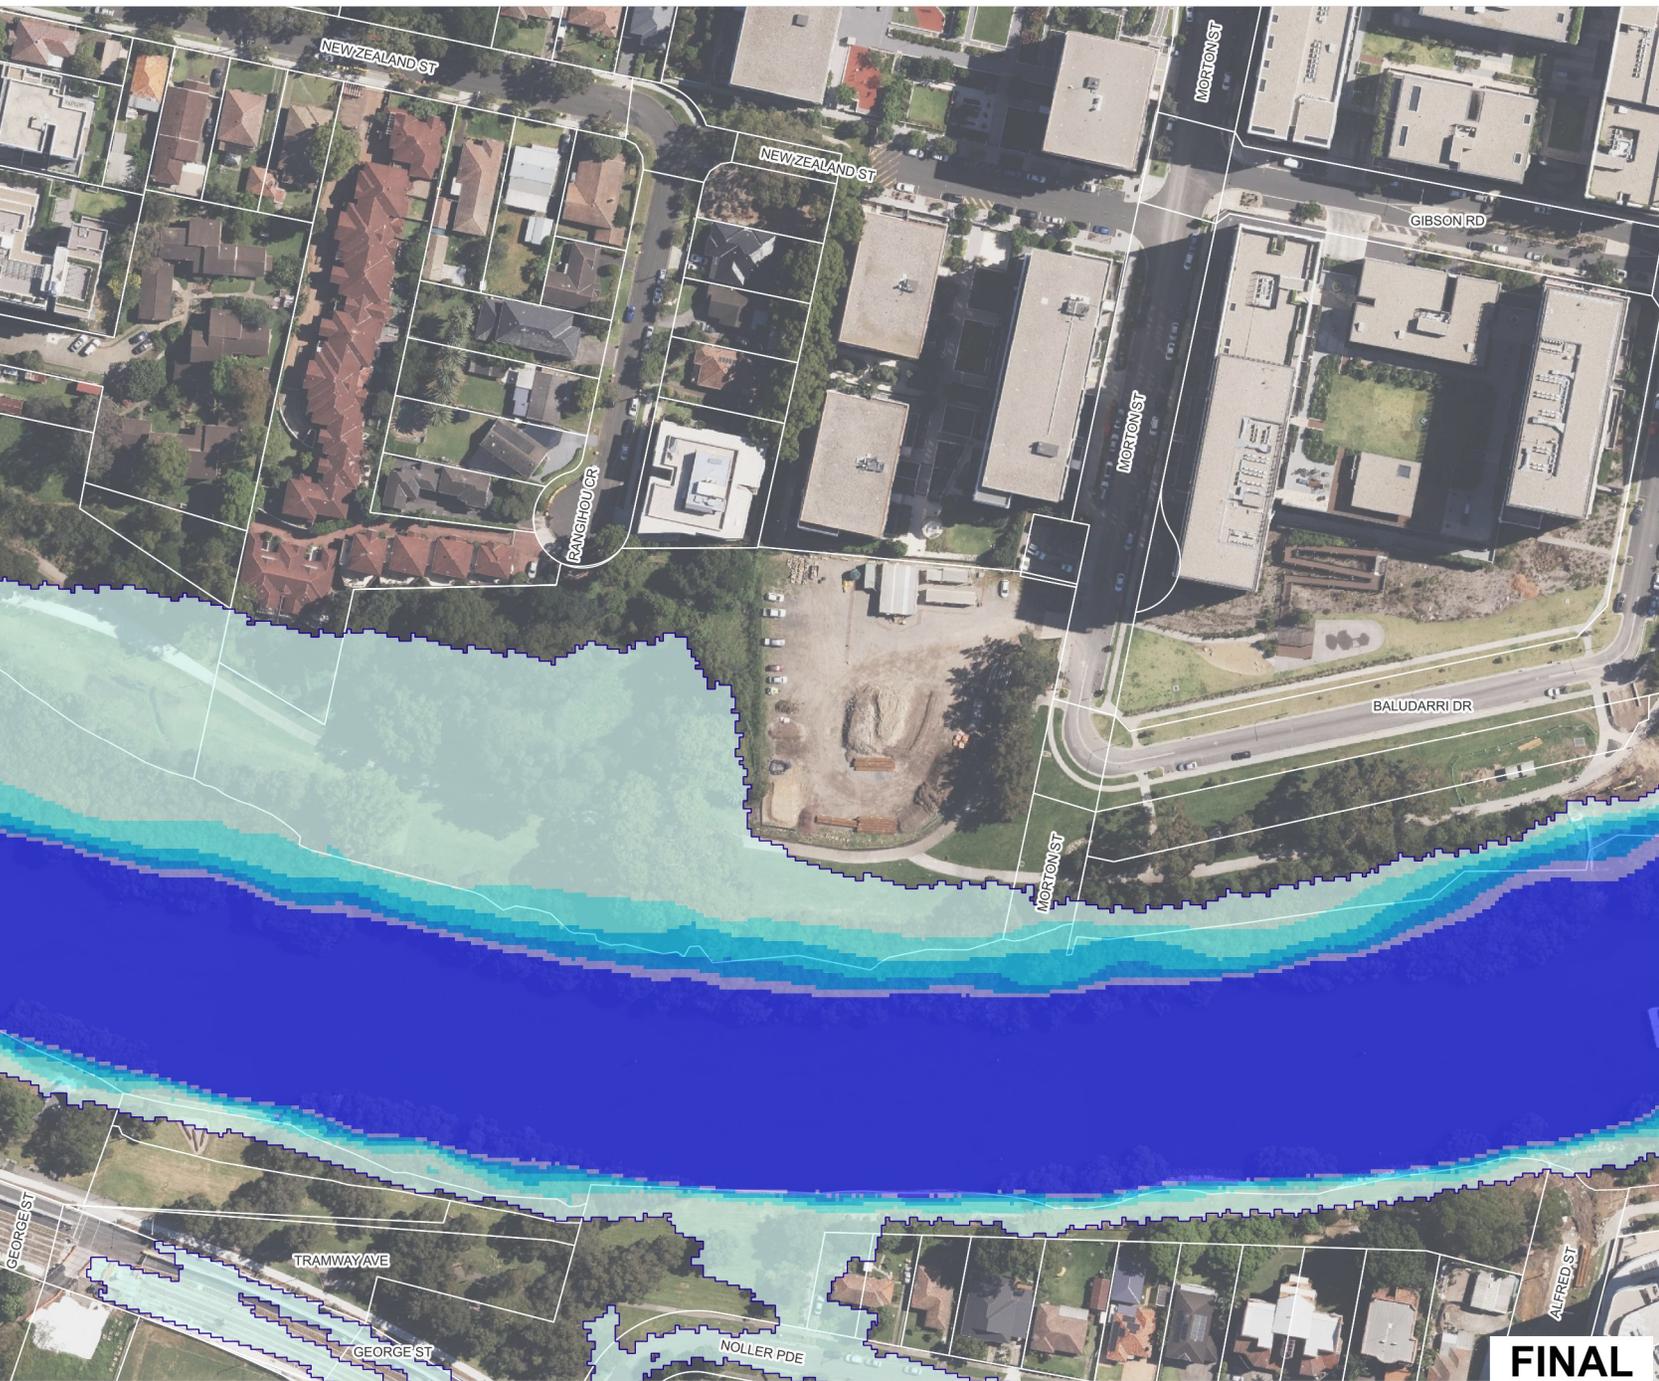
FIGURE: A3 **ISSUE:** A

20pc_Existing_Fld_Extent
	20pc_4.5hr_Existing_Fld_DxV_Max
	Band 1
	0.0-0.2
	0.2-0.4
	0.4-0.6
	0.6-0.8
	0.8-1.0
	>1

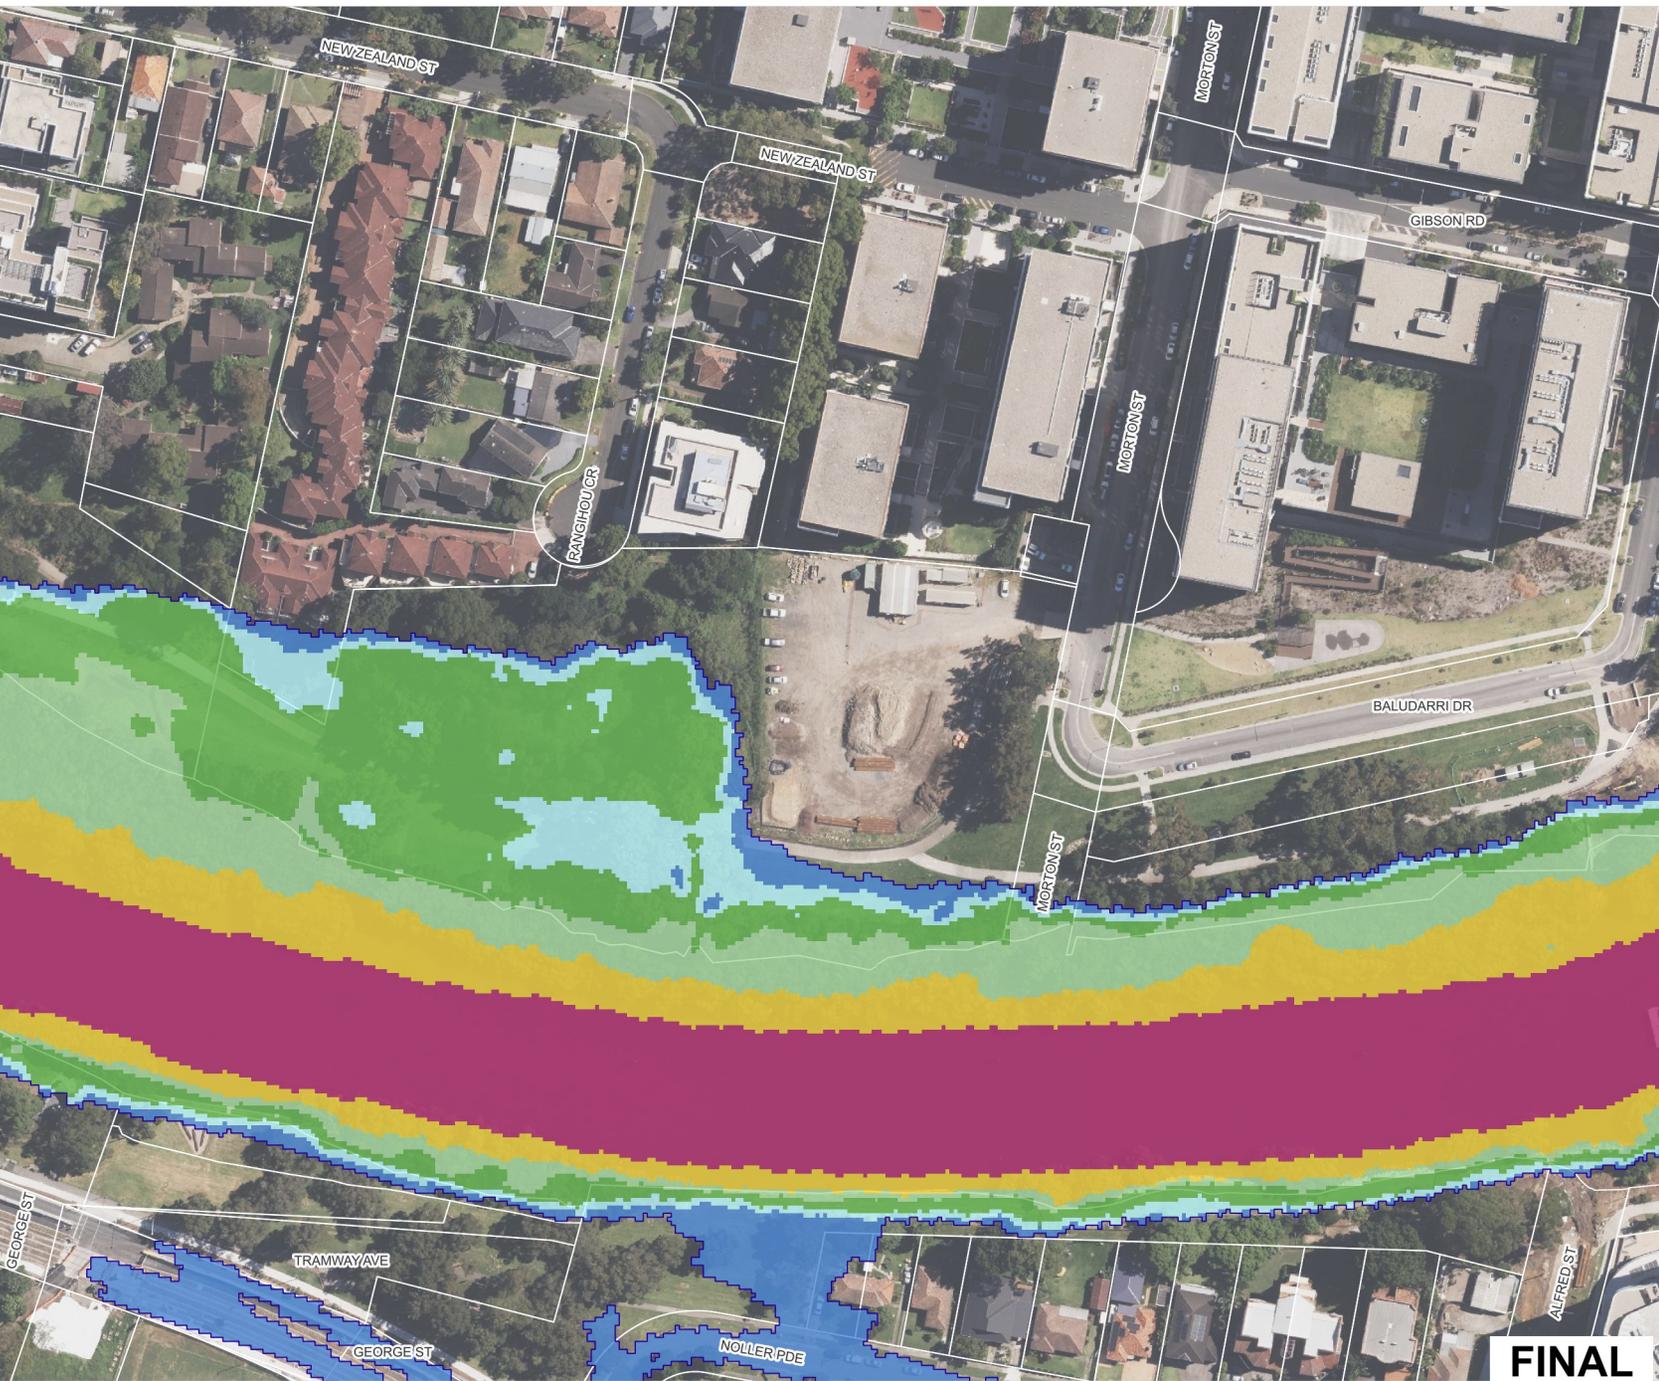
FIGURE: A4 **ISSUE:** A

- 20pc_Existing_Fld_Extent
- 20pc_4.5hr_Existing_Max_Fld_Hazard
- Band 1
- H1
- H2
- H3
- H4
- H5
- H6

DRAWING TITLE:
 EXISTING SCENARIO 5YR ARI STORM EVENT MAXIMUM FLOOD HAZARD

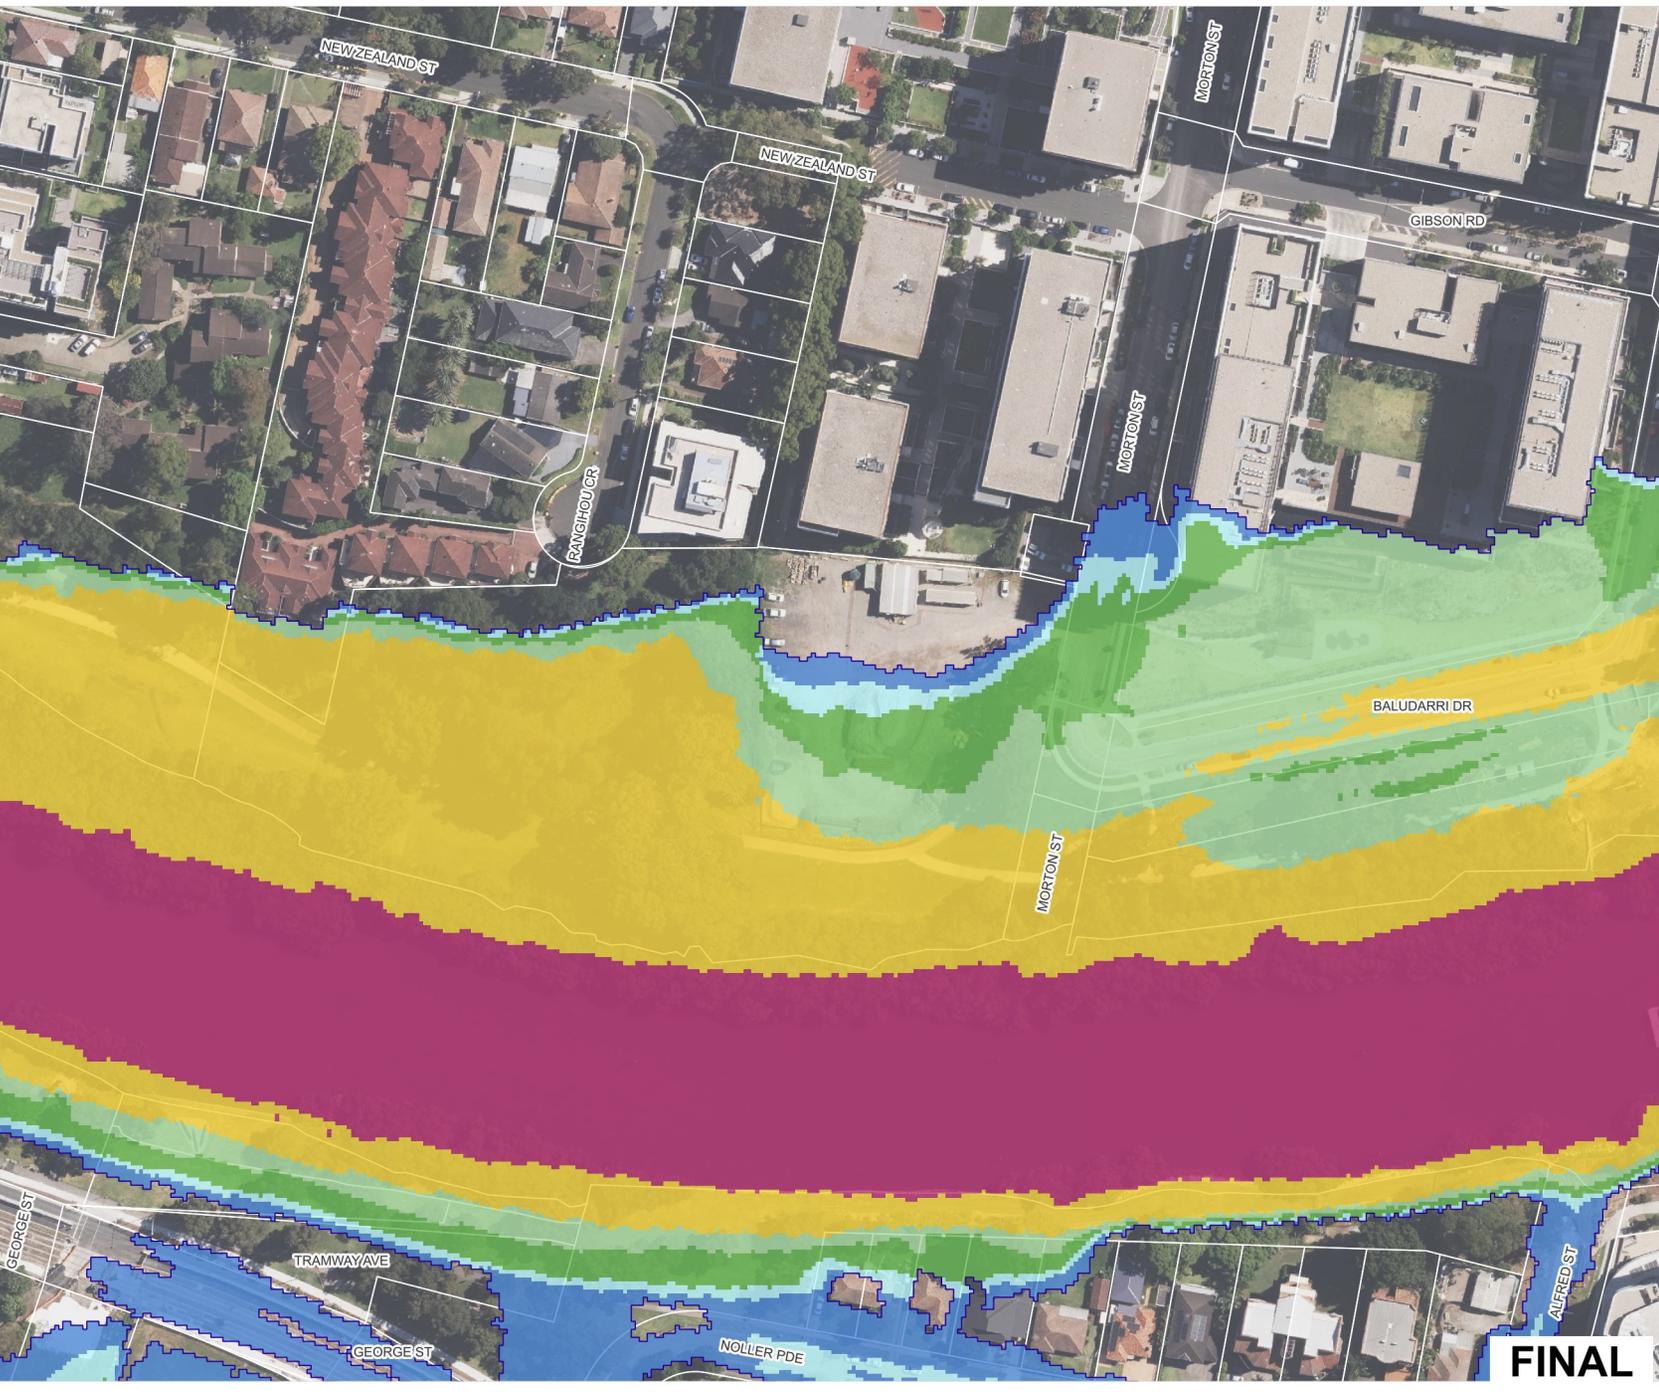
- FFA_1pc_12hr_Max_Fld_Extent
- FFA_1pc_12hr_Max_Fld_Hazard
- Band 1
- H1
- H2
- H3
- H4
- H5
- H6

DRAWING TITLE:
 EXISTING SCENARIO FFA_100YR ARI STORM EVENT MAXIMUM FLOOD HAZARD

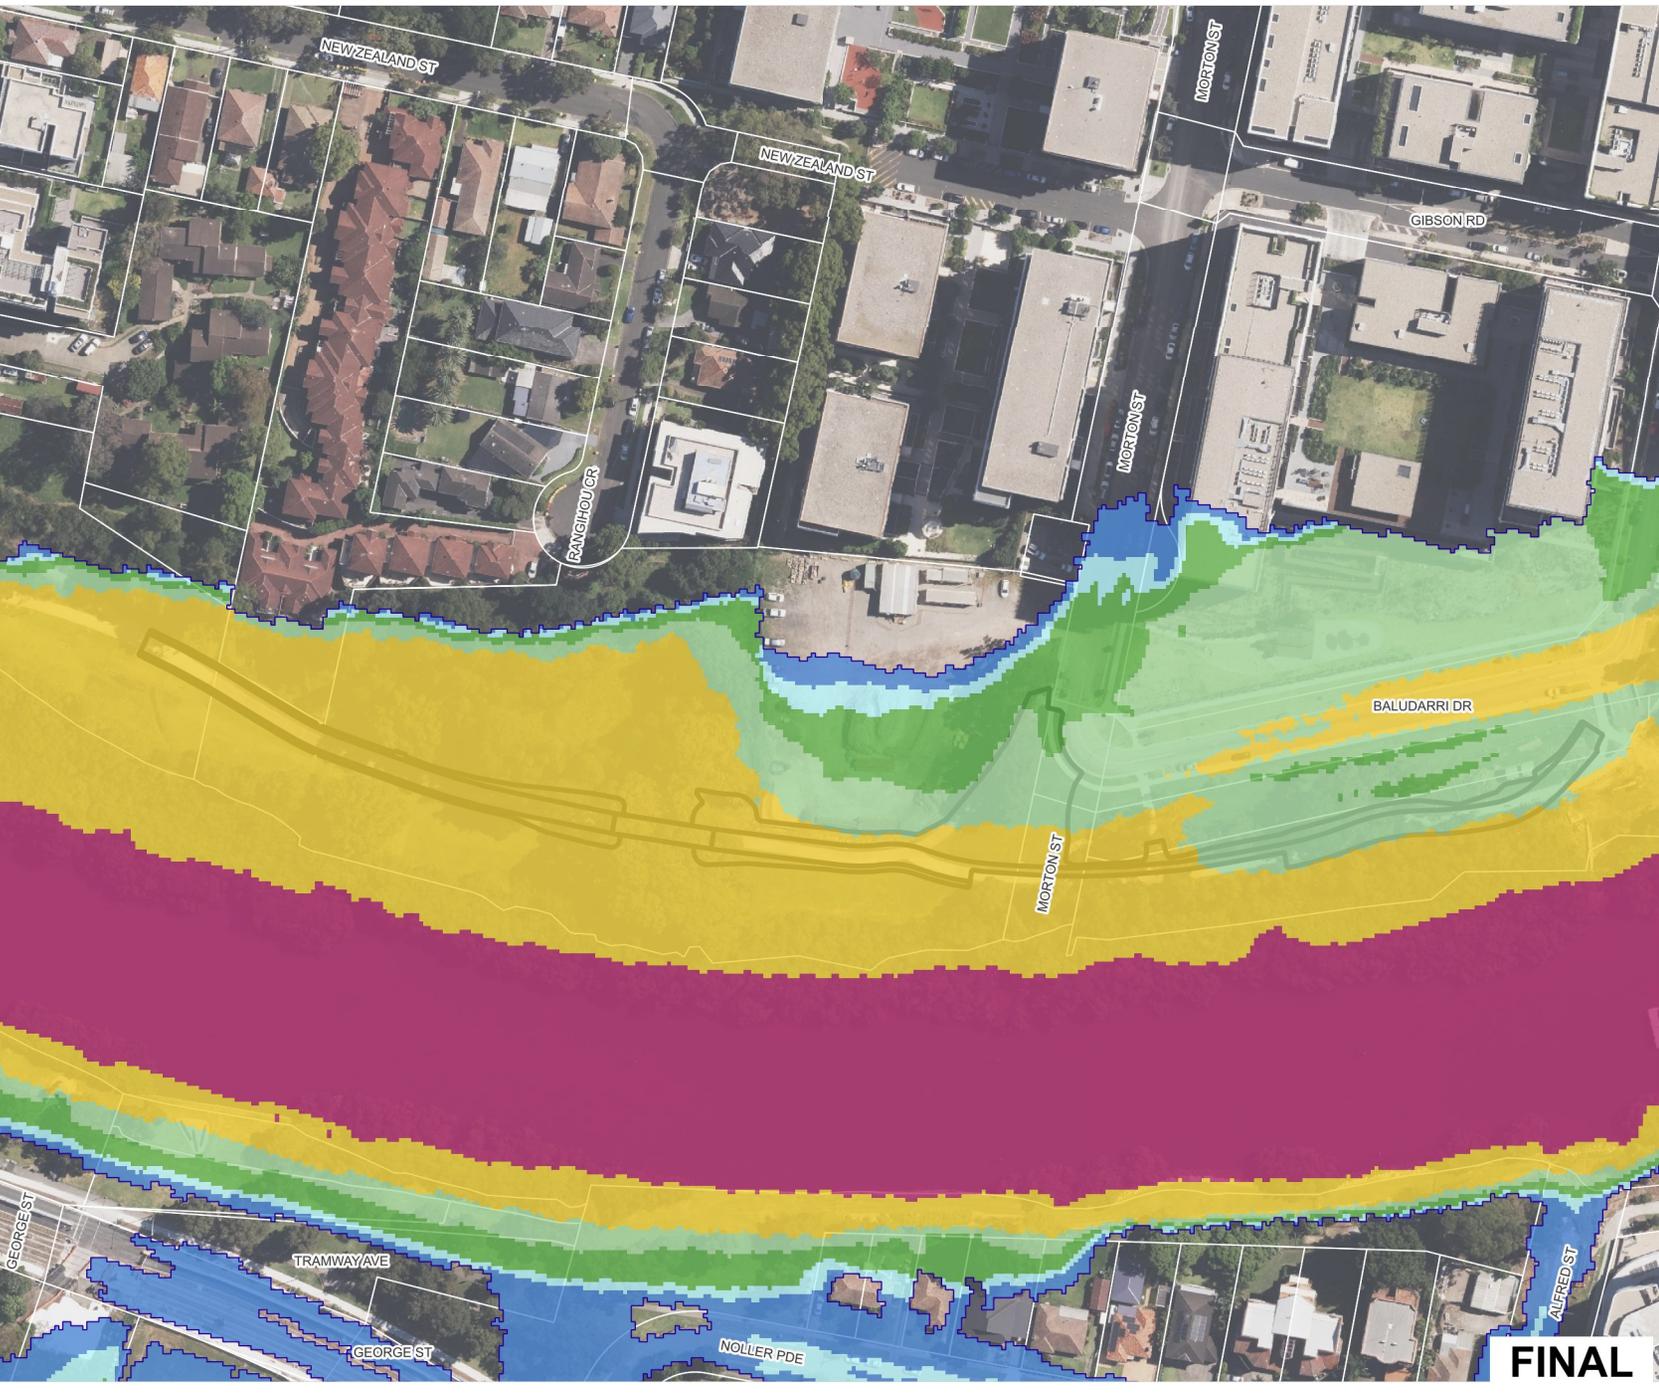
- Developed
- FFA_1pc_12hr_Max_Fld_Extnt
- FFA_1pc_12hr_Max_Fld_Hazard
- Band 1
- H1
 - H2
 - H3
 - H4
 - H5
 - H6

DRAWING TITLE:
 DEVELOPED SCENARIO FFA_100YR ARI STORM EVENT MAXIMUM FLOOD HAZARD

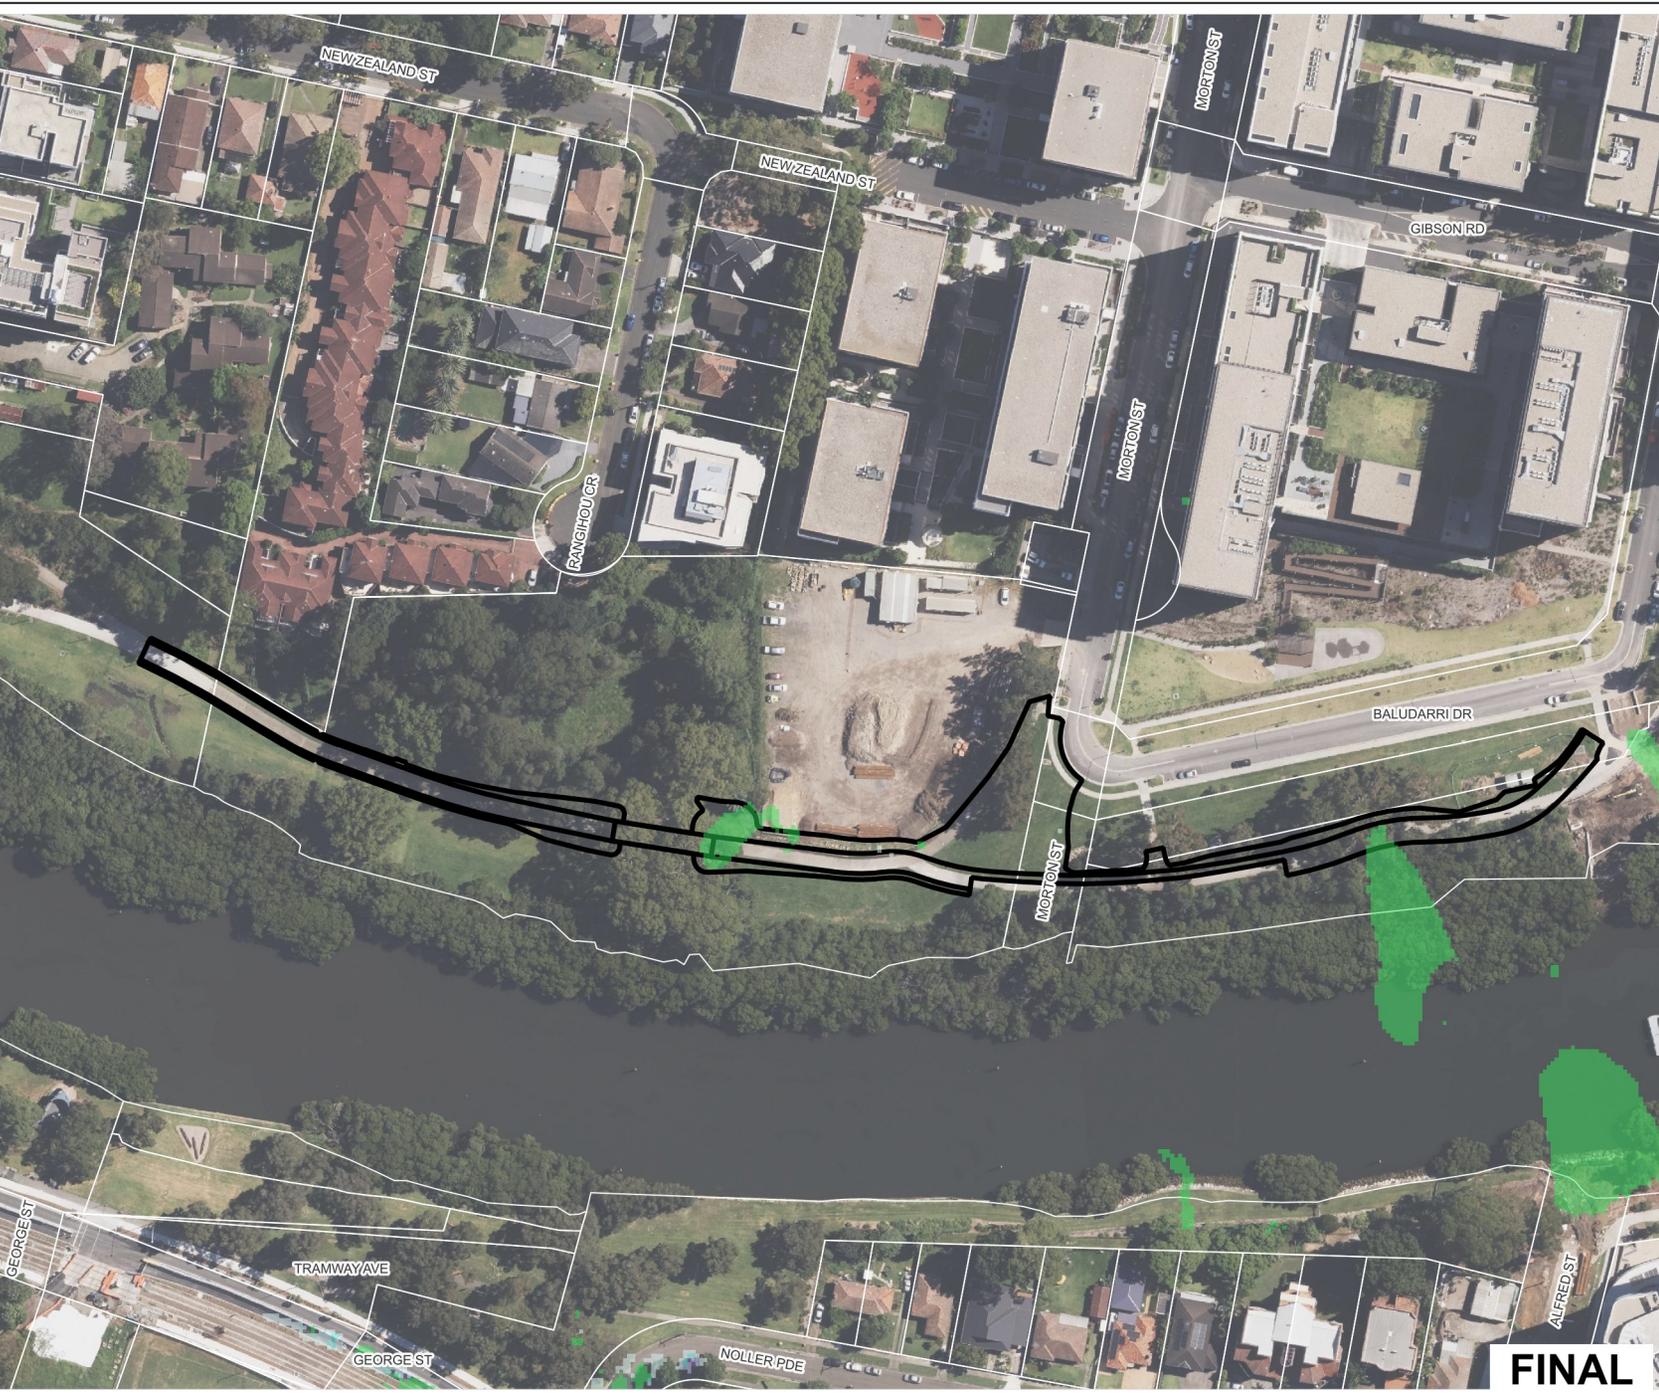
FIGURE: A13 **ISSUE:** A

- Impact
- 1pc_Impact
- Band 1
- <= -0.01
 - 0.005 - 0.002
 - 0.002 - 0.01
 - 0.01 - 0.015
 - 0.015 - 0.020
 - 0.020 - 0.030
 - 0.030 - 0.040
 - 0.040 - 0.050
 - 0.050 - 0.060
 - 0.060 - 0.080
 - 0.080 - 0.100
 - 0.100 - 0.120
 - 0.120 - 0.140
 - 0.140 - 0.165

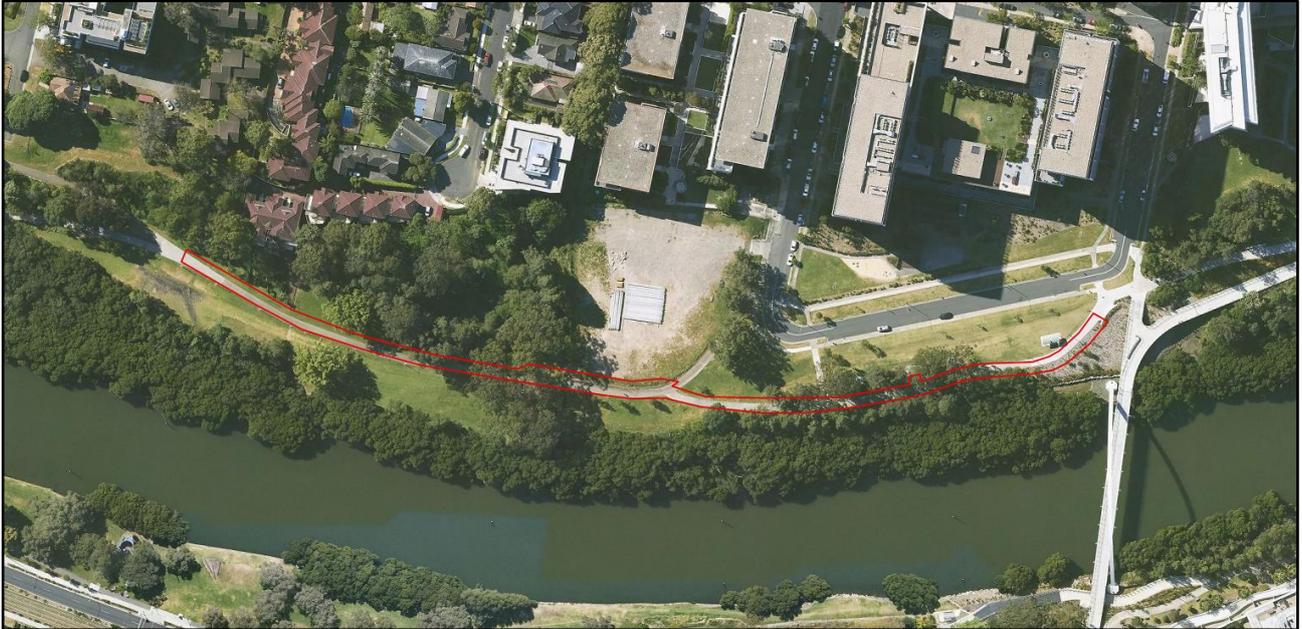
Figure 1: Site location

The site boundary is shown on Figure 1

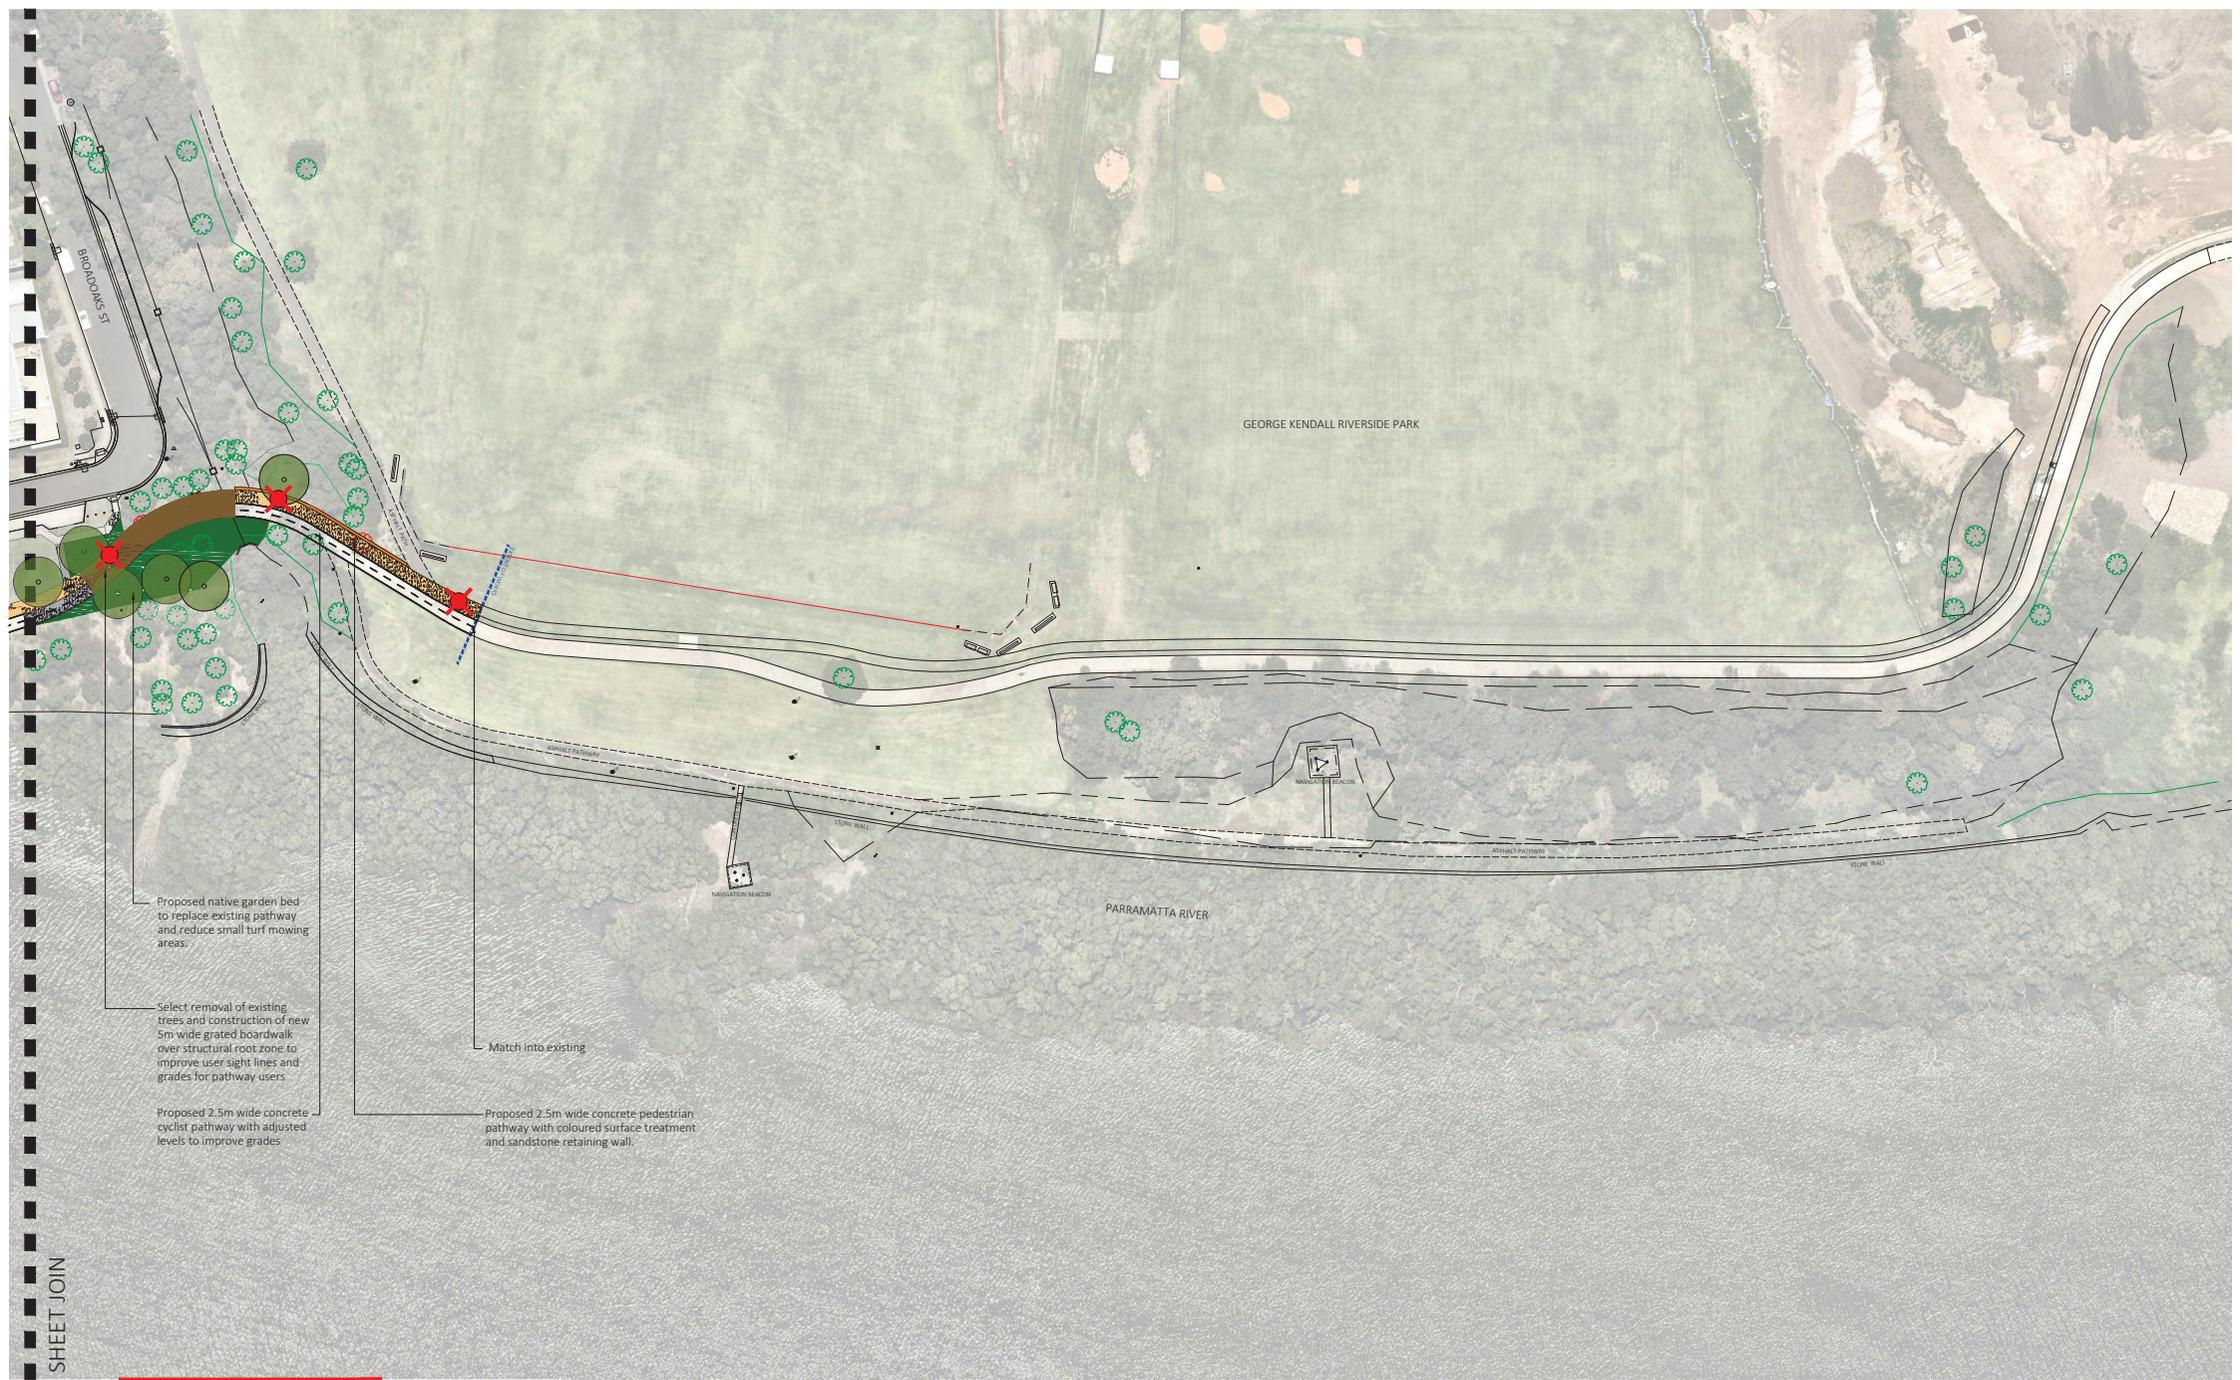
Proposed native garden bed to replace existing pathway and reduce small turf mowing areas.

Select removal of existing trees and construction of new 5m wide grated boardwalk over structural root zone to improve user sight lines and grades for pathway users

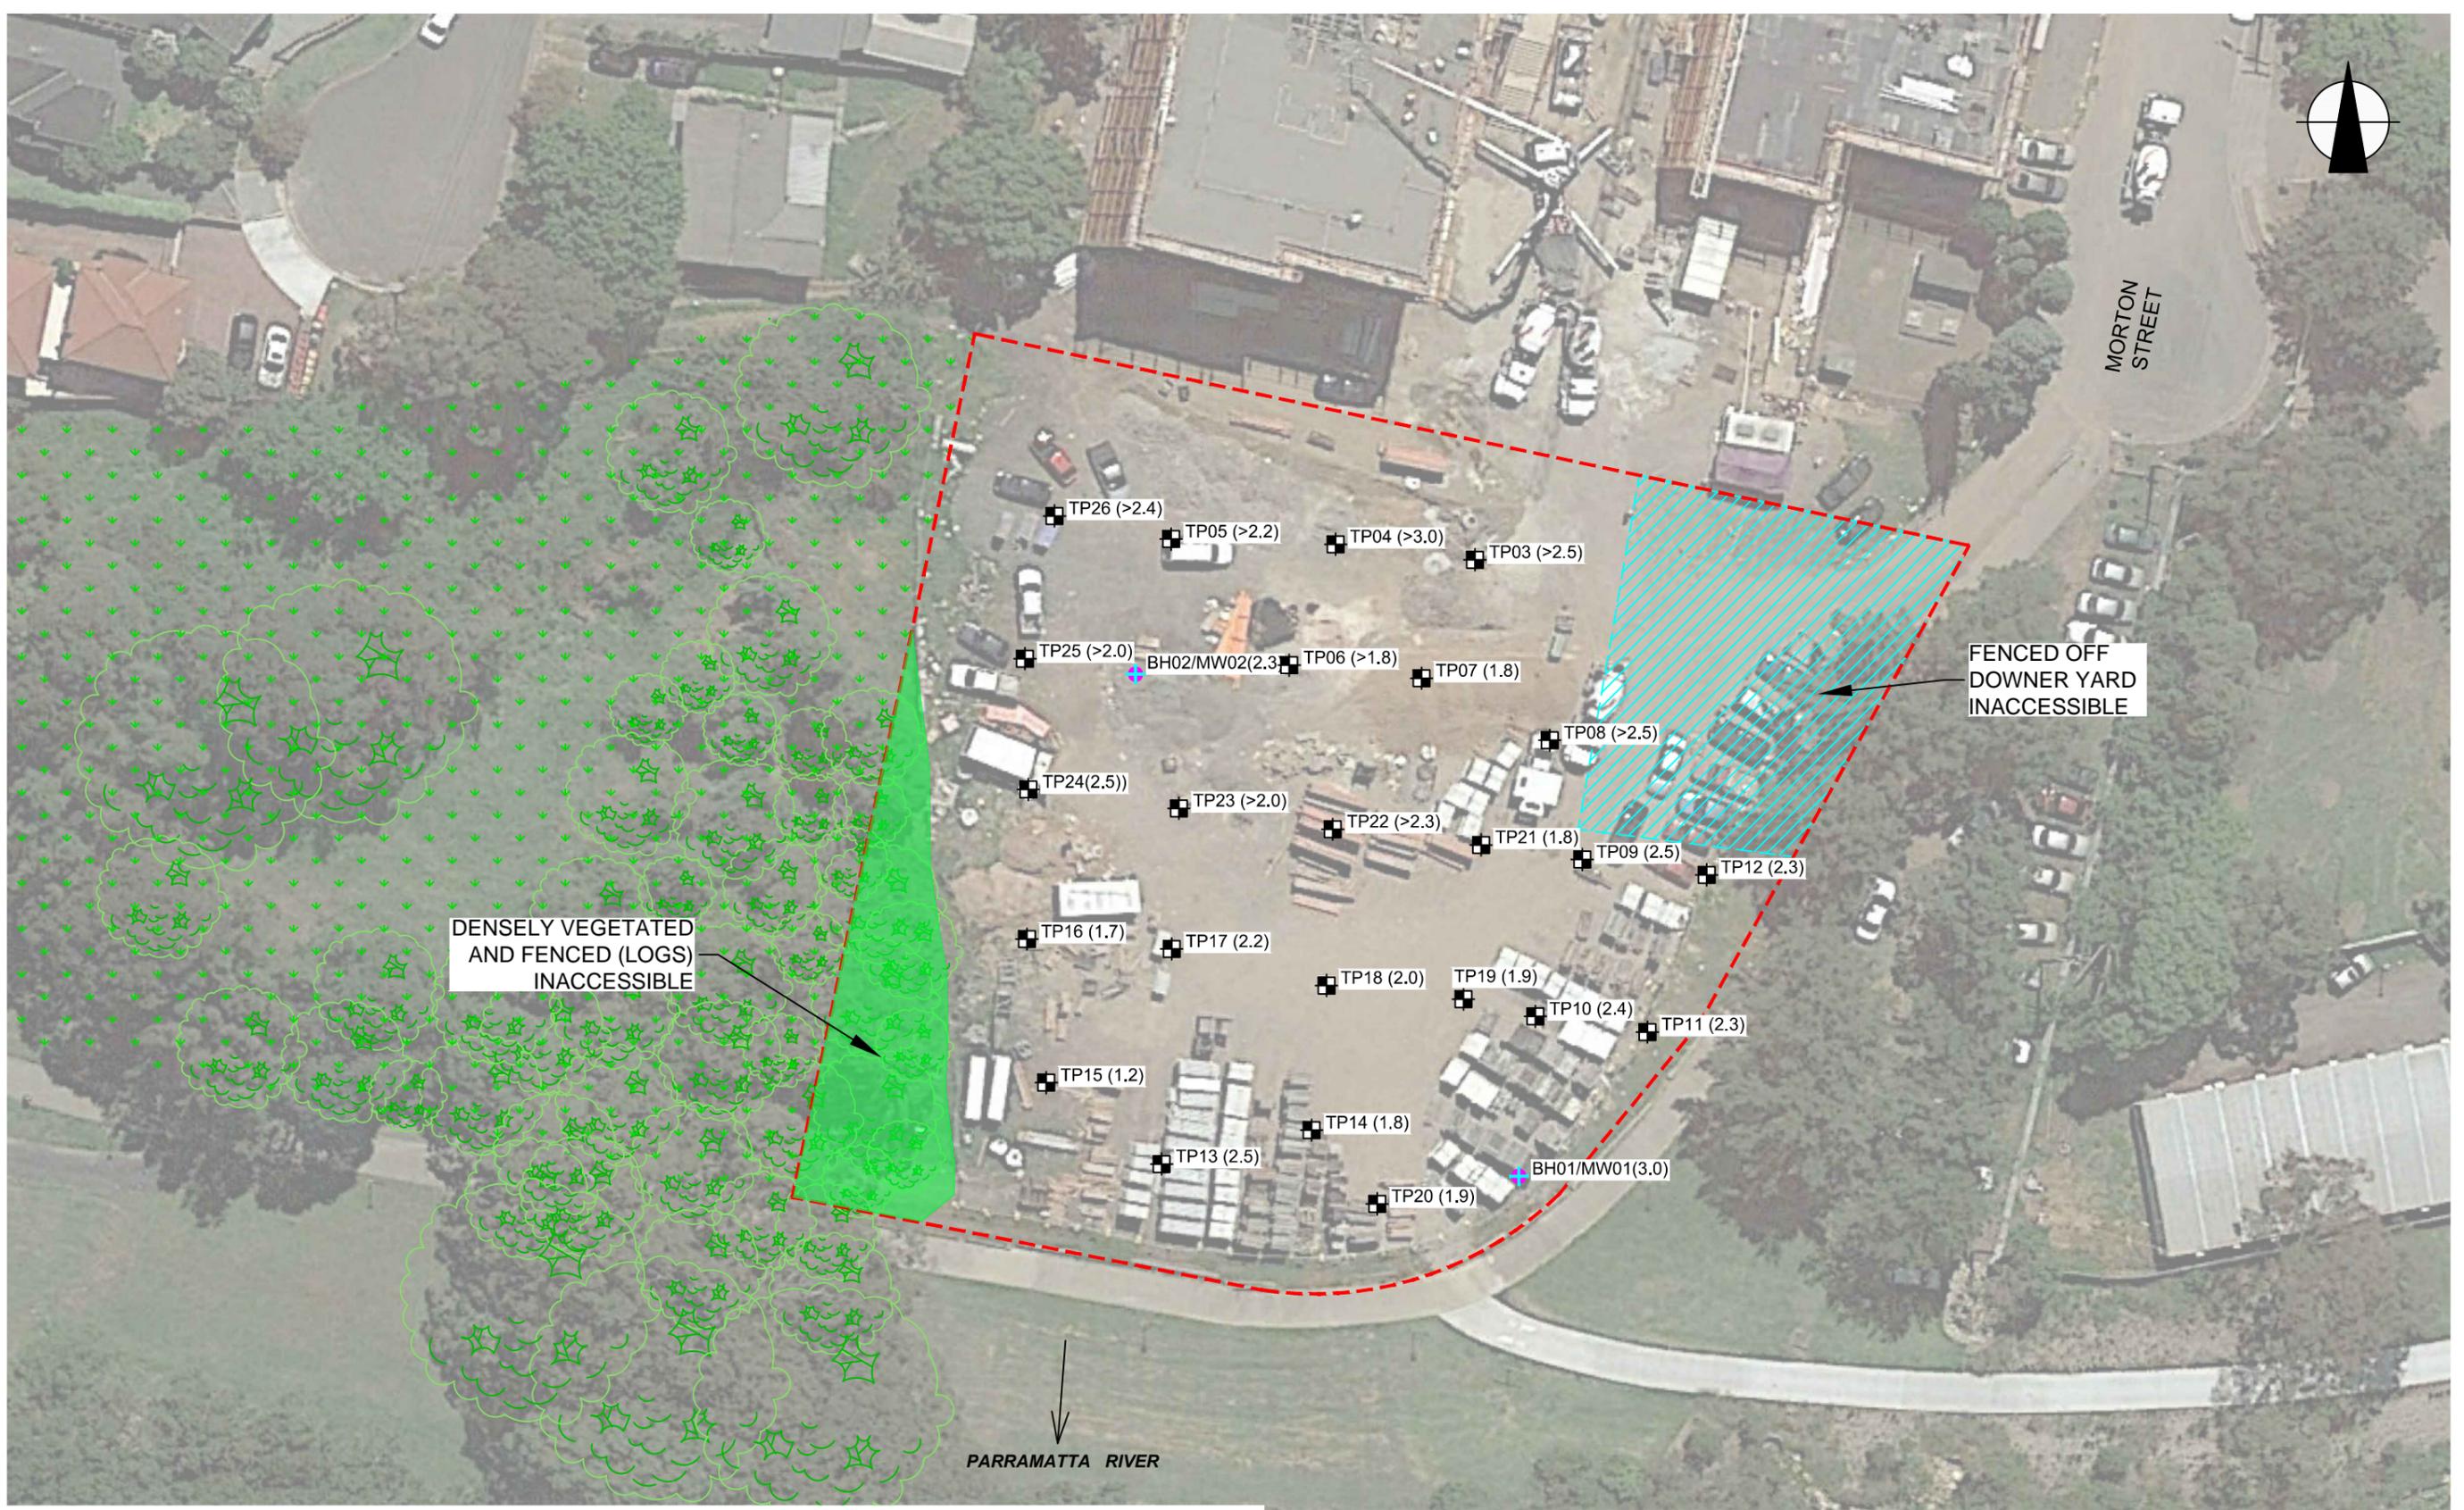
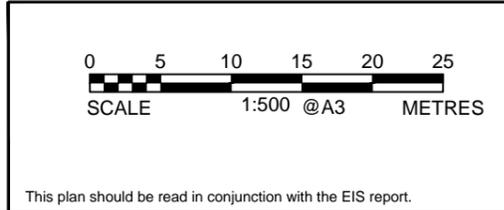
Title: SAMPLE LOCATION PLAN	
Location: RANGIHOU RESERVE, PART OF 1C & 1D MORTON STREET, PARRAMATTA, NSW	
Report No: E31269K	Figure No: 2
ENVIRONMENTAL INVESTIGATION SERVICES

- - - - - APPROXIMATE SITE BOUNDARY
- ◆ BH/MW(Fill Depth) BOREHOLE AND GROUND WATER MONITORING WELL LOCATION, NUMBER AND DEPTH OF FILL (m)
- ⊕ TP(Fill Depth) TEST PIT LOCATION, NUMBER AND DEPTH OF FILL (m)

Douglas notes that the assessment area partially includes the central-north portion of the current site. Of the 26 sampling locations, one test pit (TP20) and one borehole which was converted into a monitoring well (BH01/MW01) were within the current site (refer to EIS drawing attached in Appendix A). All concentrations of CoPC analysed in sampling locations relevant to the site for soil were reported below the adopted SAC except for asbestos in TP20 at 1.2-1.8 m bgl (0.2369% w/w) from asbestos sieving. It is noted that total PAH exceeded the adopted SAC in five test pits and asbestos was identified in 22 of the 26 sampling locations across the assessment area from asbestos sieving. Furthermore, PACM fragments were identified sporadically across the ground surface. Groundwater analytical results were below the adopted SAC.
