PROJECT:
 RANGIHOU RESERVE SHARED PEDESTRIAN AND CYCLIST PATHWAY

DRAWING TITLE:
 EXISTING SCENARIO
 5YR ARI STORM EVENT
 MAXIMUM FLOOD DEPTH-VELOCITY

15.	Conclusions and recommendations	24
16.	References	25
17.	Limitations.....	26

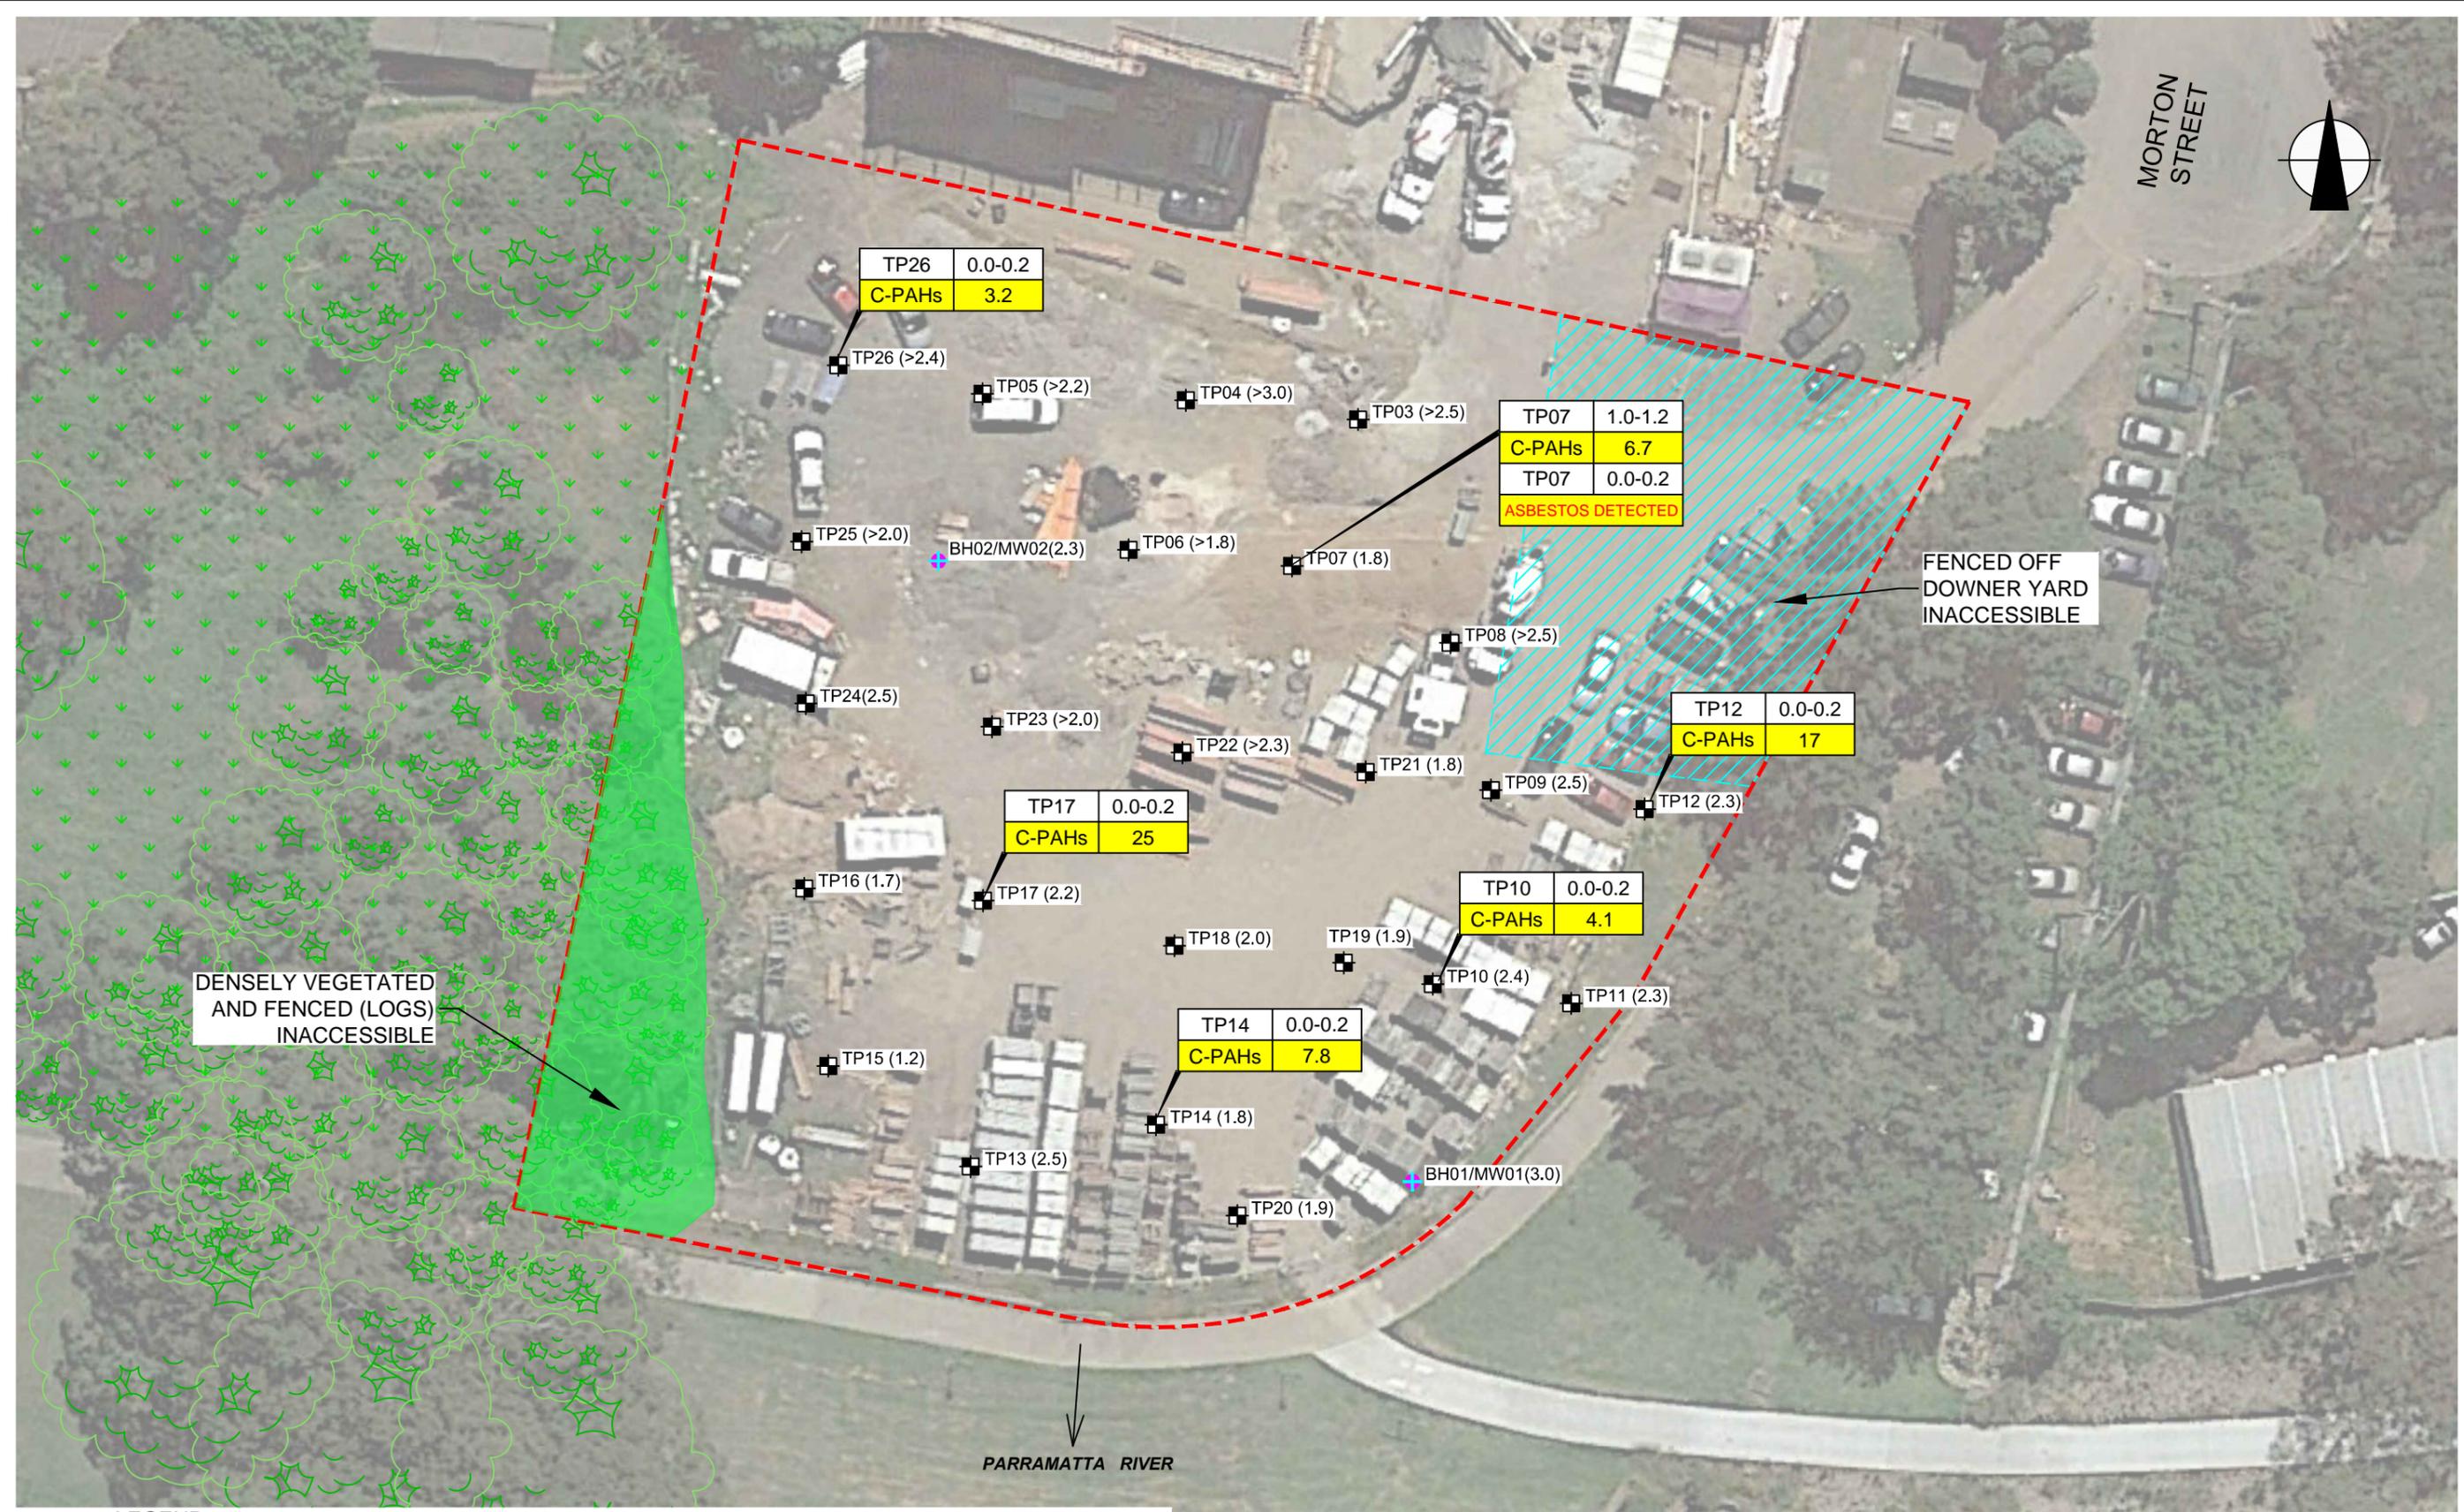
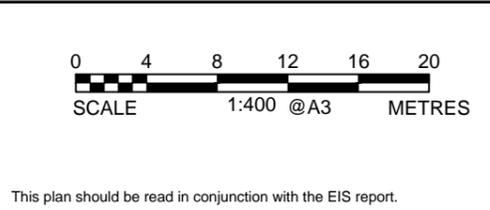
CONTAMINATION LOCATION PLAN	
Location: RANGIHOU RESERVE, PART OF 1C & 1D MORTON STREET, PARRAMATTA, NSW	
Report No: E31269K	Figure No: 3
ENVIRONMENTAL INVESTIGATION SERVICES

- - - APPROXIMATE SITE BOUNDARY
- + BH/MW(Fill Depth) BOREHOLE AND GROUND WATER MONITORING WELL LOCATION, NUMBER AND DEPTH OF FILL (m)
- + TP(Fill Depth) TEST PIT LOCATION, NUMBER AND DEPTH OF FILL (m)

SAMPLE ID	DEPTH (metres)
CHEMICAL	CONCENTRATION
CARCINOGENIC PAHs	SOIL CONTAMINATION ABOVE SAC FOR HUMAN HEALTH RISK (mg/kg)

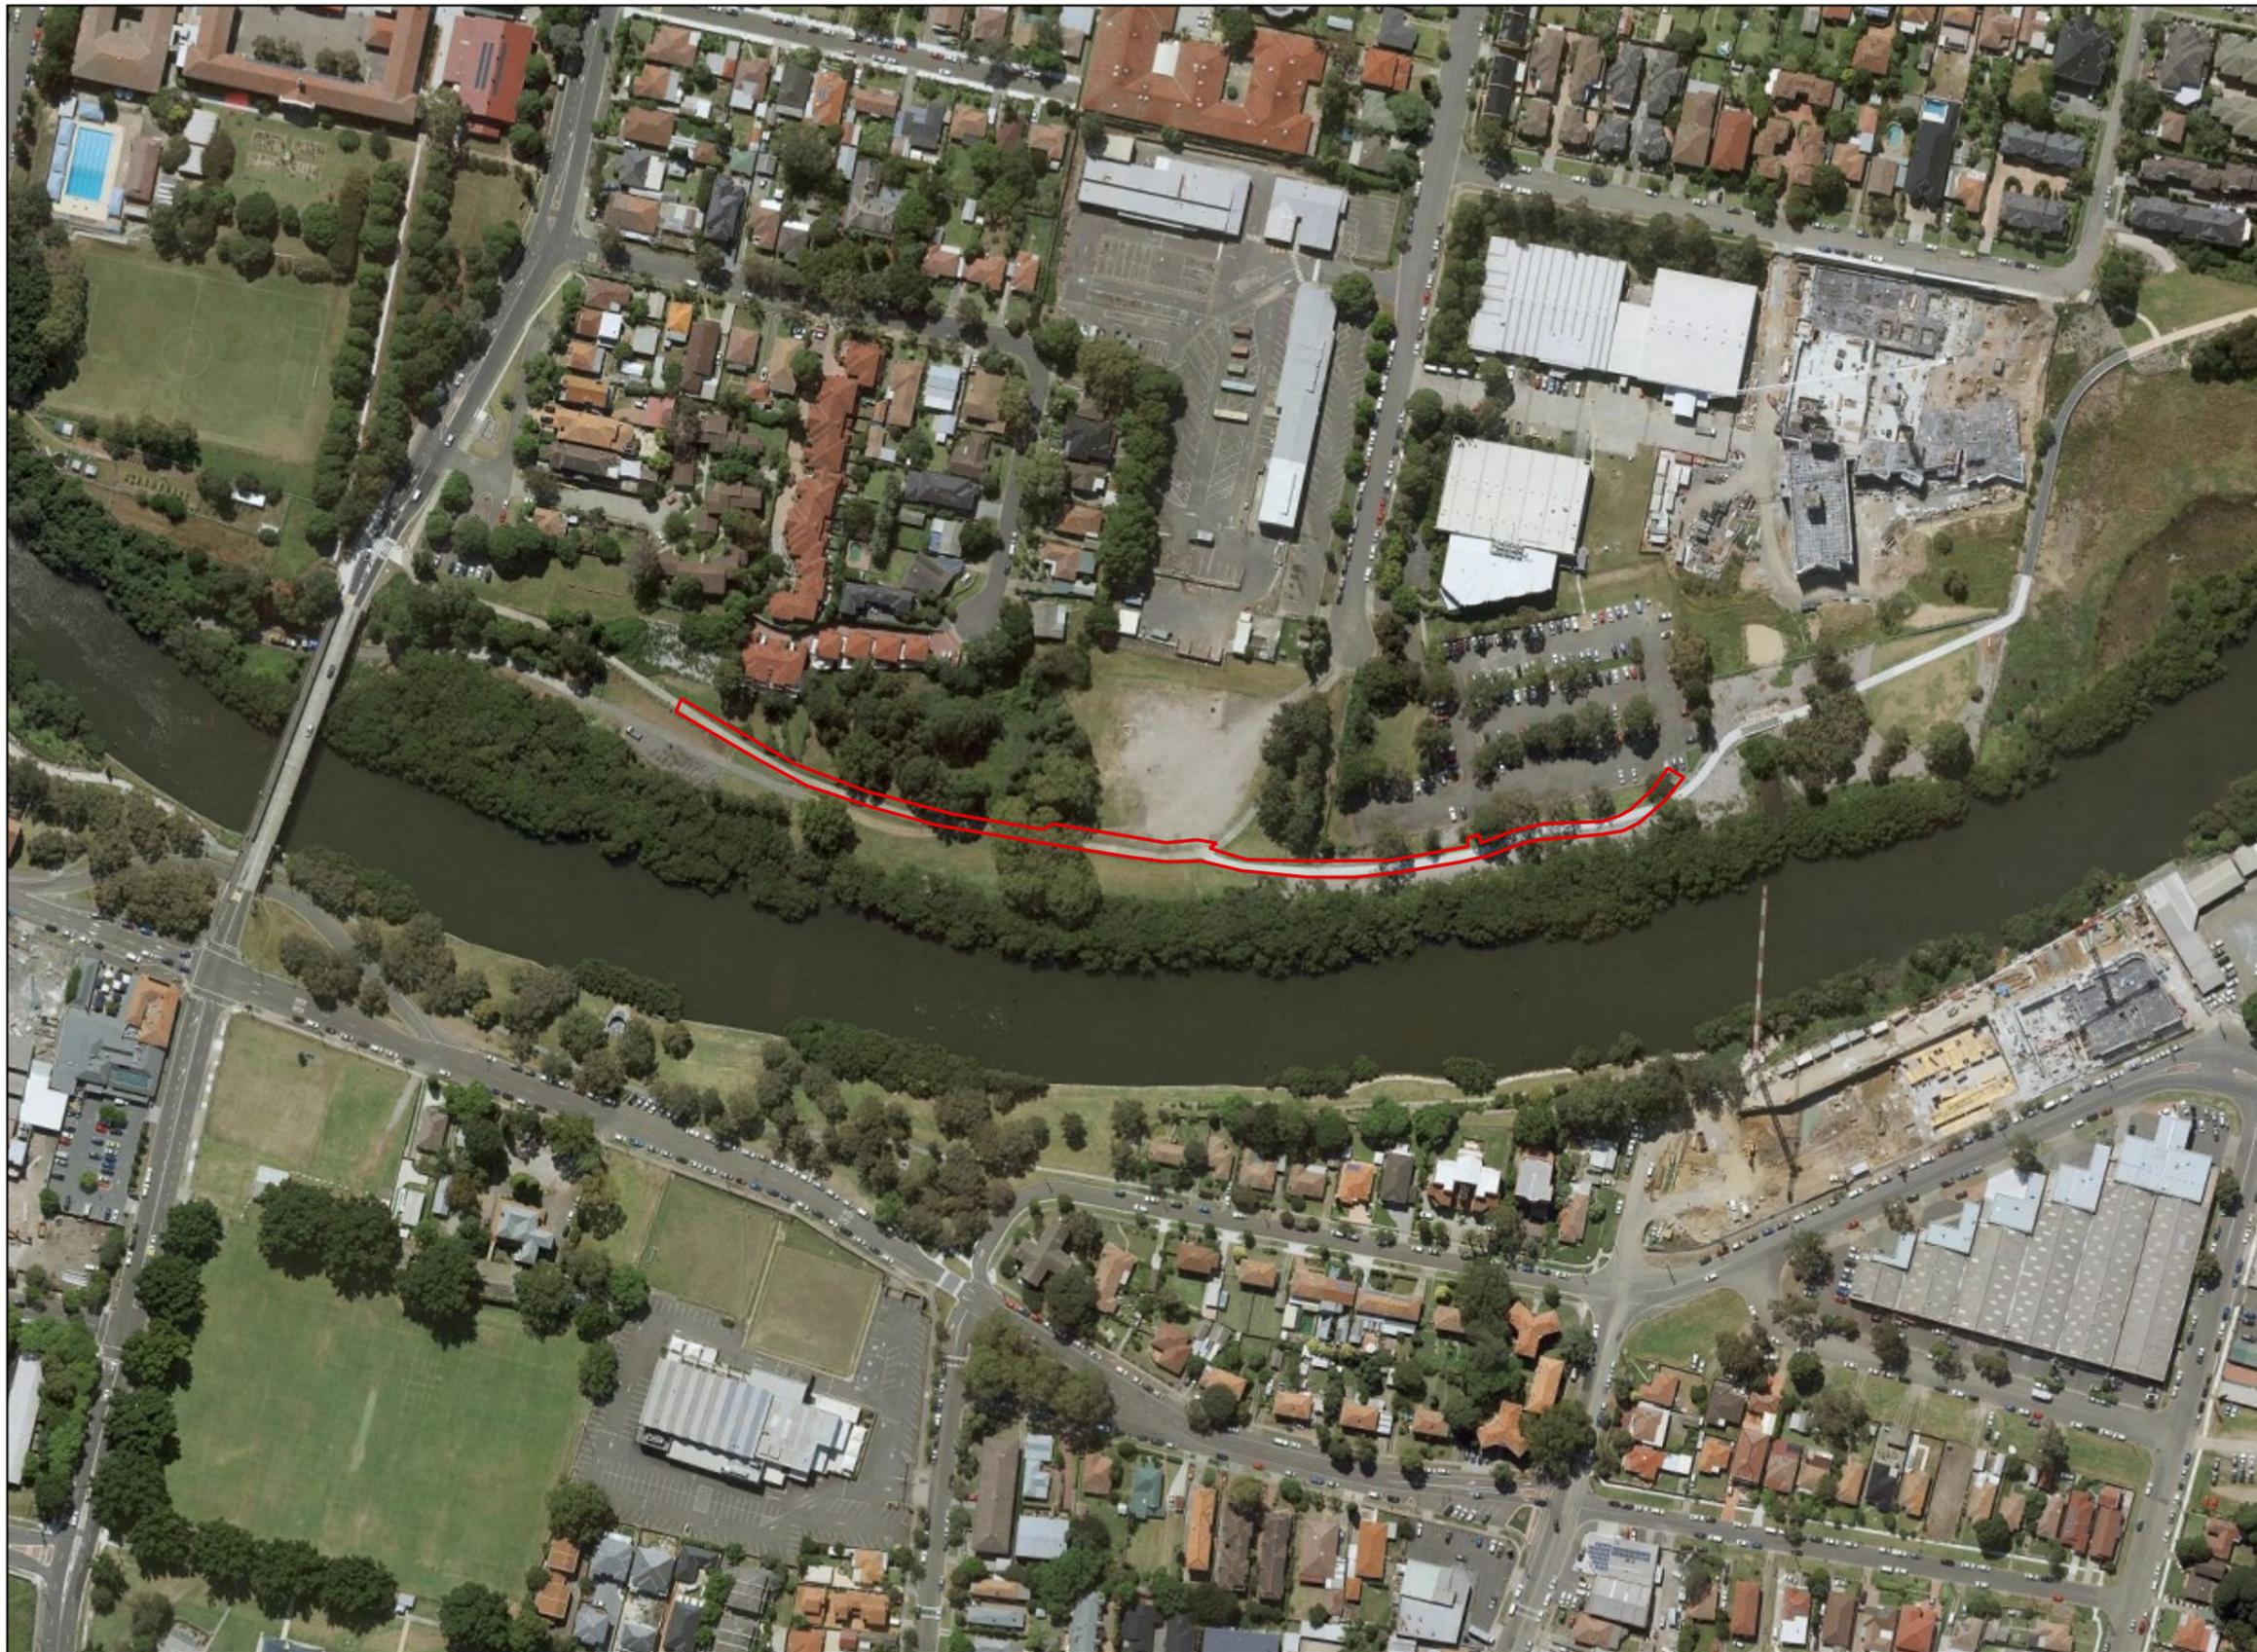
TITLE: **2005 Historical Aerial Imagery
Detailed Site (Contamination) Investigation
Rangihou Reserve, Rydalmere NSW**
