- DESIGN OPTION FEATURES
- 01 Southern Plaza - Concrete Finish
  - 02 Revitalised Riverside Walkway - Concrete Finish
  - 03 Wide Plaza Stair - Concrete Finish

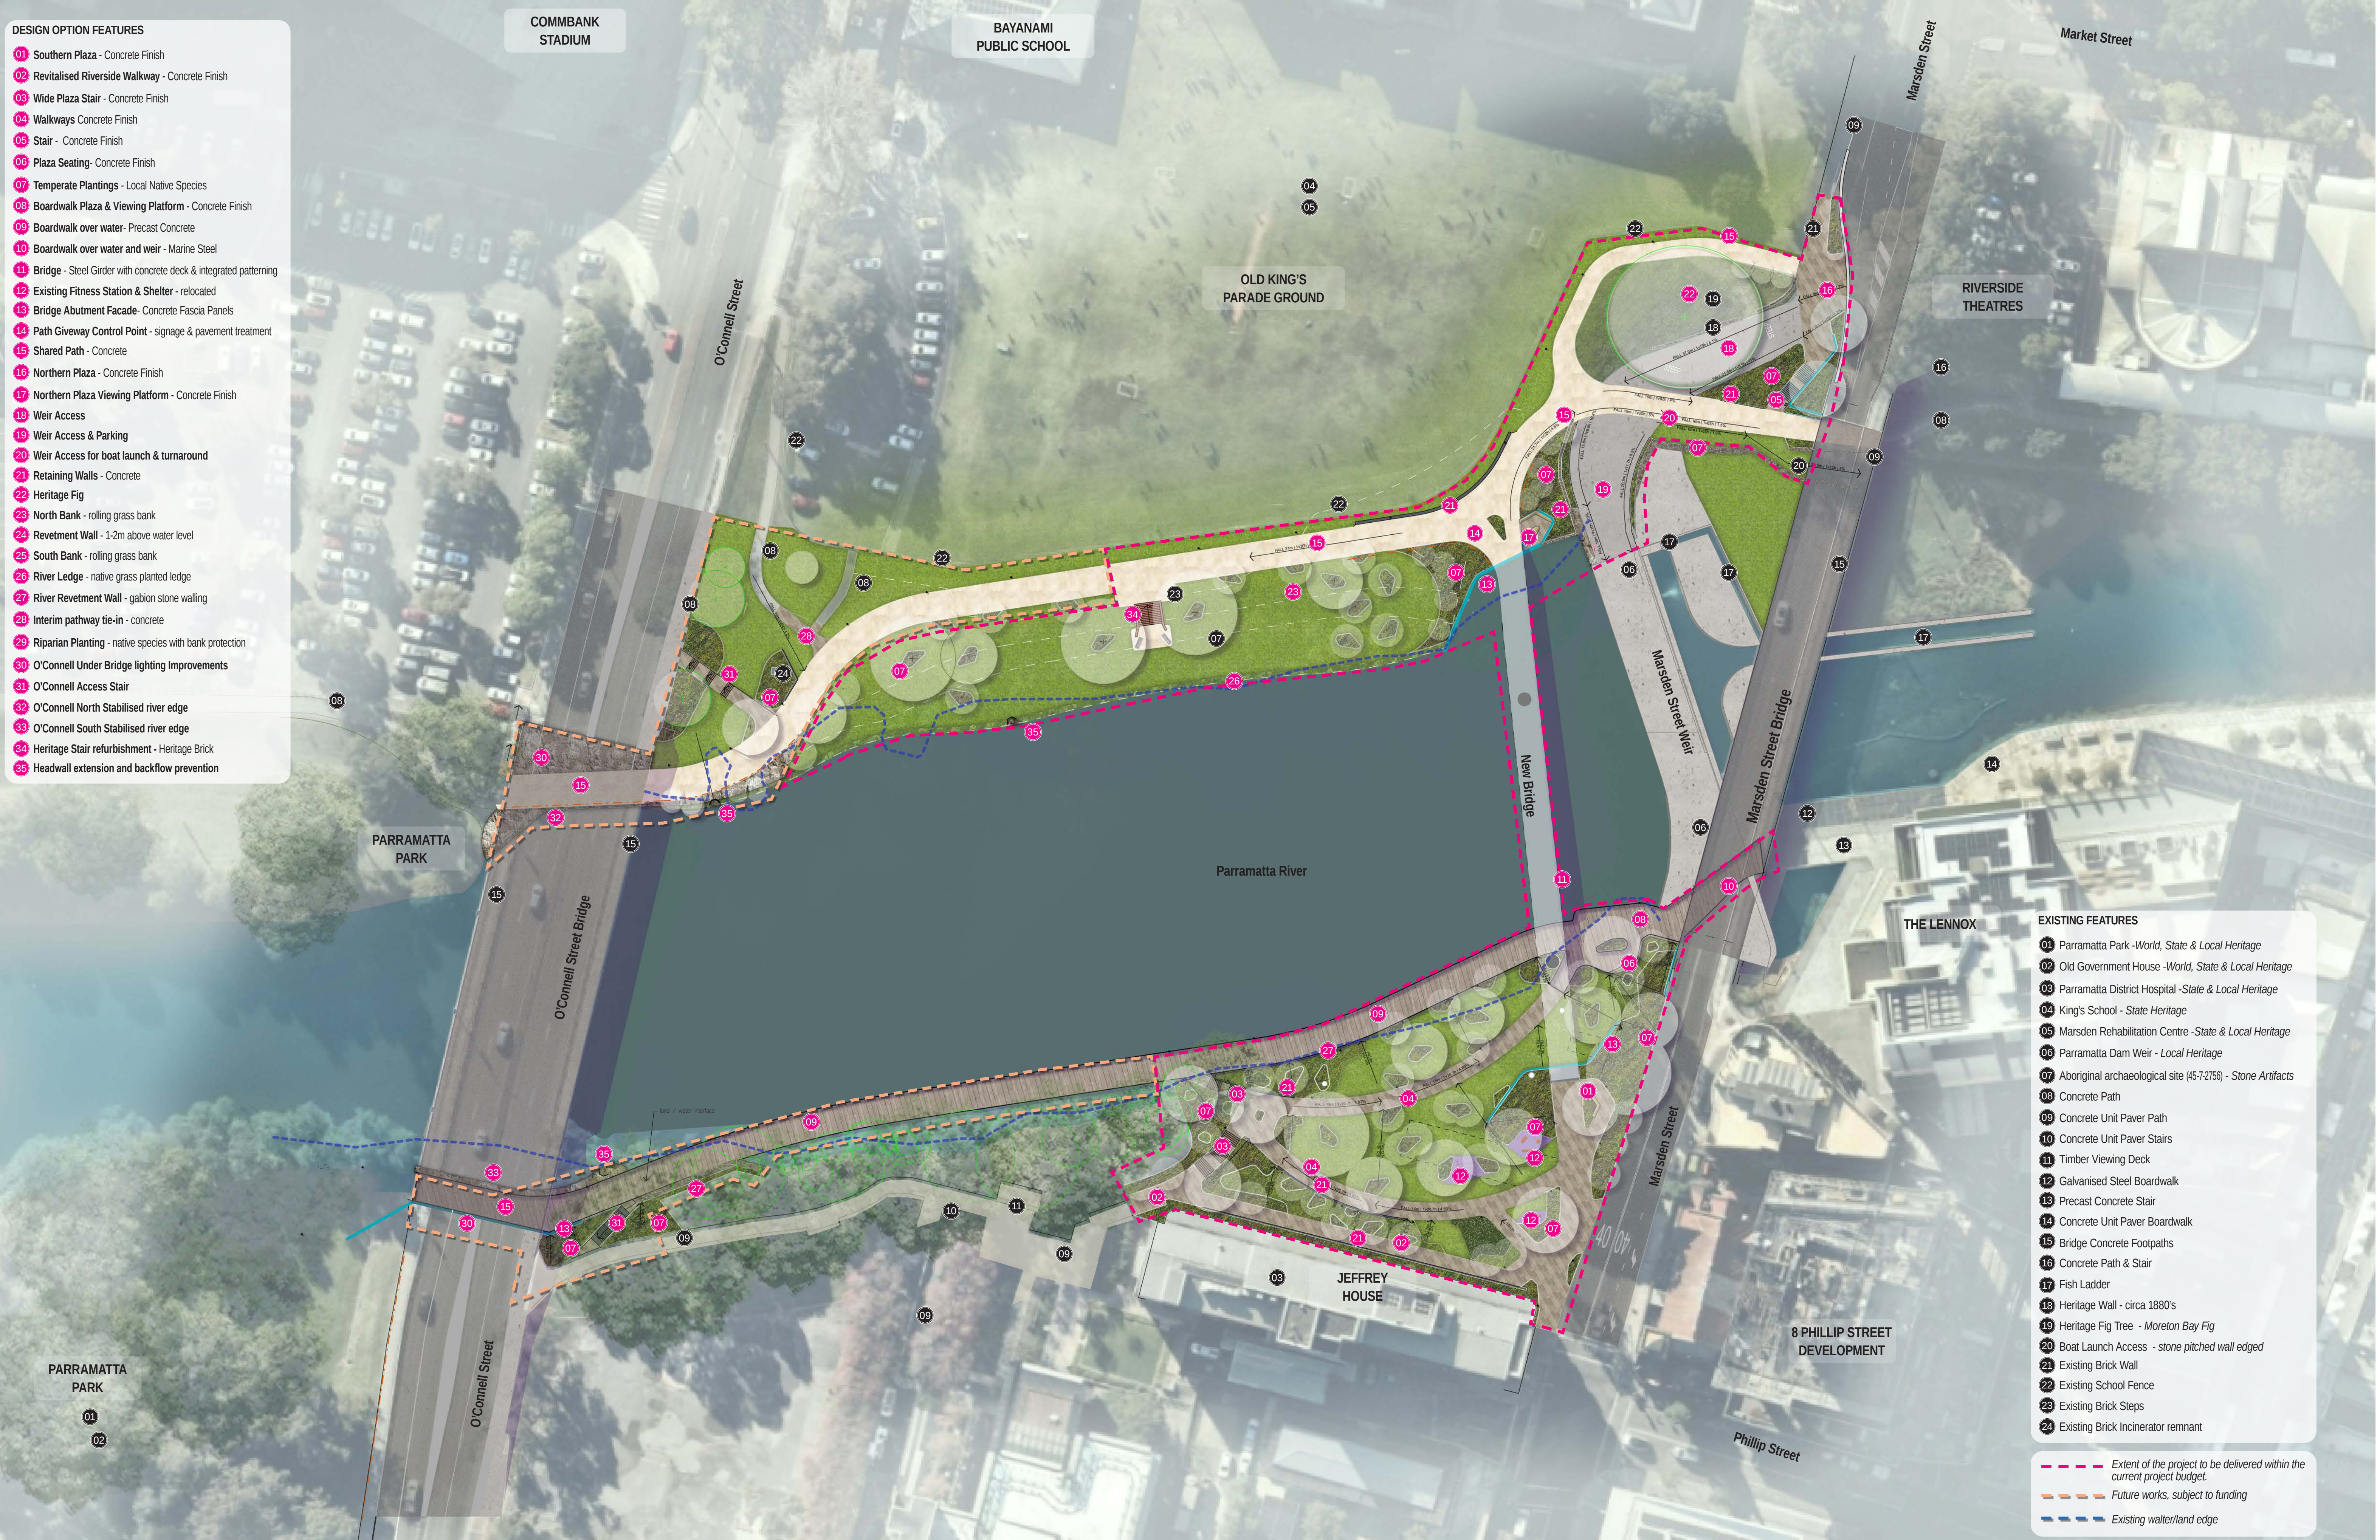
- 04 Walkways Concrete Finish
  - 05 Stair - Concrete Finish
  - 06 Plaza Seating- Concrete Finish
  - 07 Temperate Plantings - Local Native Species
  - 08 Boardwalk Plaza & Viewing Platform - Concrete Finish

- 09 Boardwalk over water- Precast Concrete
  - 10 Boardwalk over water and weir - Marine Steel
  - 11 Bridge - Steel Girder with concrete deck & integrated patterning

- 12 Existing Fitness Station & Shelter - relocated
  - 13 Bridge Abutment Facade- Concrete Fascia Panels
  - 14 Path Giveway Control Point - signage & pavement treatment

- 15 Shared Path - Concrete
  - 16 Northern Plaza - Concrete Finish
  - 17 Northern Plaza Viewing Platform - Concrete Finish
  - 18 Weir Access
  - 19 Weir Access & Parking

- 20 Weir Access for boat launch & turnaround
  - 21 Retaining Walls - Concrete
  - 22 Heritage Fig
  - 23 North Bank - rolling grass bank
  - 24 Revetment Wall - 1-2m above water level

- 25 South Bank - rolling grass bank
  - 26 River Ledge - native grass planted ledge
  - 27 River Revetment Wall - gabion stone walling
  - 28 Interim pathway tie-in - concrete

- 29 Riparian Planting - native species with bank protection
  - 30 O'Connell Under Bridge lighting Improvements
  - 31 O'Connell Access Stair
  - 32 O'Connell North Stabilised river edge

- 33 O'Connell South Stabilised river edge
  - 34 Heritage Stair refurbishment - Heritage Brick
  - 35 Headwall extension and backflow prevention

- EXISTING FEATURES
- 01 Parramatta Park - World, State & Local Heritage
  - 02 Old Government House - World, State & Local Heritage
  - 03 Parramatta District Hospital - State & Local Heritage

- 04 King's School - State Heritage
  - 05 Marsden Rehabilitation Centre - State & Local Heritage
  - 06 Parramatta Dam Weir - Local Heritage
  - 07 Aboriginal archaeological site (45-72756) - Stone Artifacts

- 08 Concrete Path
  - 09 Concrete Unit Paver Path
  - 10 Concrete Unit Paver Stairs
  - 11 Timber Viewing Deck
  - 12 Galvanised Steel Boardwalk
  - 13 Precast Concrete Stair

- 14 Concrete Unit Paver Boardwalk
  - 15 Bridge Concrete Footpaths
  - 16 Concrete Path & Stair
  - 17 Fish Ladder
  - 18 Heritage Wall - circa 1880's
  - 19 Heritage Fig Tree - Moreton Bay Fig

- 20 Boat Launch Access - stone pitched wall edged
  - 21 Existing Brick Wall
  - 22 Existing School Fence
  - 23 Existing Brick Steps
  - 24 Existing Brick Incinerator remnant
